***Federal Railroad Administration
Office of Railroad Safety
Accident and Analysis Branch***

***Accident Investigation Report
HQ-2018-1294***

***BNSF Railway Company (BNSF) Derailment
Devore, California
August 21, 2018***

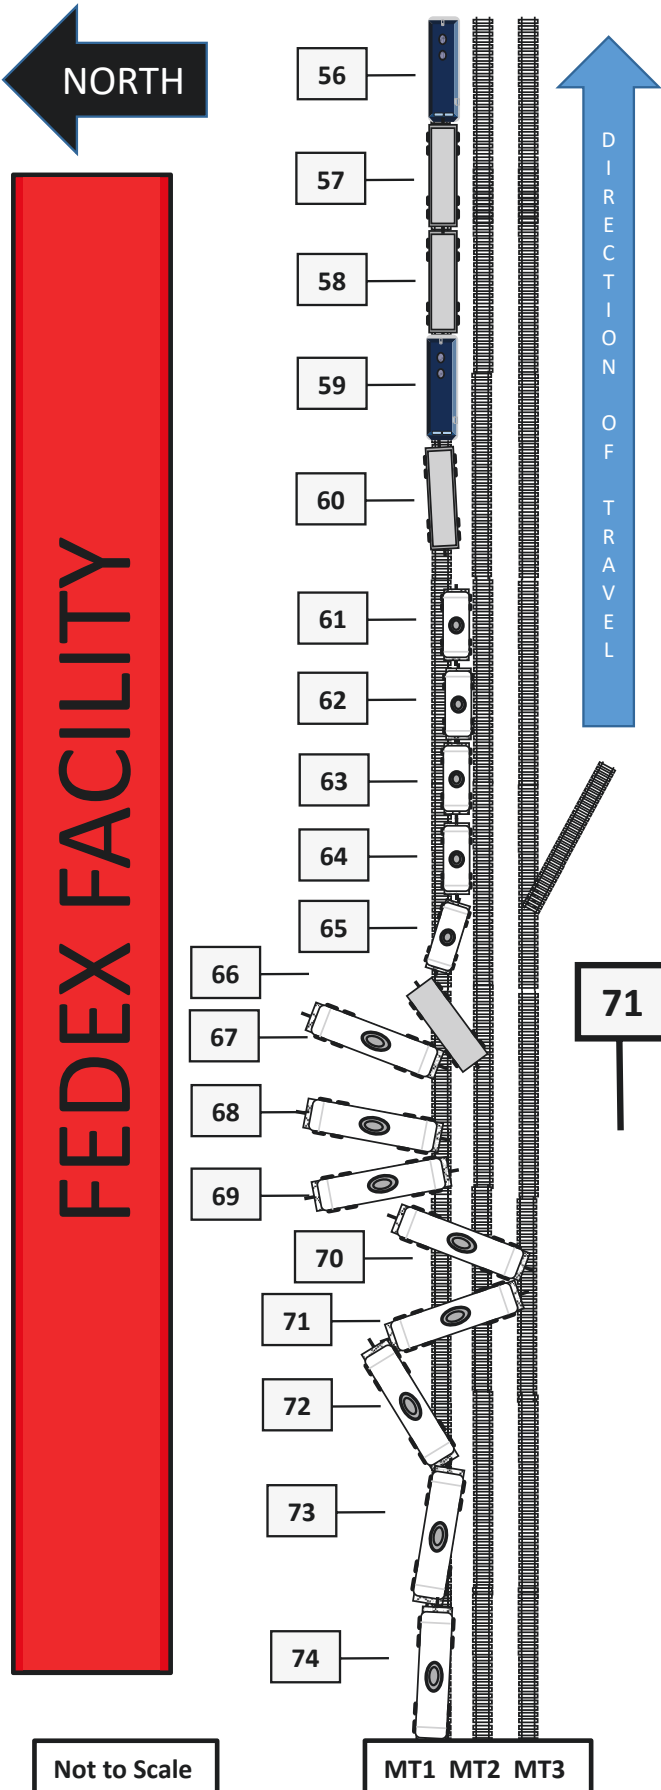
Sketch - Accident Sketch

**BNSF CAJON SUB DERAILMENT
AUGUST 21, 2018
Pileup at Milepost 71.0, MT #3**

- 56 – Metrolink Locomotive # 928
- 57 – Flat car # TPAX 93868
- 58 – Flat car # HTTX 93073
- 59 – Metrolink Locomotive # 931
(1 set of trucks derailed)
- 60 – Flat car # OTTX 97210
- 61 – Tank car # ADMX 19582
- 62 – Tank car # GATX 225272
- 63 – Tank car # CRGX 7270
- 64 – Tank car # CRGX 8184
- 65 – Tank car # CRGX 7808
- 66 – Box car # CNA 406117
- 67 – Tank car # GATX 22539 – (HAZ)
- 68 – Tank car # GATX 89009
- 69 – Tank car # GATX 200626
- 70 – Tank car # UTLX 201919 - (Breached HAZ)
- 71 – Tank car # GBRX 703653 - Breached HAZ)
- 72 – Tank car # GATX 223085 – (HAZ)
- 73 – Tank car # NCPX 51 - (HAZ)
- 74 – Tank car # GATX 89136 - (HAZ)
(1 set of trucks derailed)

This sketch represents the crash site of westbound BNSF train H-BARLAC-1-20A (BNSF 3755 West). The point of derailment (POD) was located on MT #3 at Milepost 69.3, at the CP Keenbrook, east switch, east cross-over Track 3 to Track 2 near the guard rail.
