***Federal Railroad Administration  
Office of Railroad Safety  
Accident and Analysis Branch***

***Accident Investigation Report  
HQ-2019-1340***

***Union Pacific Railroad Company (UP) Derailment  
Stanwood, Iowa  
June 6, 2019***

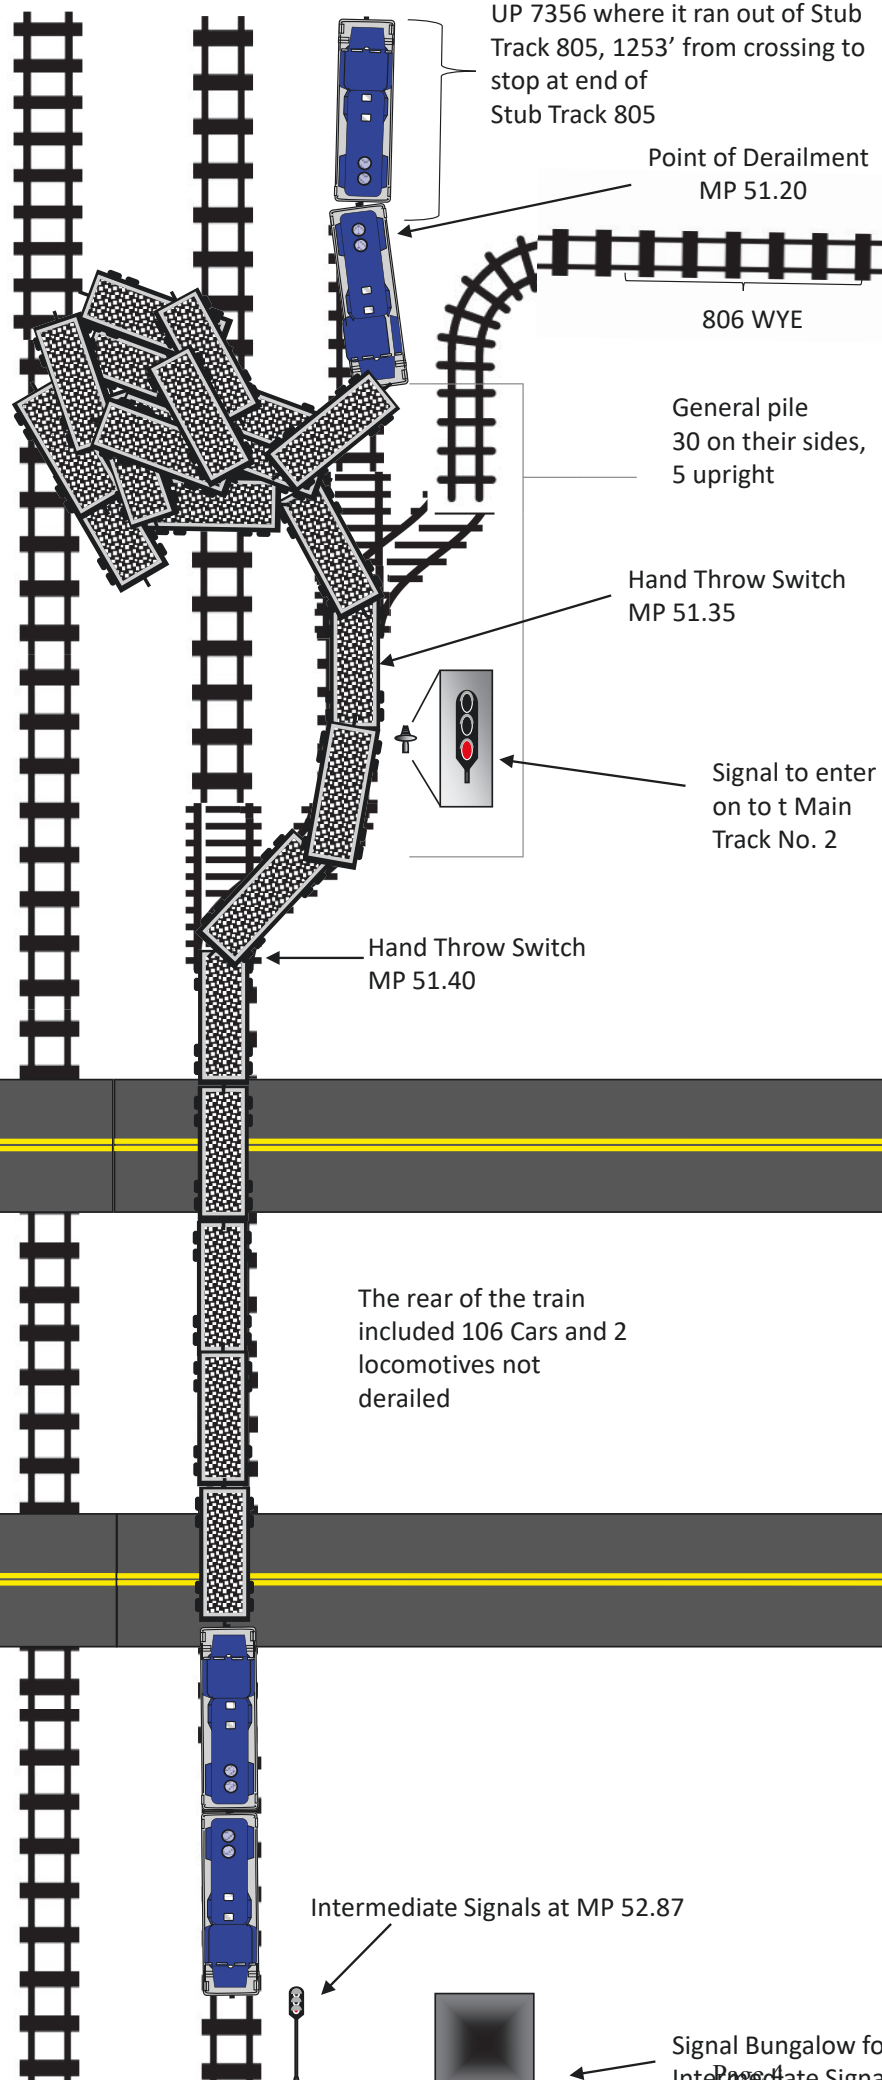
Maple Street crossing/Track Repeater Bungalow

Maple St Crossing MP 51.43  
Crossing DOT No. 190442B

Main Street Crossing MP 51.57  
Crossing DOT No. 190443H
