***Federal Railroad Administration
Office of Railroad Safety
Accident and Analysis Branch***

***Accident Investigation Report
HQ-2018-1306***

***Wheeling & Lake Erie Railway Company (WE)
Head-On Collision
Akron, Ohio
November 19, 2018***

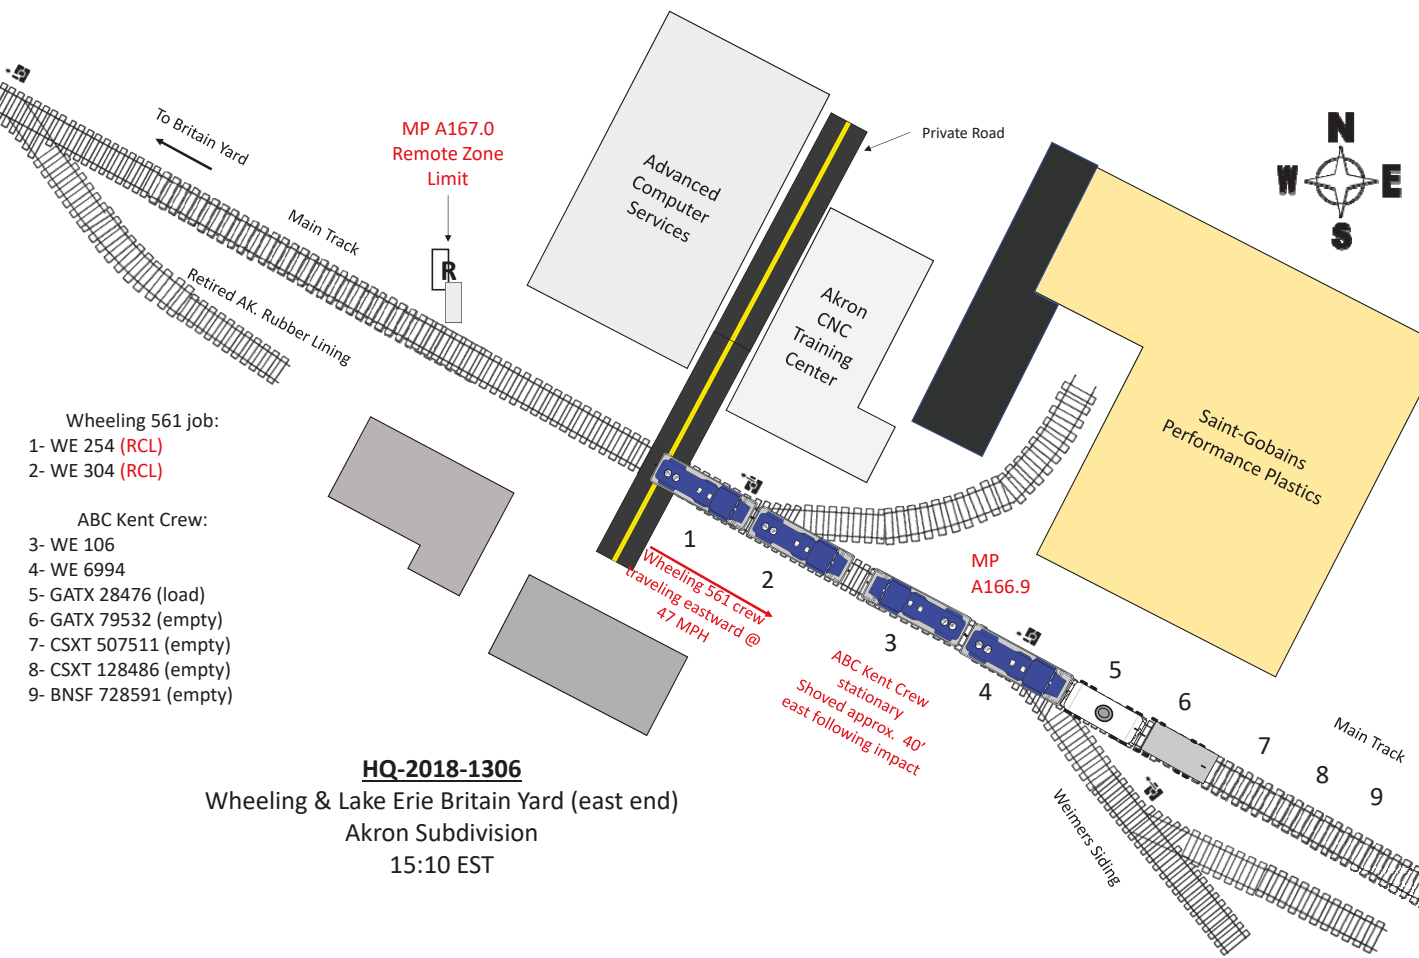
Sketch - Accident Sketch

HQ-2018-1306
Wheeling & Lake Erie Britain Yard (east end)
Akron Subdivision
15:10 EST
