***Federal Railroad Administration  
Office of Railroad Safety  
Accident and Analysis Branch***

***Accident Investigation Report  
HQ-2019-1344***

***Union Pacific Railroad Company (UP) Derailment  
Wells, Nevada  
June 19, 2019***

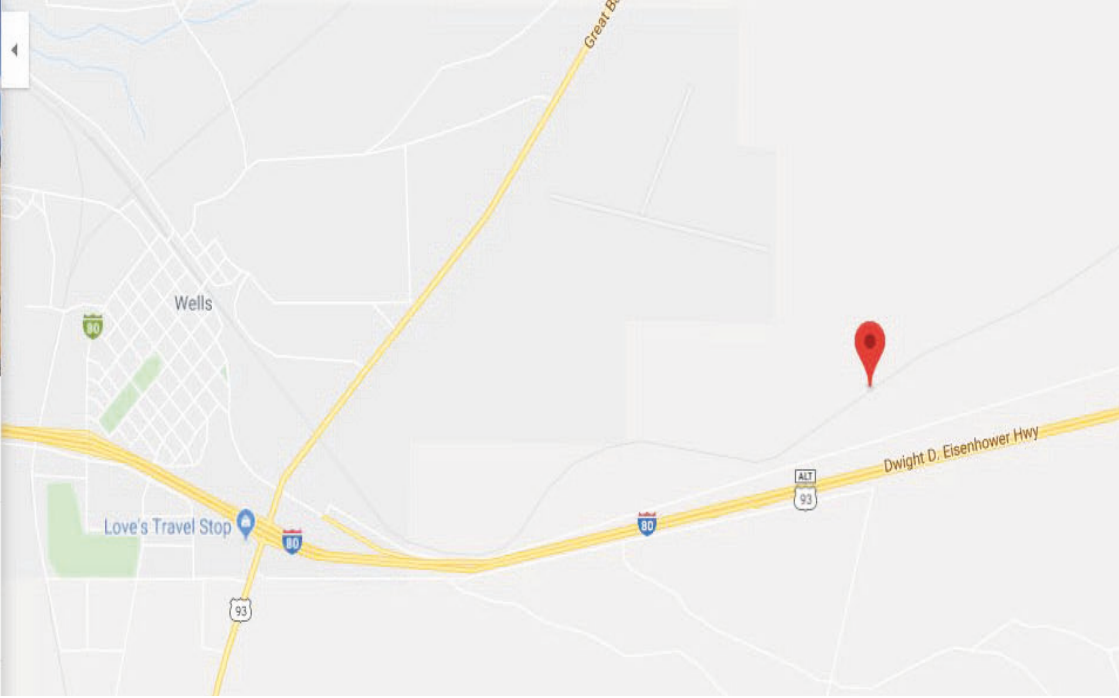
Sketch - Sketch Wells, NV

DPU Locomotive No. UP 4609 (2 total mid-train DPU's locomotive behind 78<sup>th</sup> car from the head end of train )

27 derailed cars (59<sup>th</sup> – 85<sup>th</sup> from head-end of train)

58 head non-derailed cars
