***Federal Railroad Administration
Office of Railroad Safety
Accident and Analysis Branch***

***Accident Investigation Report
HQ-2019-1368***

***Norfolk Southern Railway Company (NS) Derailment
Perry, Georgia
October 9, 2019***

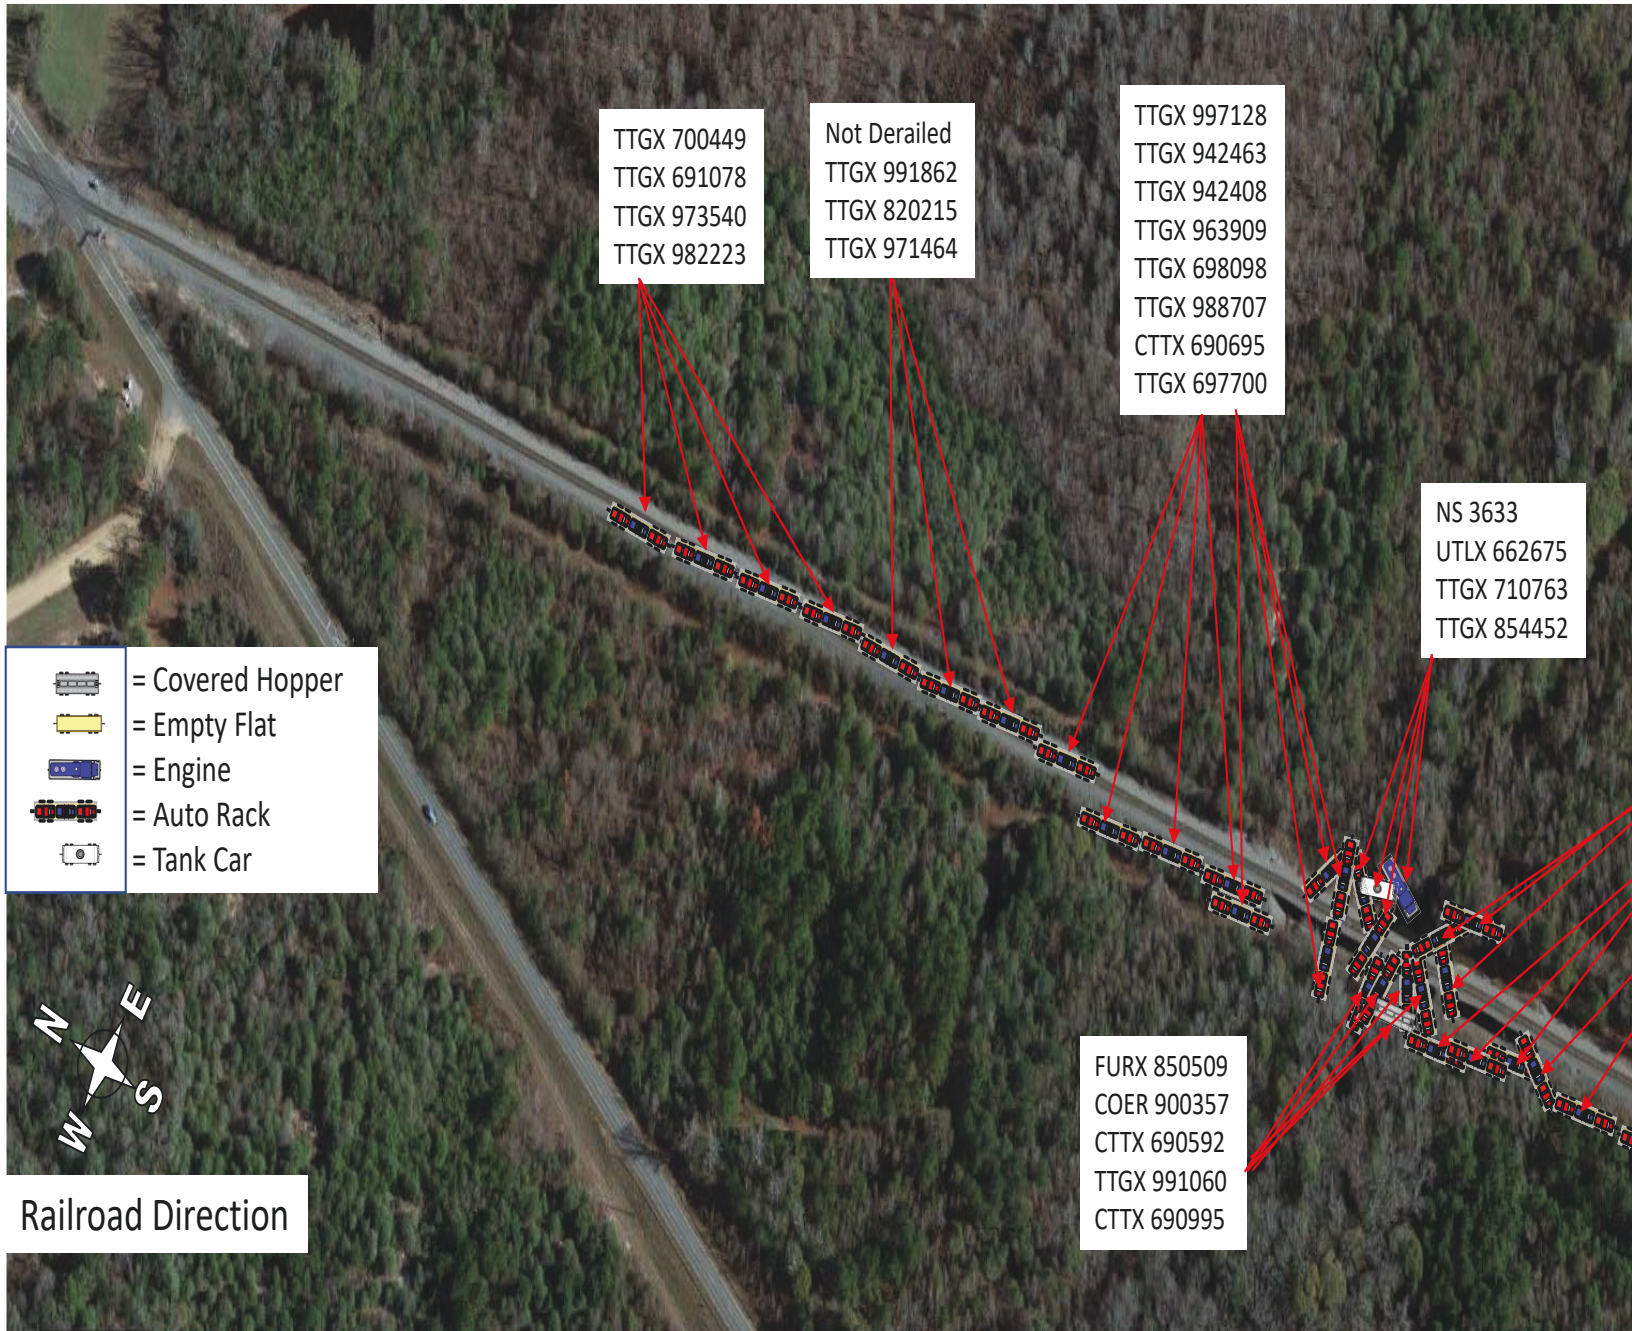
Sketch - Perry derailment sketch

Approximately 750 feet south of road crossing DOT 729192, cars 61 – 88, and 92 – 95 derailed. Cars 61 - 62 remained upright, while cars 64 - 87, including the DP locomotive, derailed in an accordion-style. Additionally, cars 88 and 92 - 95 derailed and remained upright, totaling 32 cars and 1 locomotive derailed. The first 3 cars derailed were empties and the remaining 29 were loaded. None of the cars derailed contained hazardous material. One tank car line No. 74 (UTLX 662675) was punctured,
