FOURTH FIVE-YEAR REVIEW REPORT FOR ORMET CORP. SUPERFUND SITE MONROE COUNTY, OHIO

U.S. Environmental Protection Agency Region 5 Chicago, Illinois

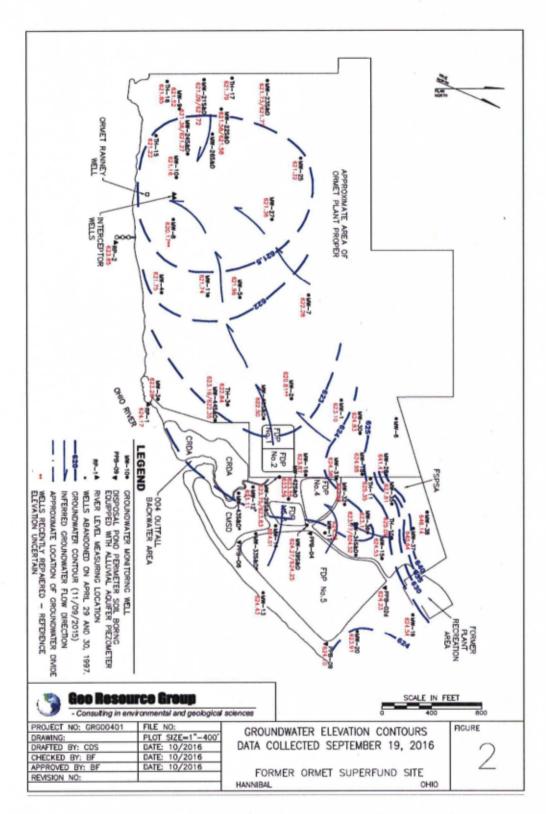
OU(s):	Issue Category: Remedy Performance Issue: The Ranney Well, operating alone at a lower pumpage rate and without the two interceptor wells, does not fully contain a small portion of the contaminant plume in the eastern portion of the Site. The facility is required to establish and maintain a capture zone of contaminated groundwater in the alluvial aquifer as established by the 1995 Consent Decree and the ROD. Recommendation: Increase the pumping rate of the Ranney well to fully contain the plume.			
01/Sitewide				
Affect Current Protectiveness	Affect Future Party Oversight Milestone Date Protectiveness Responsible Party			
No	Yes	Other- Property Owner	EPA	6/4/2017

Figure 3. Groundwater elevation contours from 2016 Remedial Action Groundwater Monitoring Report showing general groundwater flow from the northeast to the southwest towards the Ranney Well. Small portion of the groundwater flow on the easternmost part of the Site is not contained by the pumping of the Ranney Well.

A study should be conducted to determine the effectiveness of increasing the pumping rate at the Ranney well in containing the groundwater plume. A study could also be conducted to determine the effectiveness of the FSPSA sprayfield in flushing contaminates.

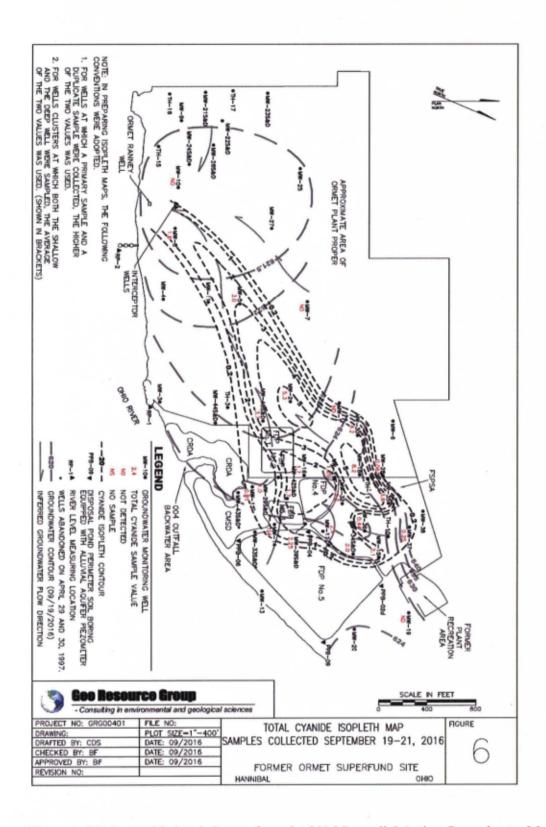
Figure 4. WAD cyanide isopleth map from the 2016 Remedial Action Groundwater Monitoring Report. WAD cyanide concentrations are highest downgradient from the FSPSA to the southwest.

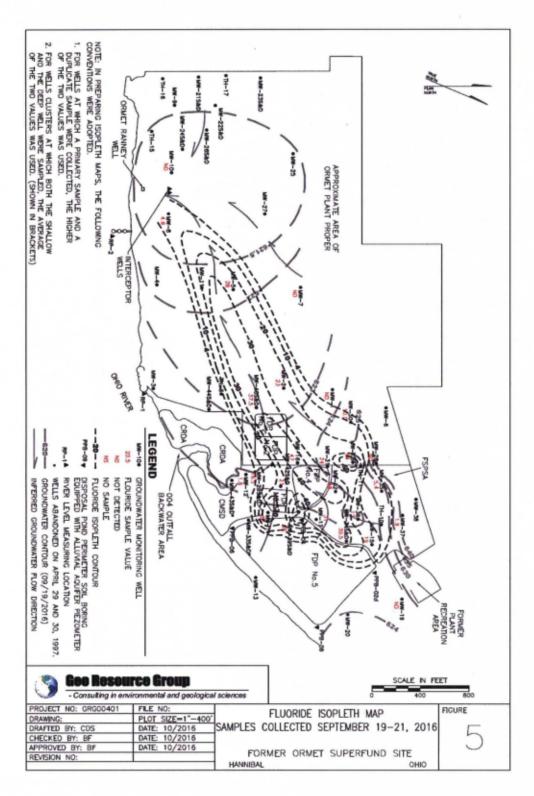
Figure 5. Fluoride isopleth map from the 2016 Remedial Action Groundwater Monitoring Report. Fluoride concentrations are highest downgradient from the FSPSA to the southwest.
