***Federal Railroad Administration  
Office of Railroad Safety  
Accident and Analysis Branch***

***Accident Investigation Report  
HQ-2020-1377***

***CSX Transportation (CSX) Derailment and Fire  
Draffin, Kentucky  
February 13, 2020***

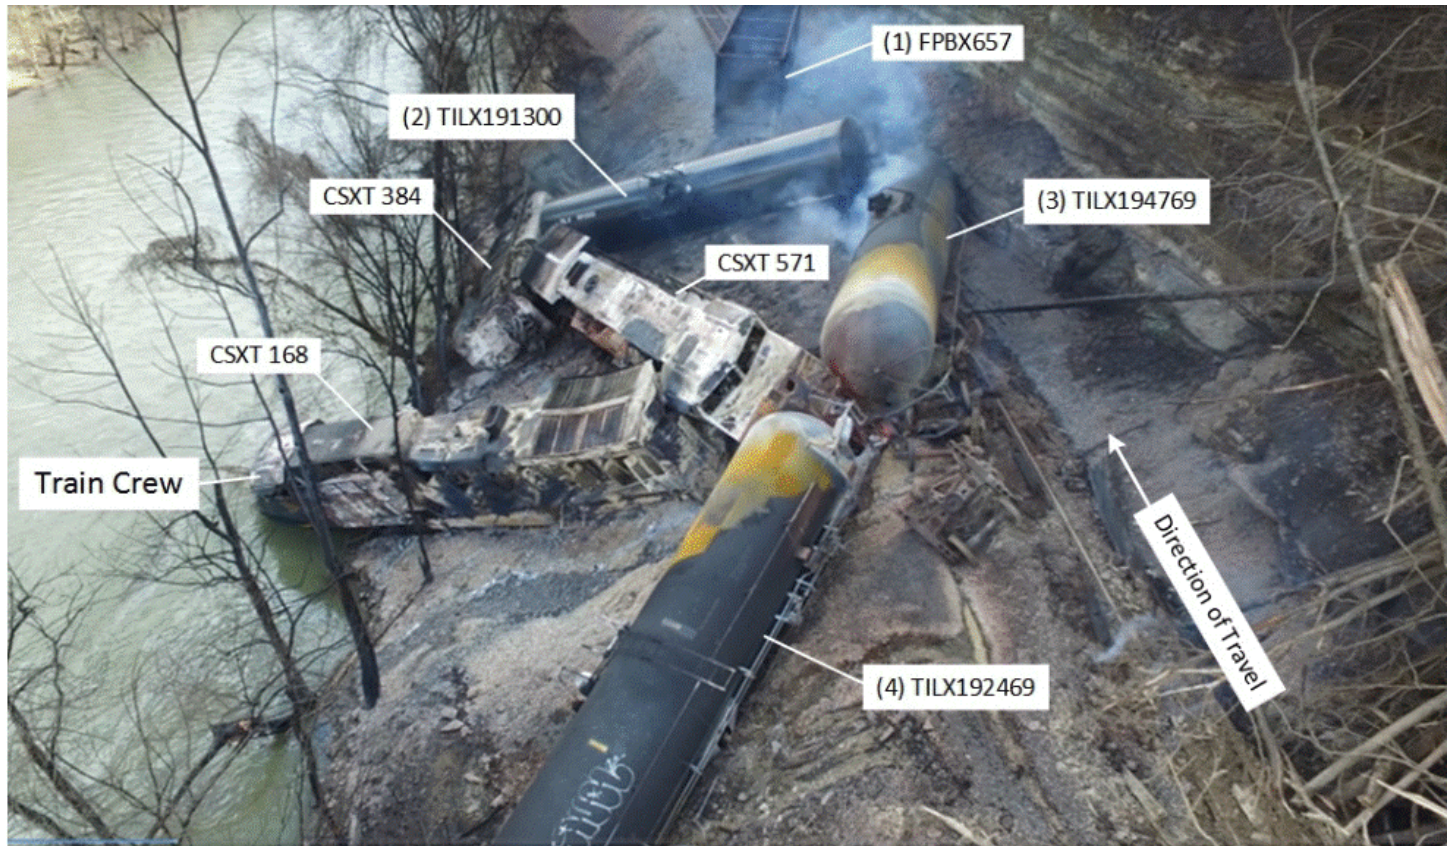
Sketch - Diagram

The point of collision or point of derailment (POC/POD) was identified at a location about midpoint into the expanse of the mudslide. Investigators observed how the depression into the mudslide angled outward away from the bluff area and toward the river side below the track structure. A still image of the area from the fire department video taken about one hour after the event confirms the above description. Due to the unsafe conditions of the active mudslide, a consensus was reached by the investigators that the point of derailment was located at MP 123.8.
