***Federal Railroad Administration
Office of Railroad Safety
Accident and Analysis Branch***

***Accident Investigation Report
HQ-2019-1363***

***Union Pacific Railroad Company (UP) Derailment
Dupo, Illinois
September 10, 2019***

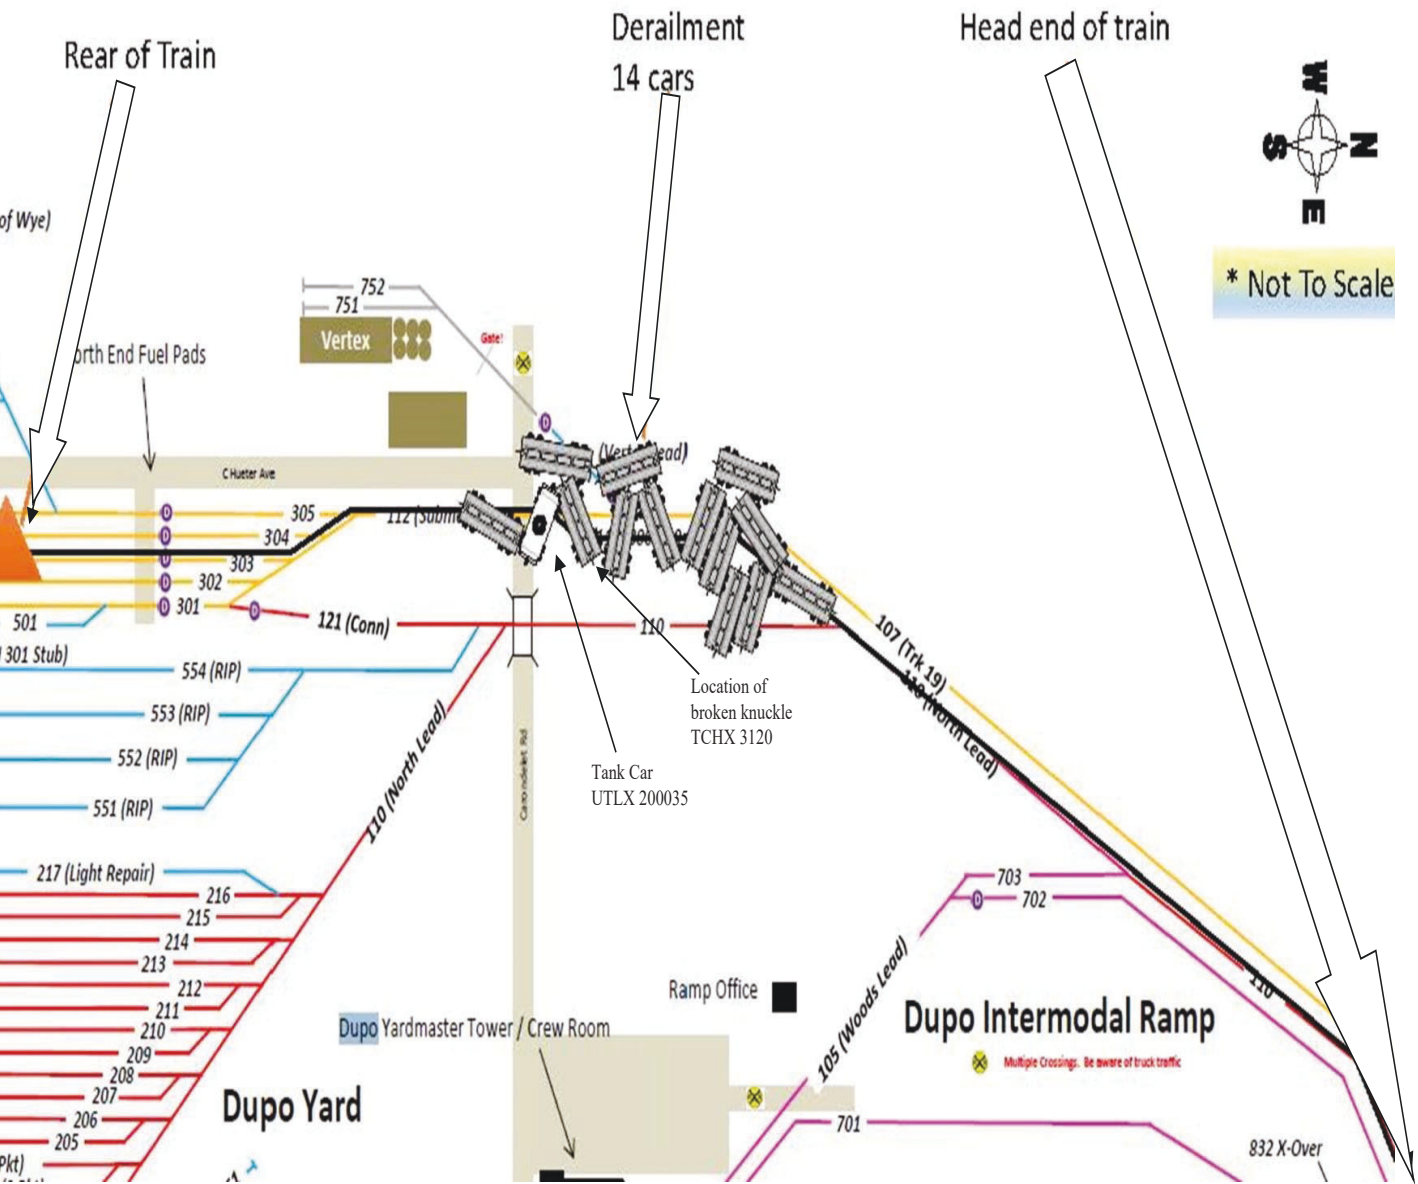
Sketch - Sketch

The force of the collision resulted in SRCX 4055 (86 cars from the head end) and SHQX 2556 (85 cars from the head end) being knocked clear of, and to the west of, Track 111. With SRCX 4055 and SHQX 2556 knocked clear of Track 111, this allowed TCHX 3120 (87 cars from the head end) to strike and puncture UTLX 200035 (84 cars from the head end), resulting in an explosion and a fire. A total of 14 cars were derailed as a result of the collision (UP 78351 located 74 cars from the head end through TCHX 3120 located 87 cars from the head end). FHRX 628621 and KLRX 47482 both sustained major fire damage, but did not derail. ETTX 700371 and ETTX 705263 sustained minor fire damage, and did not derail.
