***Federal Railroad Administration
Office of Railroad Safety
Accident and Analysis Branch***

***Accident Investigation Report
HQ-2019-1371***

***Norfolk Southern Railway Company (NS)
Head-on Collision
Bonsack, Virginia
November, 21, 2019***

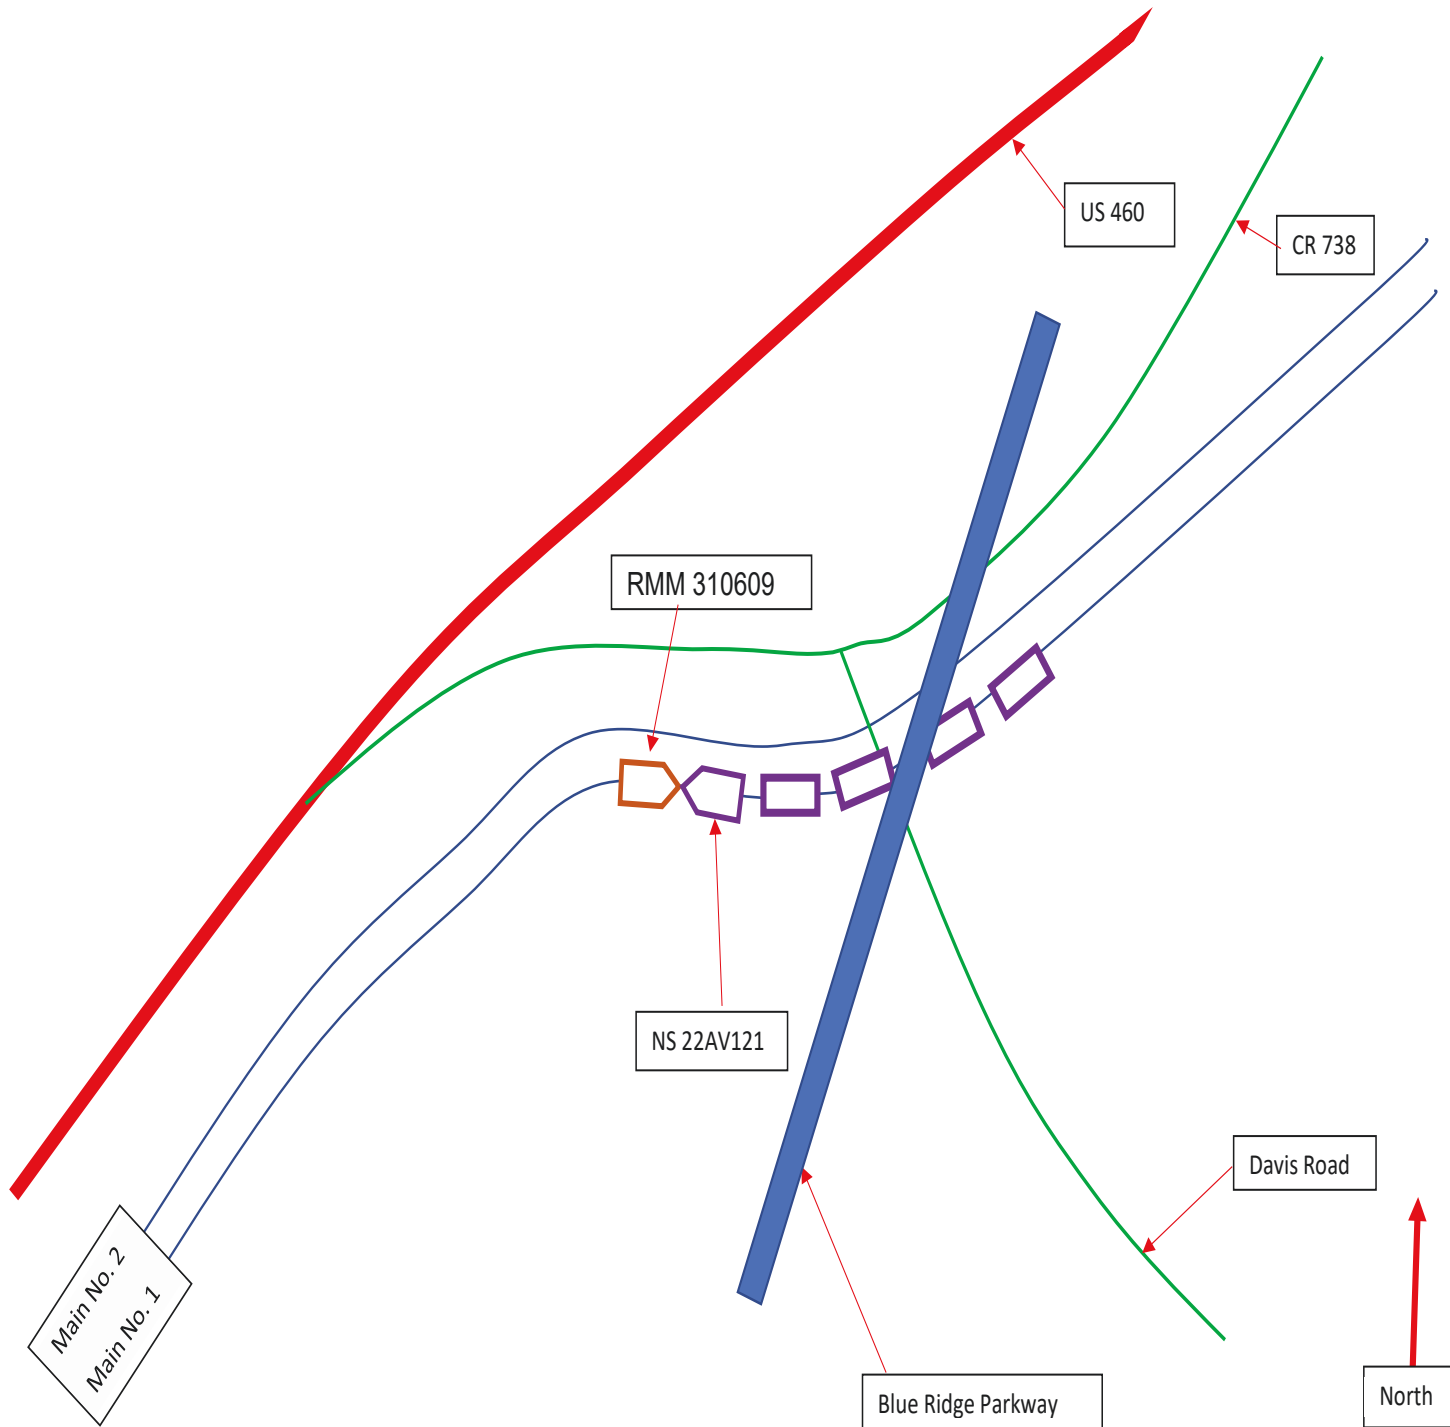
Sketch - Sketch

The collision occurred at MP N250.3 due to the RMM operator occupying the wrong track.
