***Federal Railroad Administration
Office of Railroad Safety
Accident and Analysis Branch***

***Accident Investigation Report
HQ-2020-1385***

***Buffalo & Pittsburgh Railroad, Inc. (BPRR) Derailment
East Aurora, New York
May 18, 2020***

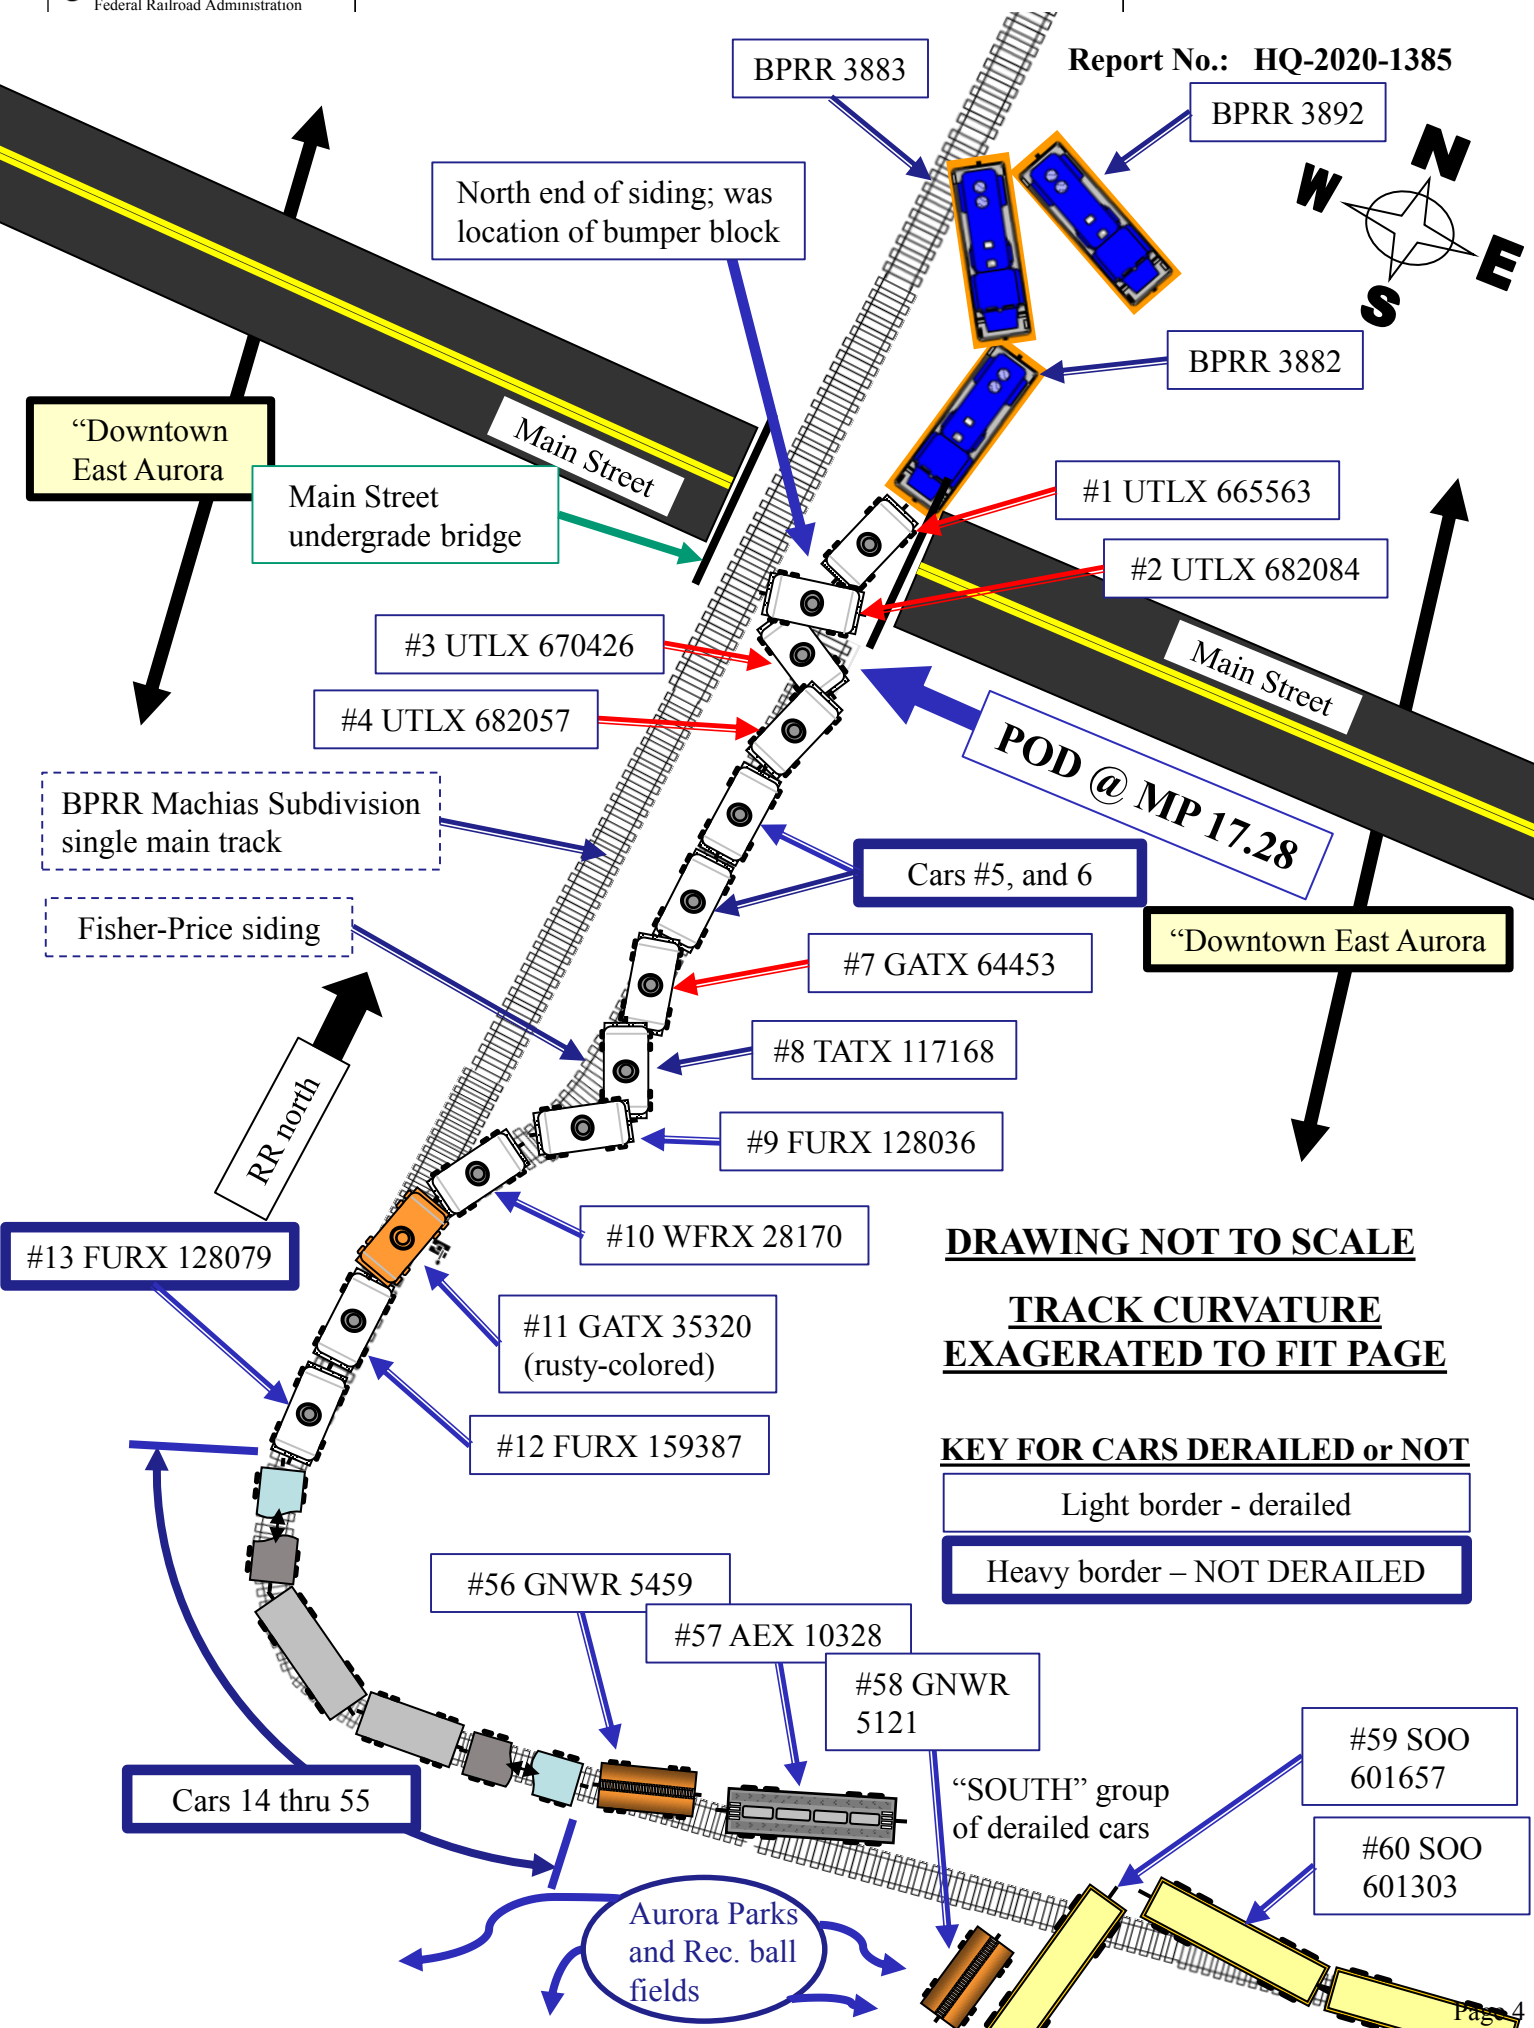
North end of siding; was location of bumper block

POD @ MP 17.28

The point of derailment (POD) is located just on the south side of the Main Street under-grade bridge. The train continued an estimated 360 feet beyond the POD. The lead unit, the BPRR 3892, eventually dug in, uncoupled, and turned 90 degrees, and finally came to rest down an embankment perpendicular to the two trailing units.

Cars # 56-60 in the consist list (2 empty rock salt and 3 loaded center beam flats) derailed, with significant damage, in the area adjacent to the East Aurora Parks and Recreation fields south of "downtown" East Aurora. The "Photographs and Maps" section show the post-derailment, at-rest positions of these cars. The 56th car (GNWR 5459) was leaning east off the center plates, but its relative position remained in line with the track. The trailing truck of the 57th car (AEX 10328) derailed to the east, away from the recreational fields. The R-3 and R-4 wheels remained on the rail, with the left-side wheels above the rail due to the car leaning east. The 58th car (GNWR 5121) and 59th car (SOO 601657) derailed and travelled off the roadbed and down the west side embankment of the right-of-way. The 58th car was rotated during the derailment with damage to the B-R corner, which shoved the 57th car to the east. The derailment of the 58th and 59th car is due in part to the combination of the short shank coupler on the empty 58th car and long shank coupler of the loaded 59th car. The 60th car had the lead truck, A-end pulled off to the west by the 59th car.
