U.S. Department of  
Transportation  
Federal Railroad  
Administration

## Retrofit and Full-Scale Testing of a State-of-the-Art End Structure on a Budd M1 Cab Car

1. AGENCY USE ONLY (Leave blank)		2. REPORT DATE August 2021		3. REPORT TYPE AND DATES COVERED Final Report July 2007 – July 2009
4. TITLE AND SUBTITLE Retrofit and Full-Scale Testing of a State-of-the-Art End Structure on a Budd M1 Cab Car			5. FUNDING NUMBERS DTRS57-04-D-30008

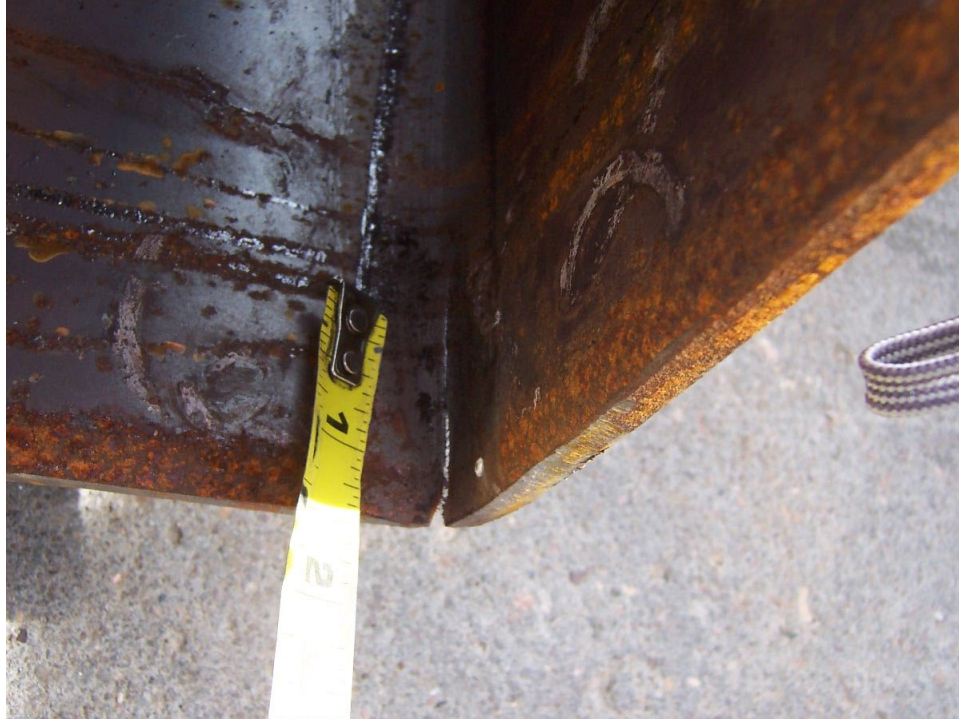
- Several parts were not labeled or were incorrectly labeled. These deficiencies were corrected on-site.
- One of six backing angles used for car body reinforcement (part no. D038-009-032) was found to have a crack in it. This part was later re-fabricated by Zimmerman and delivered to TTCI.

**Figure 14. Photograph of cracked buffer beam channel that was rejected and re-fabricated**

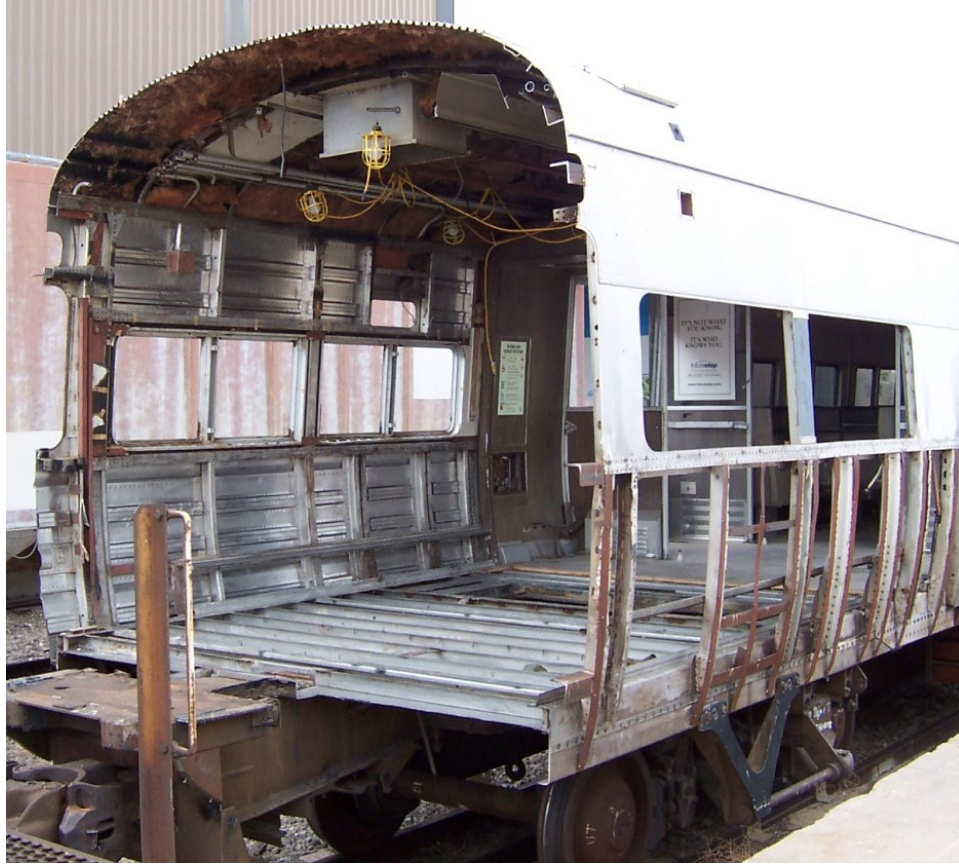
**Figure 15. The cut M1 car ready for retrofit**

- This car had been in an accident and was damaged. As is evident in [Figure 15](#), the left side of the car was missing much of its skin. There was some concern that this might affect the strength of the car body. It was decided that all of the loads would be applied on the other side of the car to limit the forces transmitted through to this side of the car. In addition, an FE analysis was performed with the skin removed that showed that there was sufficient strength even without the skin.

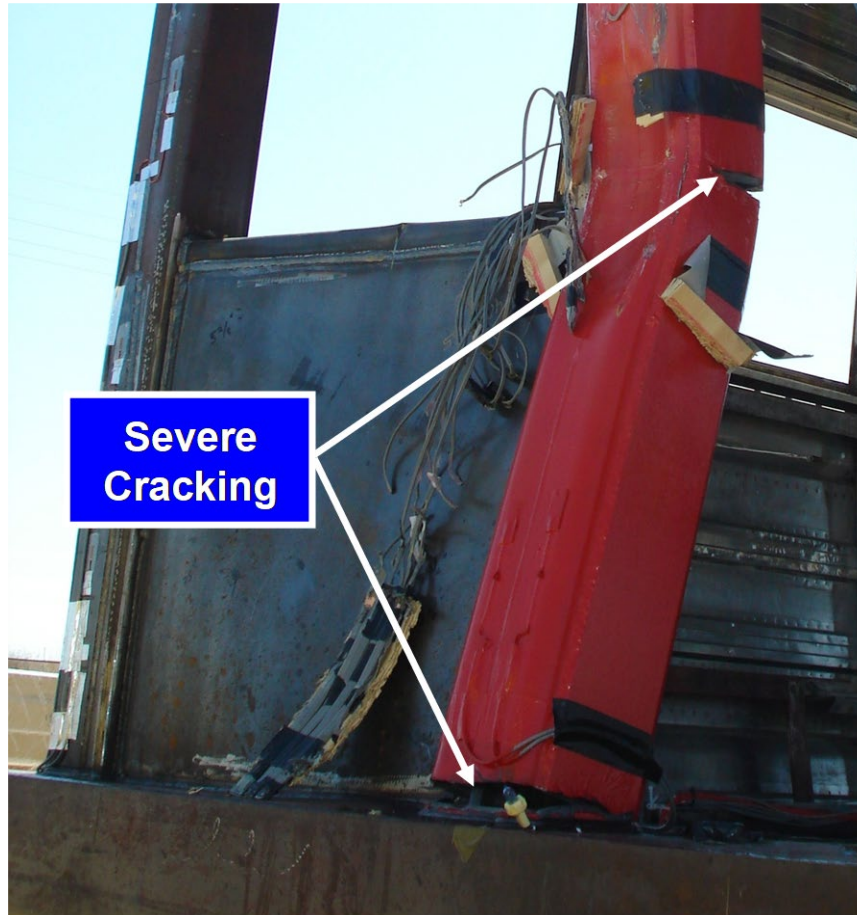
A photograph taken following the test, shown in Figure 30, indicates that not only was the fracture at the front base of the post slightly more extensive than predicted, but that fracture also occurred at the rear of the post, behind the point of impact.

**Figure 30. Dynamic impact test – fracture occurred at the front base of the post and at the back of the post, opposite the point of impact**

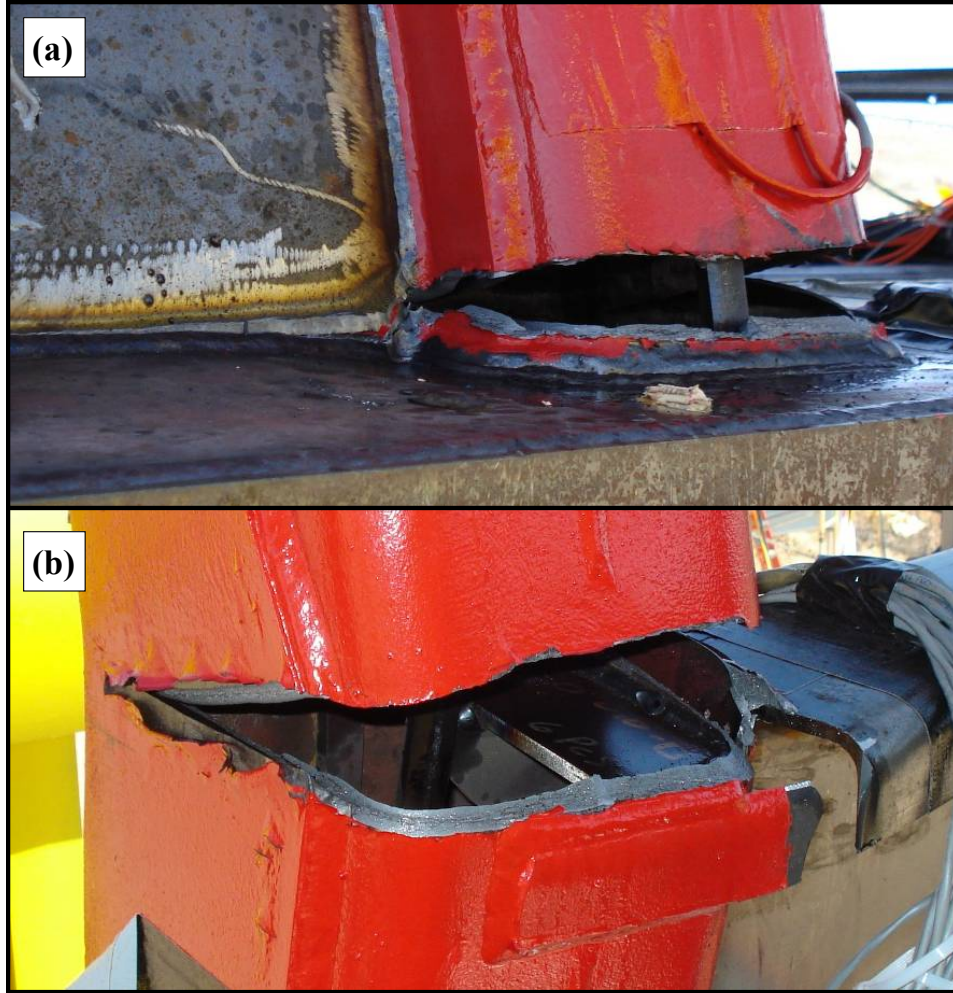
An inspection of the fracture at the back of the post following the test revealed that it occurred at a location where both an internal gusset and an external tab are welded to the post (see [Figure 31](#)). The fracture, in fact, occurred along the edge of one of the two welds. These details, which were not in the original model, were subsequently added and the analysis was run again. Material failure model parameters were adjusted so that the extent of fracture was more consistent with the test results.

**Figure 31. Post-test photographs showing fracture regions: (a) front base of the collision post and (b) in back of the collision post, opposite impact point**

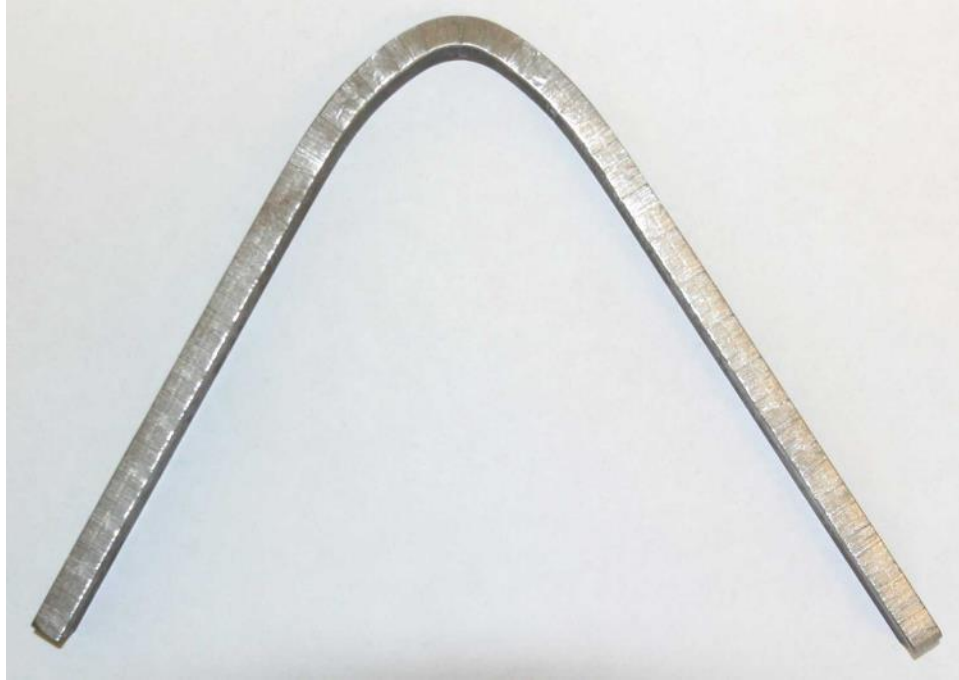
**Figure 36. Post-test photograph of a specimen cut out from the collision post, across the shelf tab weld**

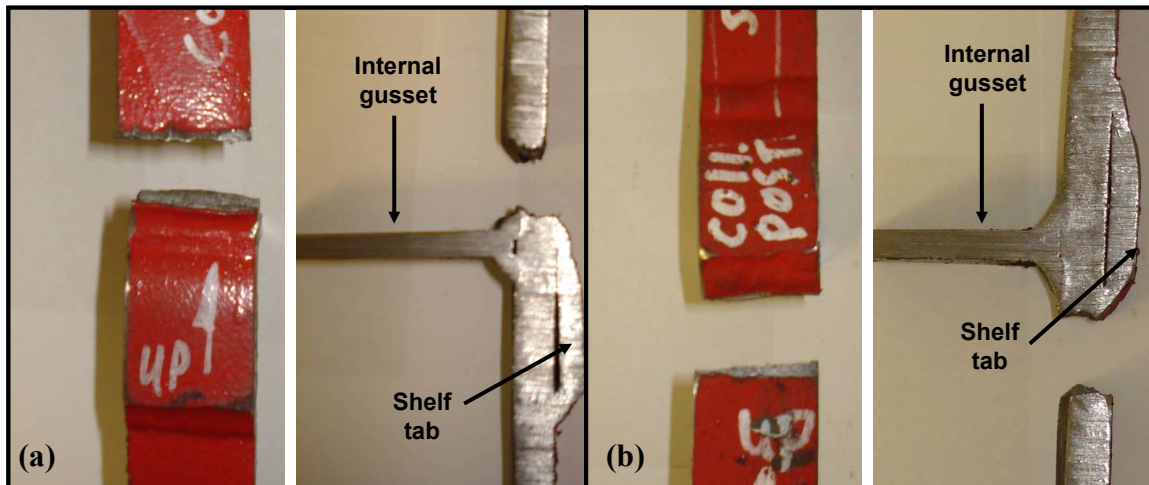
**Figure 37. Photographs showing cross-sections of fractures that occurred at the back of the collision post during (a) the dynamic test and (b) the quasi-static test**

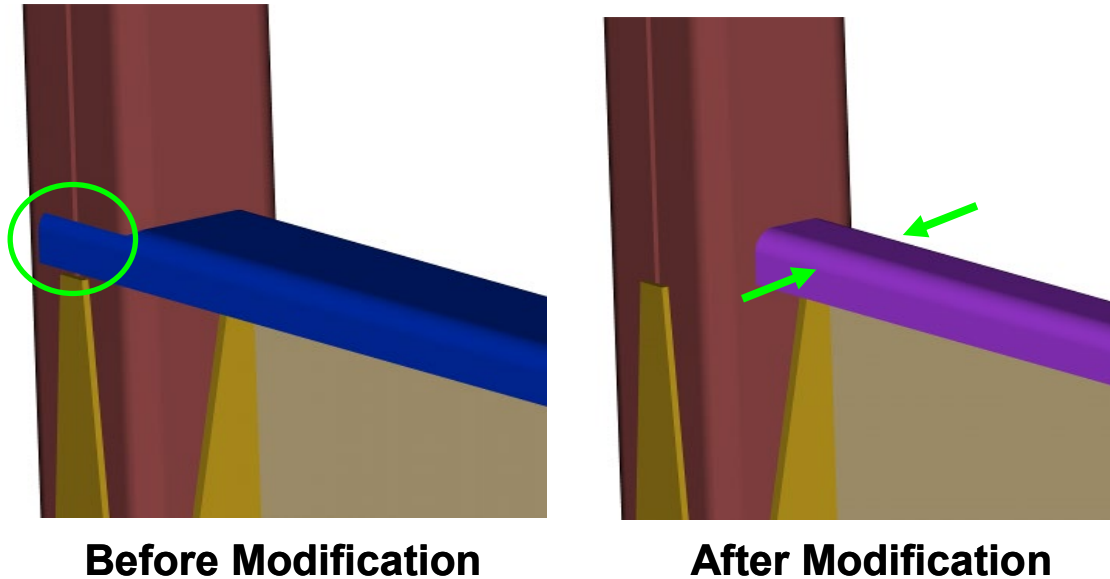
**Figure 38. Schematic illustration of modifications to shelf connecting collision and corner posts**

Another modification was made following the quasi-static collision post-test. The depth of the shelf was decreased and straps tying the back of the shelf to the corner and collision posts were removed. This change is described in [Section 5.3](#).

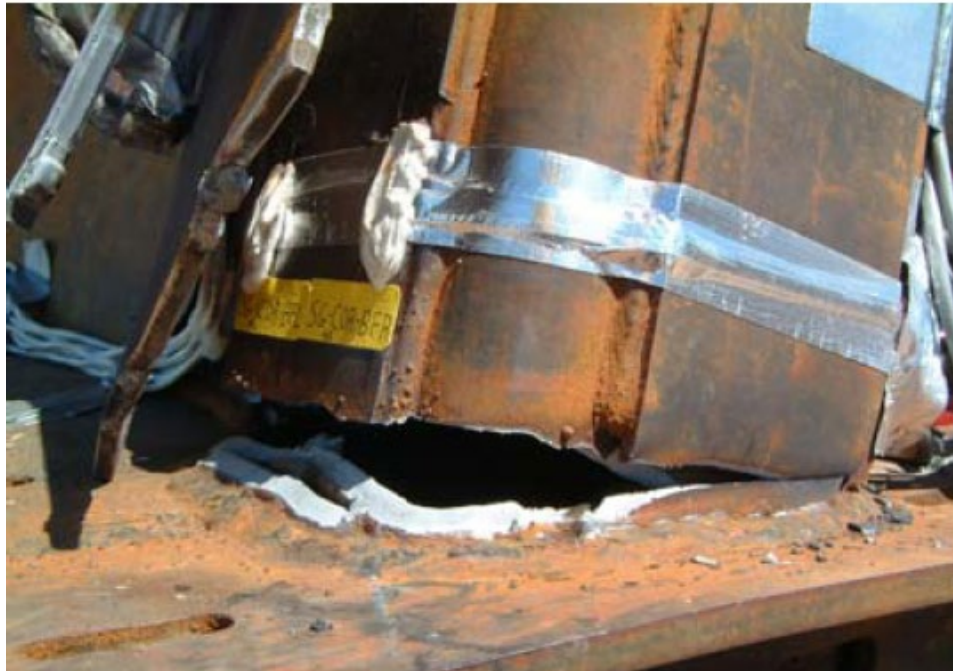
**Figure D-10. Post-test photograph of base of corner post following coil impact**
