***Federal Railroad Administration
Office of Railroad Safety
Accident and Analysis Branch***

***Accident Investigation Report
HQ-2020-1403***

***Union Pacific
Elkhart, Iowa
December 25, 2020***

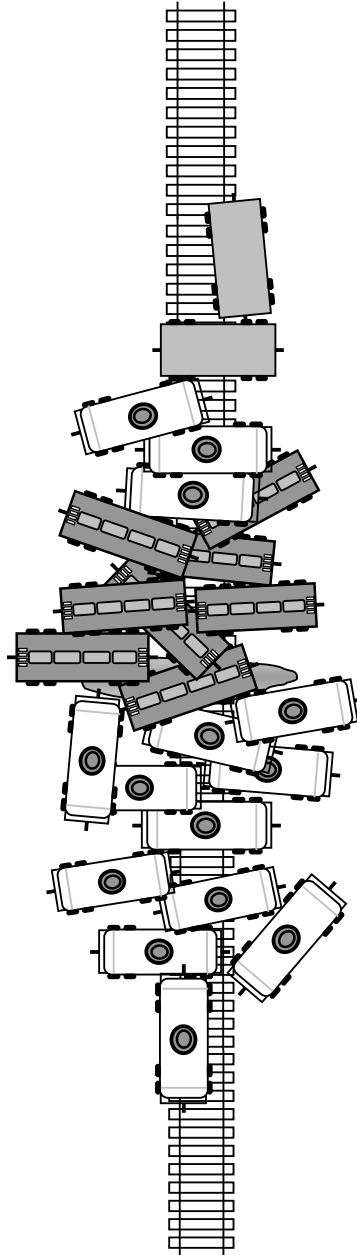
Sketch - Sketch UP Ankeny IA

The conductor inspected the train after stopping and found a total of 24 cars derailed (18 loads and 6 empties) lines 108 through 86 and a 36-foot ballast deck bridge destroyed.
