U.S. Department
of Transportation
Federal Railroad
Administration

Wheel Failure Investigation Program: Phase 2

1. REPORT DATE (DD-MM-YYYY) December 2021		2. REPORT TYPE Technical Report		3. DATES COVERED (From - To) September 2017 – March 2020	
4. TITLE AND SUBTITLE Wheel Failure Investigation Program: Phase 2				5a. CONTRACT NUMBER DTFR53-12-D-00001L	
				5b. GRANT NUMBER	
				5c. PROGRAM ELEMENT NUMBER

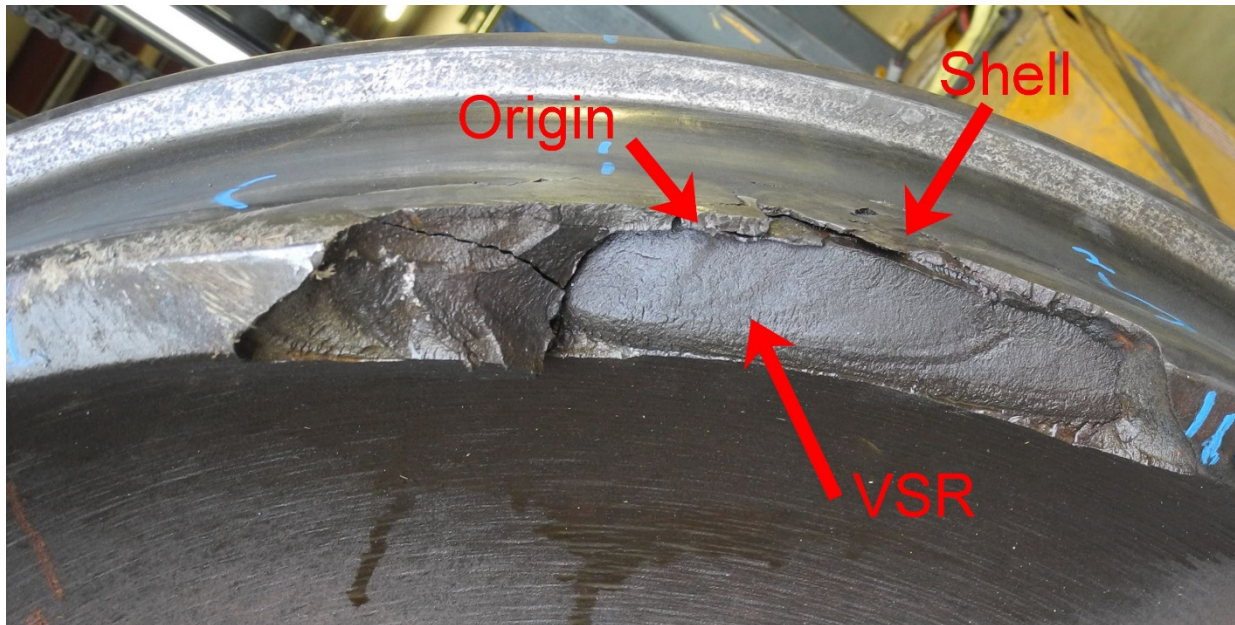
VSRs tend to initiate in connection with shell defects. Typically, an area of delamination occurs approximately 0.20 inches (5 mm) below and parallel to the wheel tread surface, as shown in [Figure 2](#). A vertical crack begins on the delaminated surface which then grows as a vertical crack through the thickness of the wheel rim.

Figure 2. Typical VSR Defect

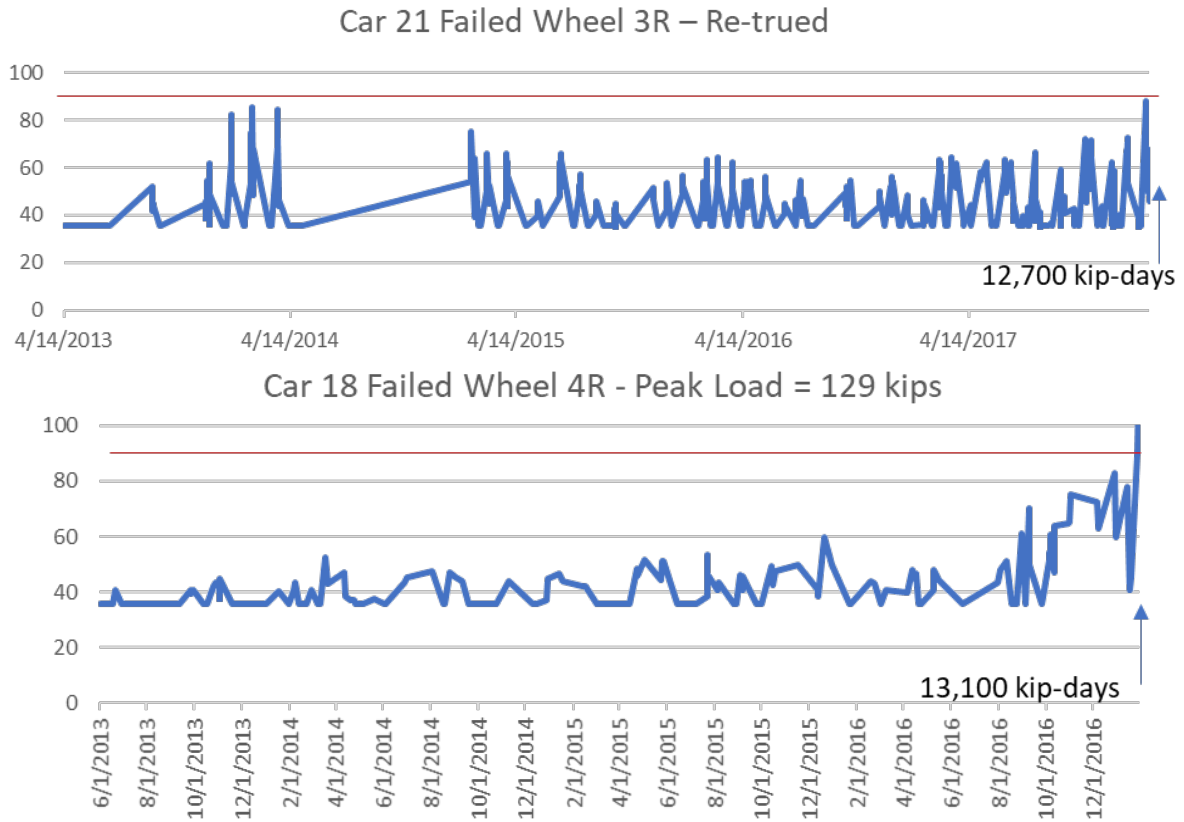
Cummings suggests a possible limiting threshold value of 11,000 kip-days to prevent a VSR failure based on his research [8]. Using this criterion, the wheel would have been removed from service before the 81.2-kip impact load event, approximately 2 months before failure. Figure 12 shows two additional examples of wheels, using the 11,000-kip days limit, that would have been removed from service before failure at 12,700 and 13,100-kip days, respectively.

Figure 12. Further Examples Showing Number of Kip-Days at VSR Failure

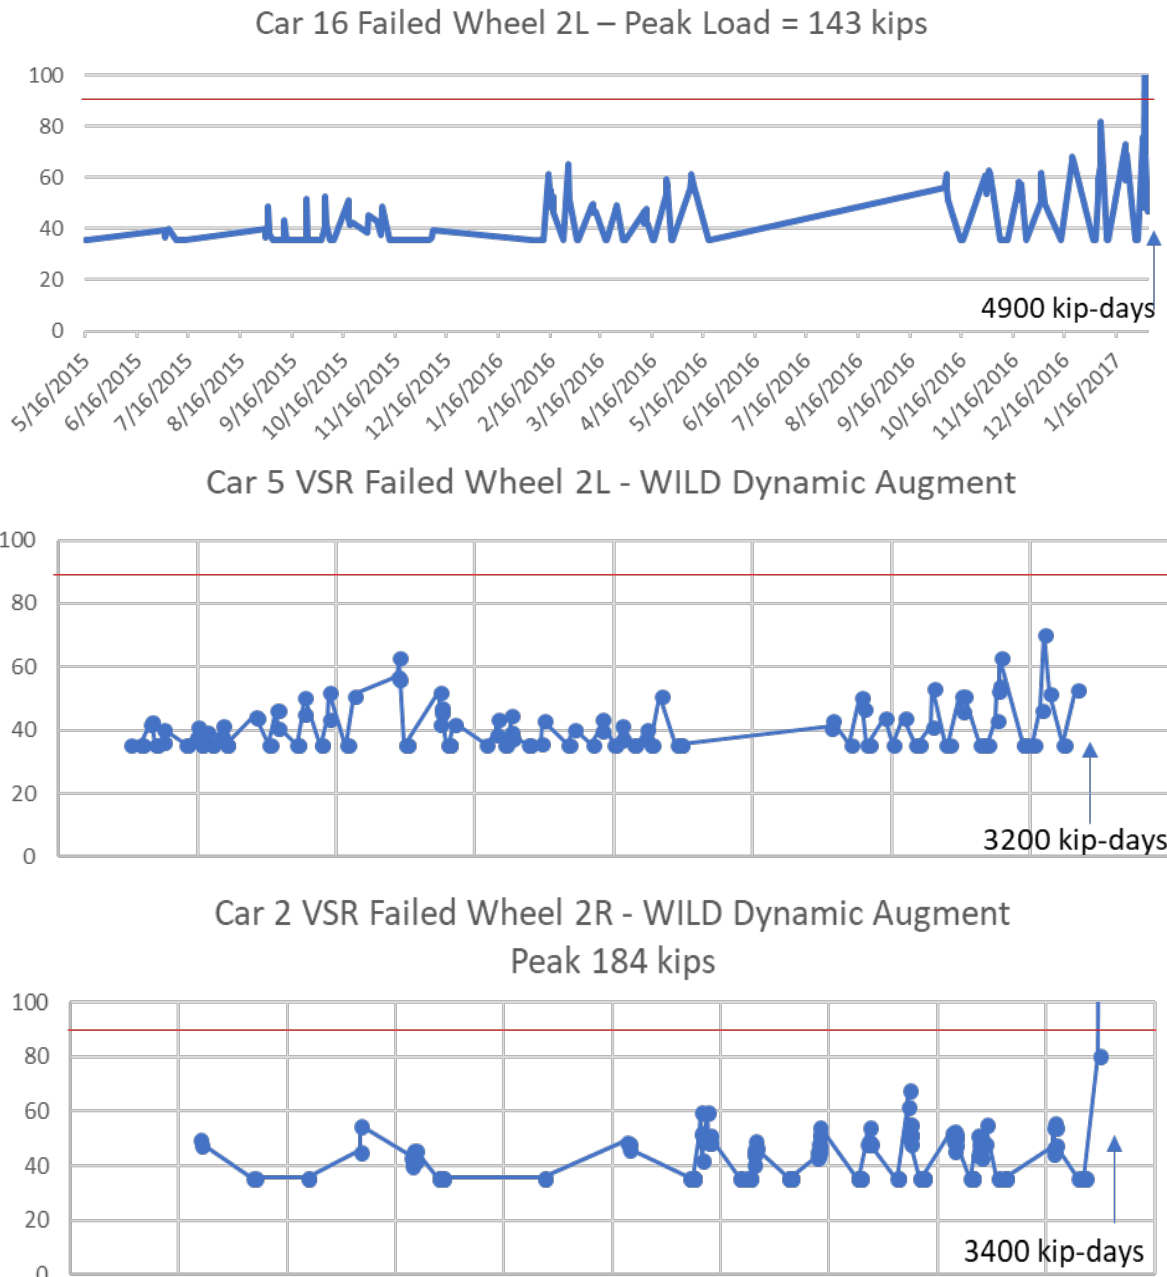
However, further review of WILD data yields examples of VSR failures well before 11,000-kip days have elapsed; [Figure 13](#) shows three examples.

Figure 13. Examples of VSR Failure Well Before Suggested 11,000 Kip-Days Limiting Criterion

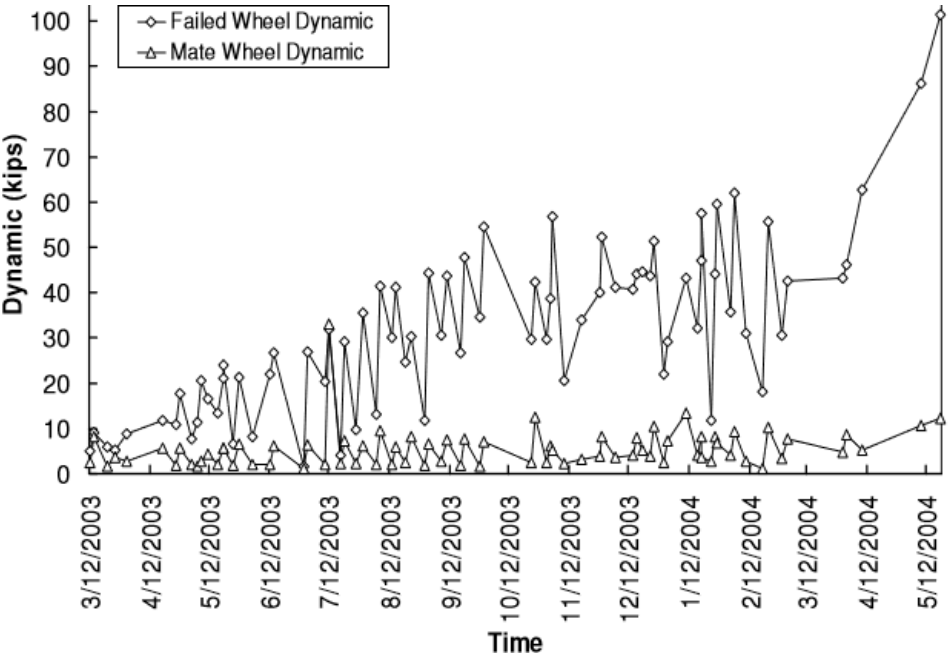
Figure 14 shows impact data for a wheel that failed due to a VSR when the impact load increased suddenly after April 12, 2004 [9]. However, the sustained increase in impact loads over the prior year, from March 12, 2003, to March 12, 2004, would not necessarily be distinguishable from other wheels that have increasing impact loads yet do not fail. The feature that seems to indicate imminent failure is the exponential increase in impact load toward the end of the wheel life. Figure 14 provides an example of a rapid increase to VSR failure when the impact loads prior to the exponential increase are already relatively large [9]. Figure 15 shows an example of a VSR failure where the rate of increase in impact loads prior to failure is much lower [9], but the sudden increase has the same characteristic as in Figure 14. Note that the rates of increase in impact load in Figure 14 and Figure 15 are similar to the characteristic curve for the increasing size of a fatigue crack in a rail before failure shown in Figure 16 [10]. It is expected that crack growth rates in the wheel would display similar trends observed in the rail, with slow initial growth followed by rapid growth to failure.

Figure 14. WILD Data for a VSR Wheel with a Large Impact Load Before Failure [9]

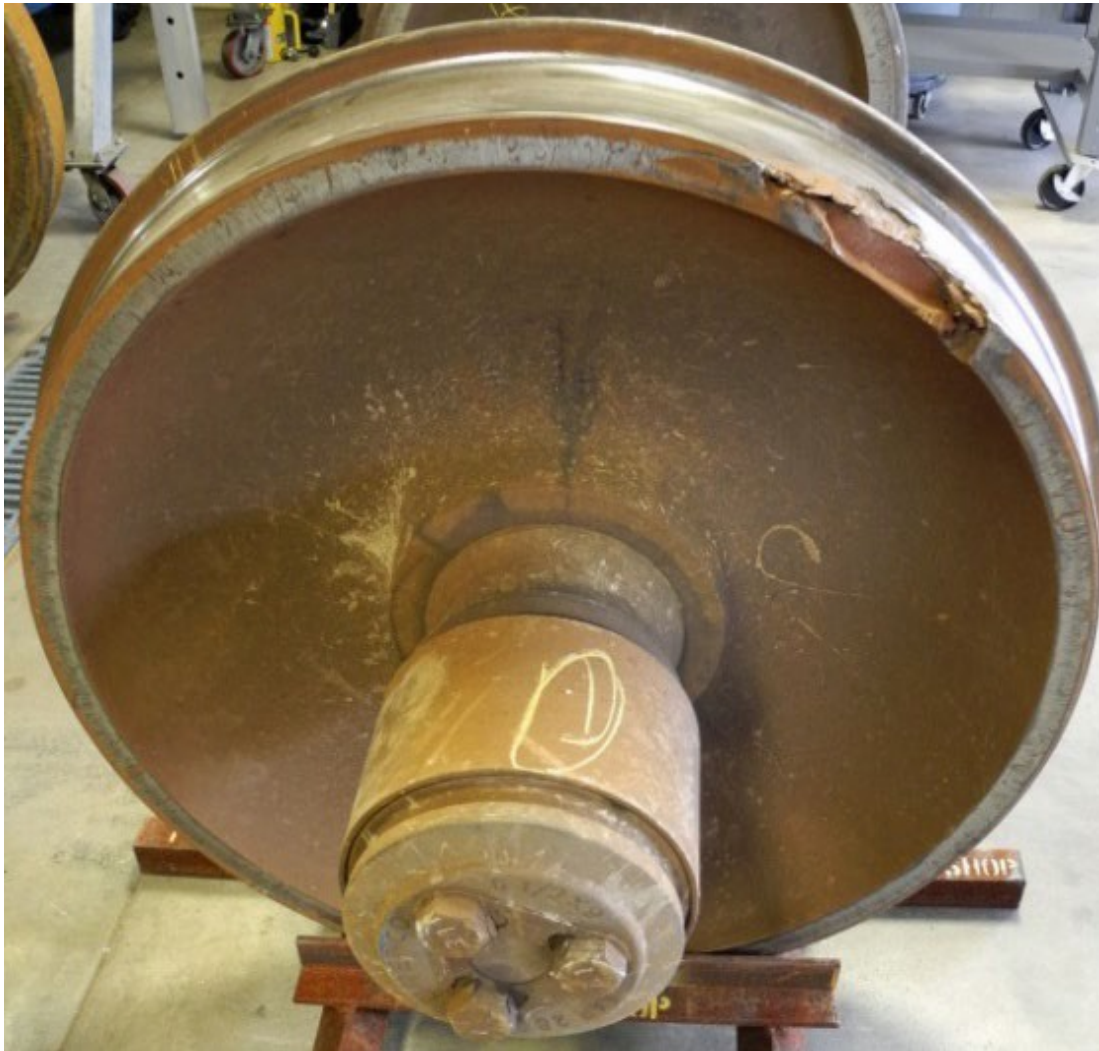
Figure A-1. Overall View of Wheelset, as Received

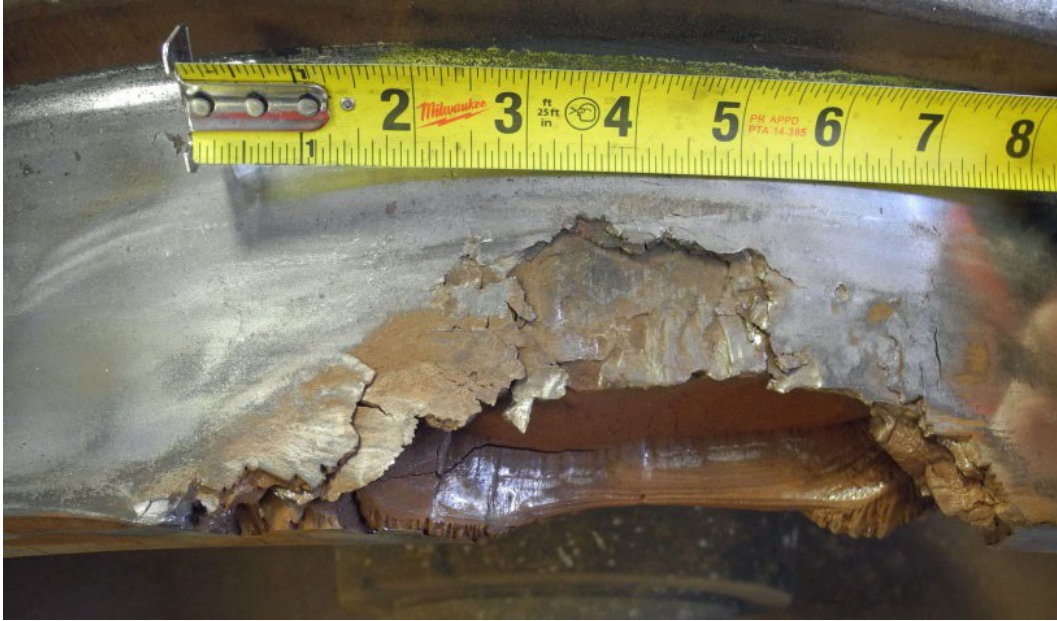
Figure A-2. Overall View of Fractured Portion

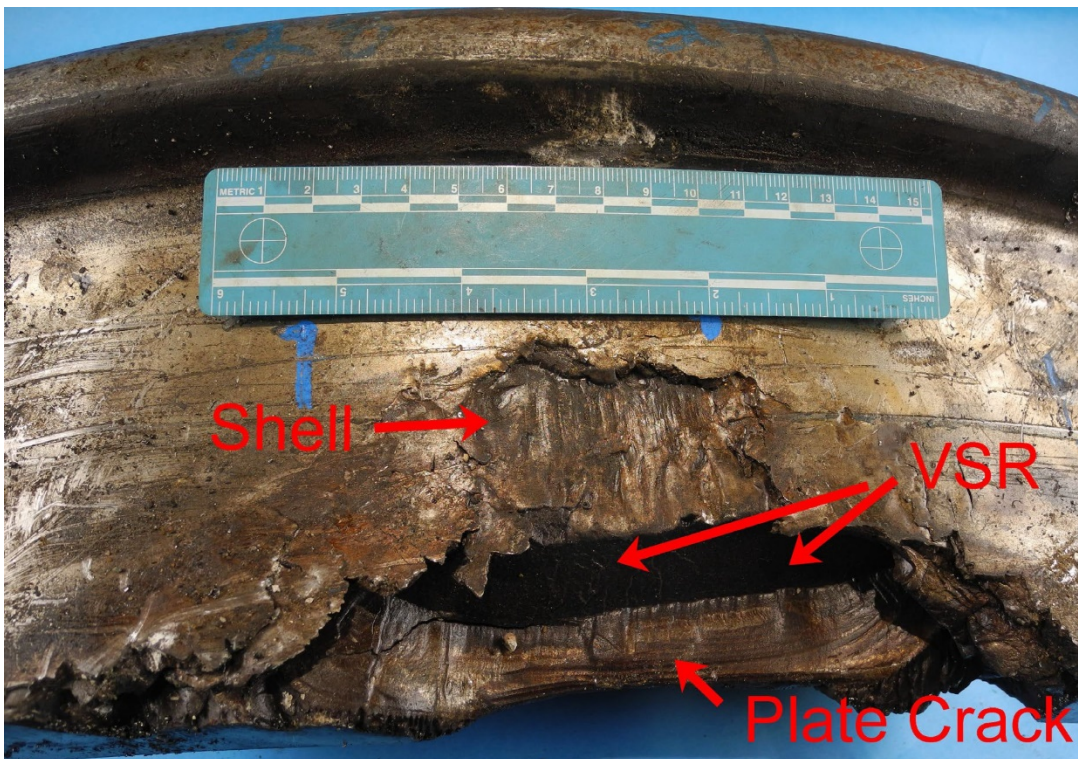
Additionally, a separate shattered rim developed from the VSR, 1 1/4 inches directly below the shelled area, Figure A-3.

Figure A-3. Detailed View of Fractured Areas with Tread Shelling at the Origin of the Rim

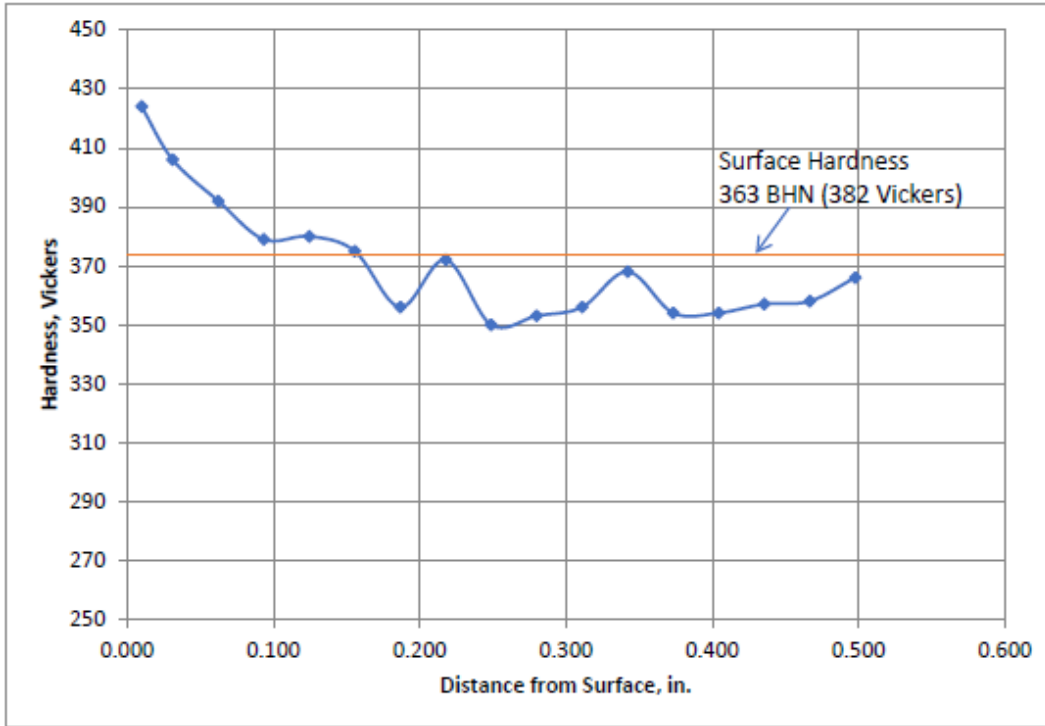
Microhardness measurements were made on a specimen cut adjacent to the fractured area in the radial direction from the surface to a depth of 1/2 an inch. The results of the hardness measurements versus depth shown in Figure A-4 suggest the possible presence of an area of work softening.

Figure A-4. Microhardness Traverse of Wheel UP1

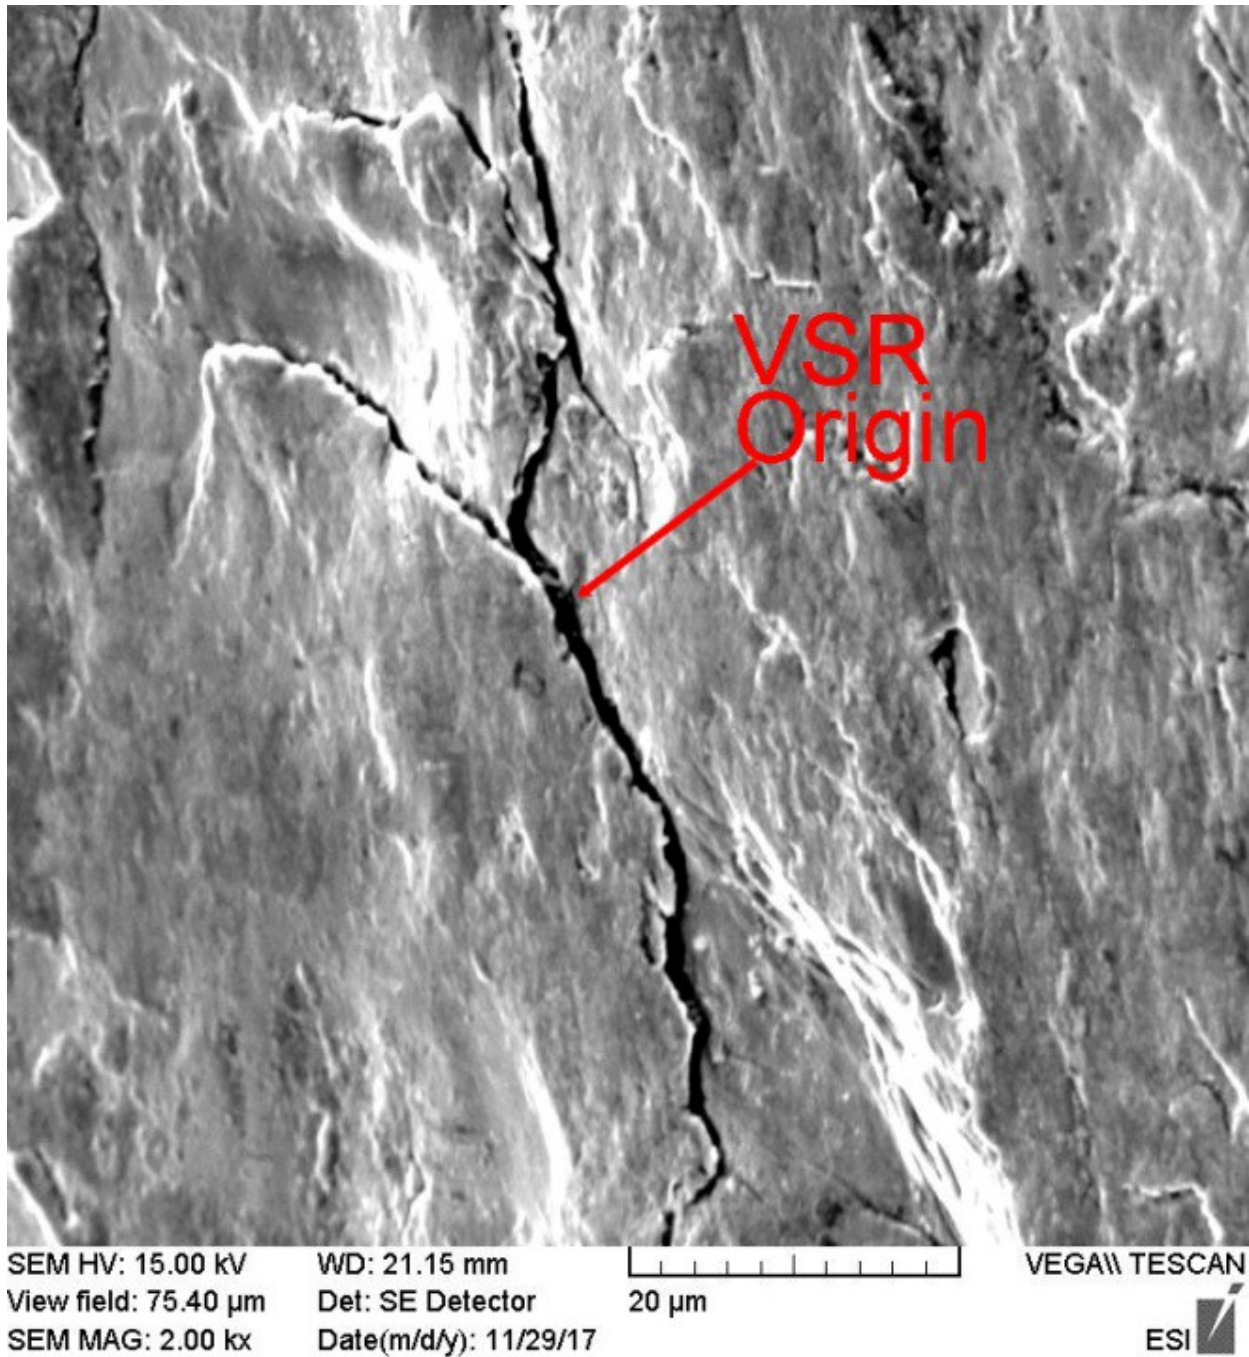
The fracture surfaces of the shell area and the VSR surface were examined by scanning electron microscopy. In Figure A-8, the shelled surface has the appearance of repeated shear with a vertical crack that has formed within one of the shear bands that could be the nucleation point of a VSR. The VSR surface shown in Figure A-9 has quasi-cleavage facets that are typical of brittle fracture.

Figure A-8. Scanning Electron Microscope Image of UP1 Shell Fracture Surface, Original Magnification x2,000

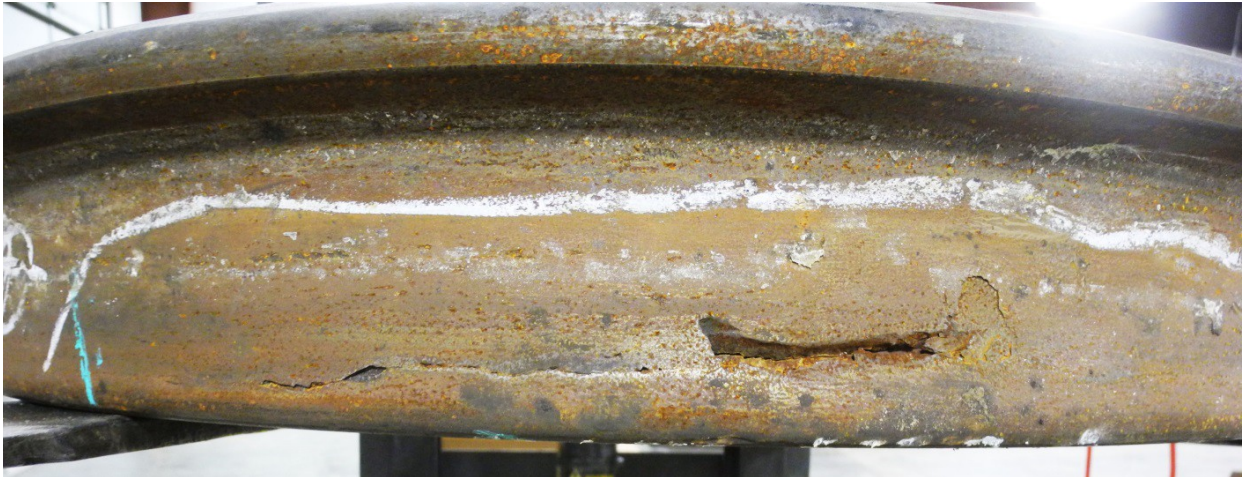
The wheel contained a VSR that had not separated, as shown in Figure A-10 and Figure A-11. The failure occurred in two steps. First, a large shell defect grew approximately 3/16 of an inch below the tread surface and formed an initial VSR that grew from the tread shell, as shown in Figure A-12. The fatigue crack then initiated the remainder of the VSR by a quasi-cleavage rupture, Figure A-13.

Figure A-10. Cracking on Tread of Wheel PR2

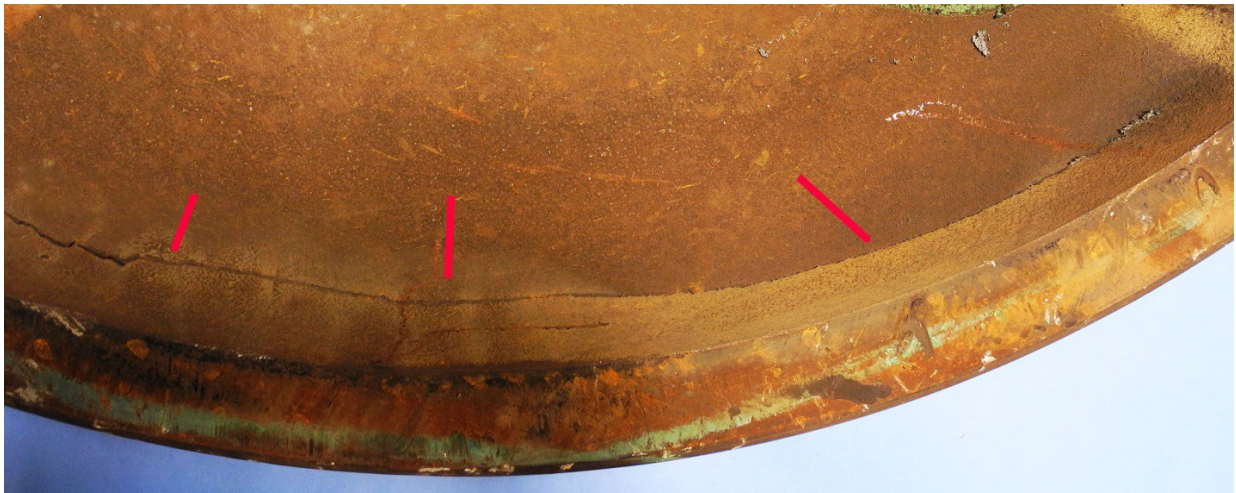
Figure A-11. Termination of VSR at Rim-Plate Fillet

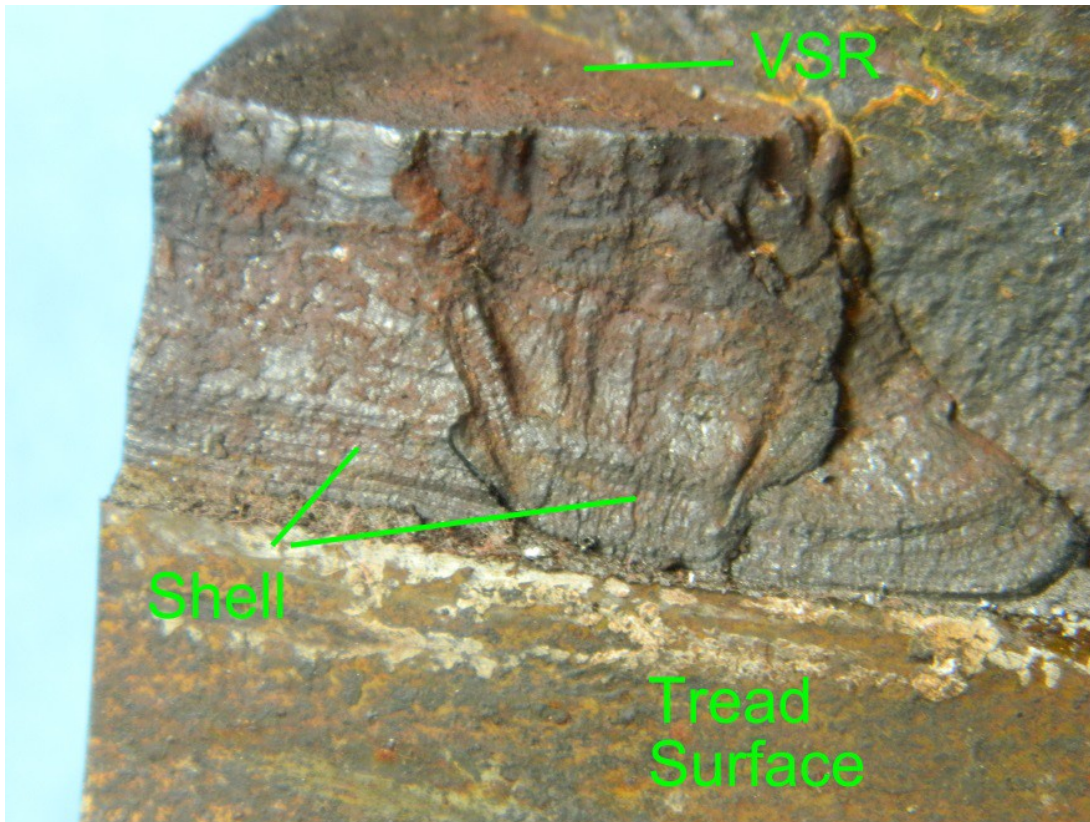
Figure A-12. Initial Fracture Location on Wheel PR2

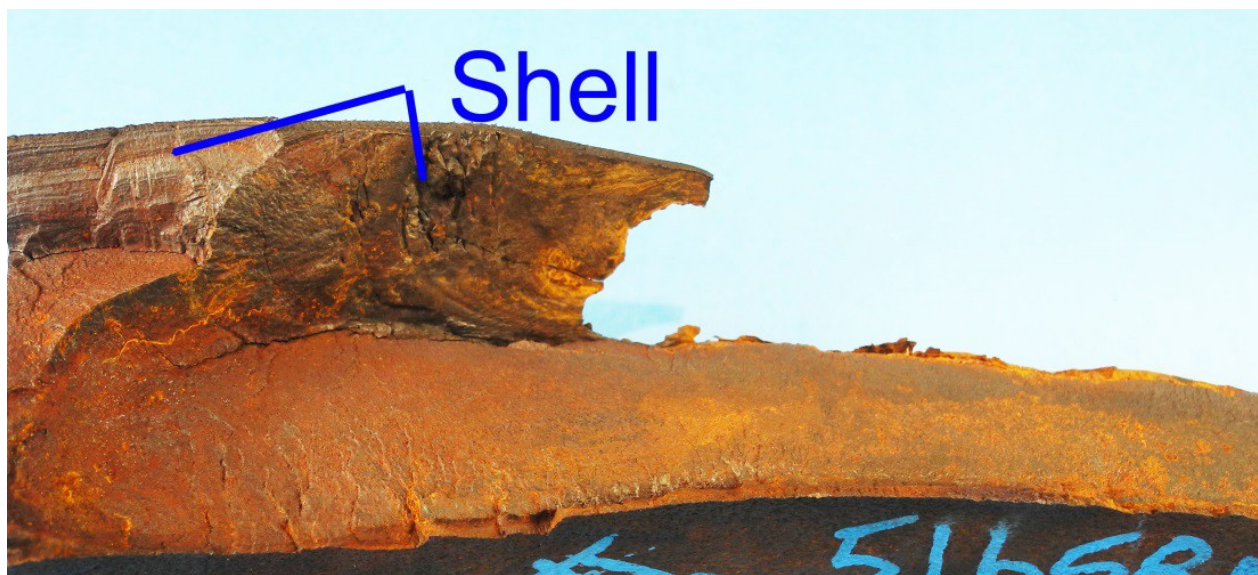
Figure A-13. Transition of Shell to VSR on Wheel PR2

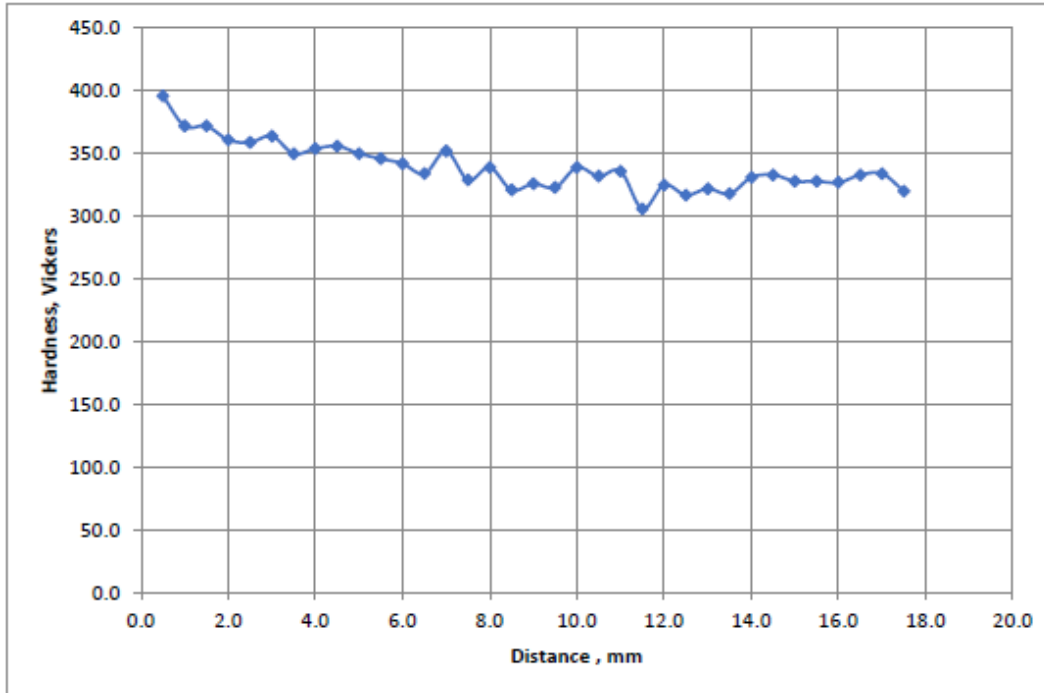
Microhardness measurements were made on a specimen cut adjacent to the fractured area in the radial direction from the surface to a depth of 1/2 inch. The results of the measurements versus depth of hardening suggest the possible presence of an area of work softening, shown in Figure A-14.

Figure A-14. Microhardness from Wheel PR2 Tread Surface in Axial Direction

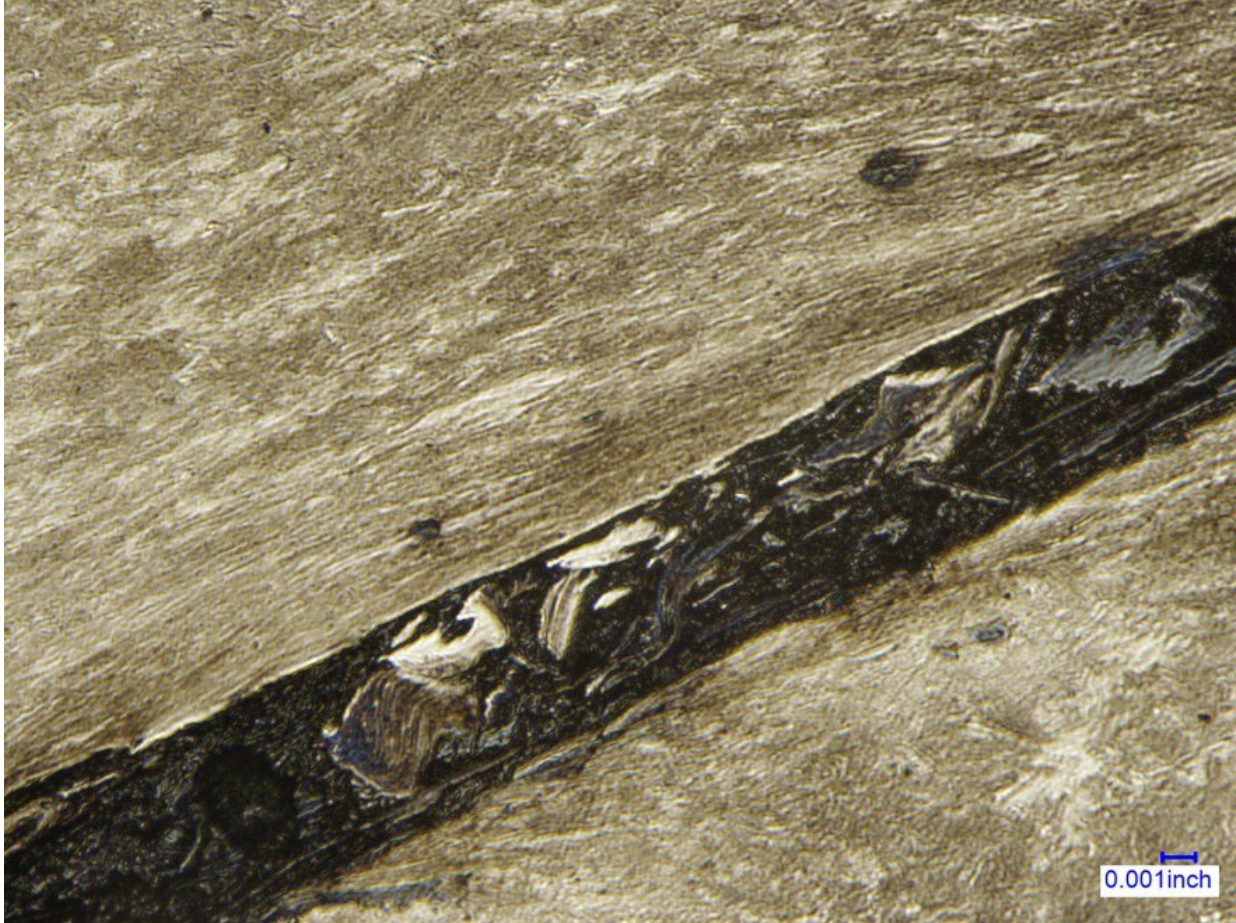
Metallographic analysis of the areas above the shell crack shows flowed and deformed grains, while the area below the crack appears unaffected, shown in Figure A-15. However, this wheel did not show any evidence of martensite or oxide on the crack surfaces, that would have been the result of brake heating, as was the case with all the other wheels.

Figure A-15. Microstructure Above and Below PR2 Shell Crack, Original Magnification x1,000, Nital Etch

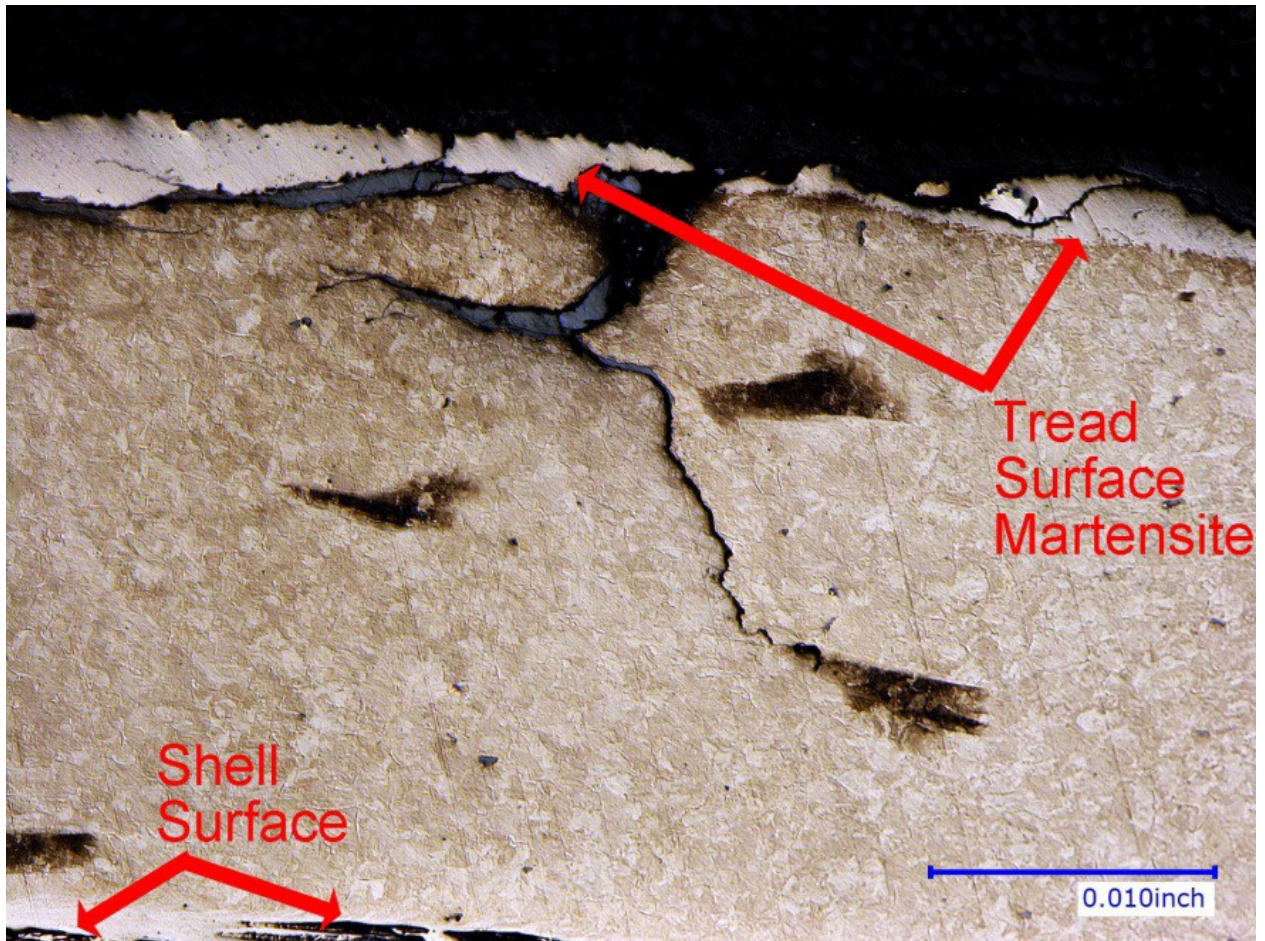
The back rim face fracture surface was coated with a layer of rust, while the front rim face fracture was not, indicating that the back rim face VSR occurred at some time before the VSR on the front face. The microstructures of the surface shelled area and VSR initiation surface were evaluated and are shown in Figure A-19 and Figure A-20. Figure A-19 shows that a surface layer of martensite had developed, indicating application of an unusually high brake shoe force or wheel slide. Figure A-20 shows that the subsurface cracks are coated with a high temperature oxide that is typical of most of the other VSR and shell cracks that have been observed. However, an approximately 0.003-mm diameter, non-metallic inclusion is present at the shell-VSR transition. Analysis of the inclusion indicated that it was iron oxide (i.e., rust).

Figure A-19. BNSF3 Microstructure at Surface of Back Face VSR, Original Magnification x200, Nital Etch

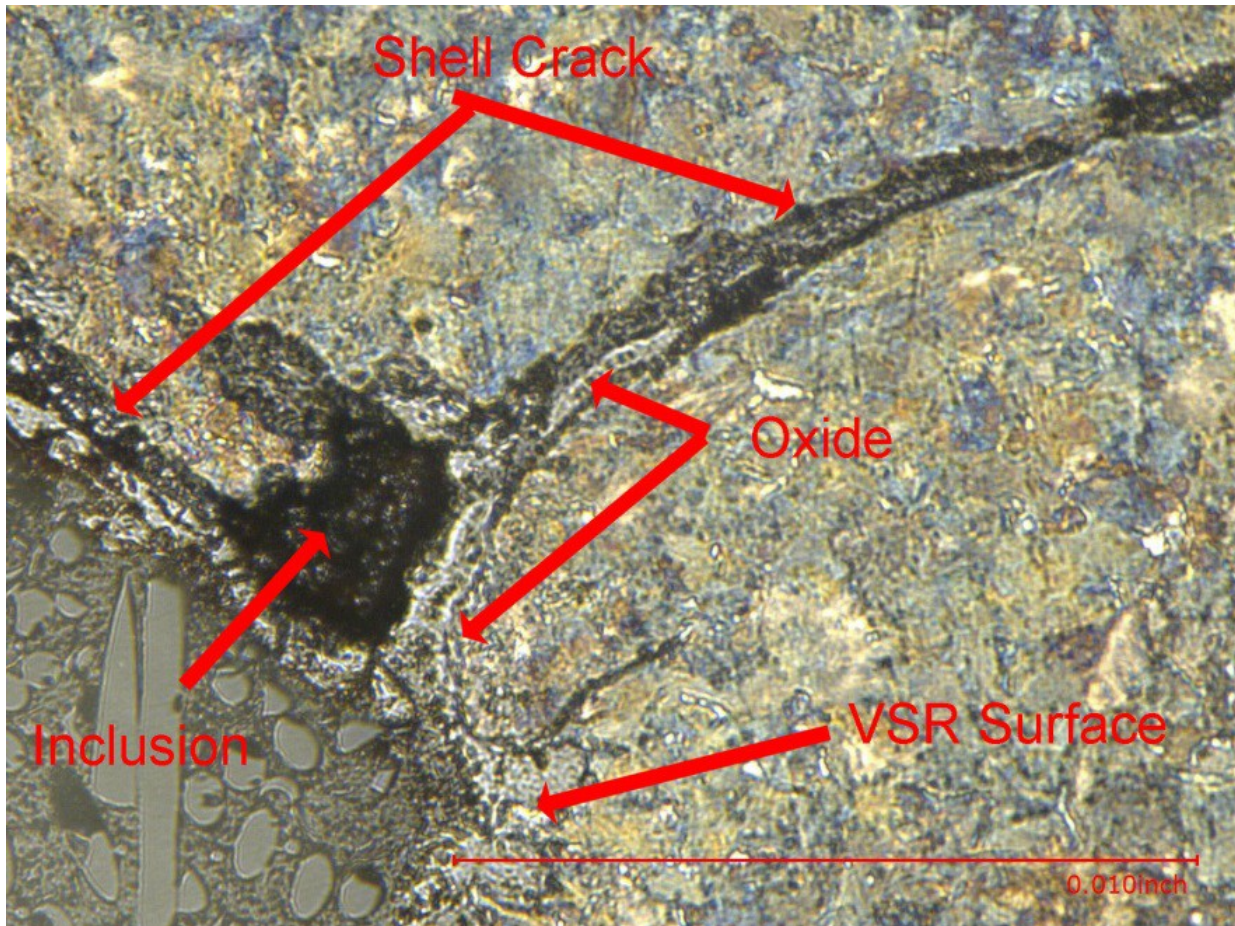
Figure A-20. BNSF3 Microstructure at Shell-VSR Boundary, Original Magnification x700, Nital Etch

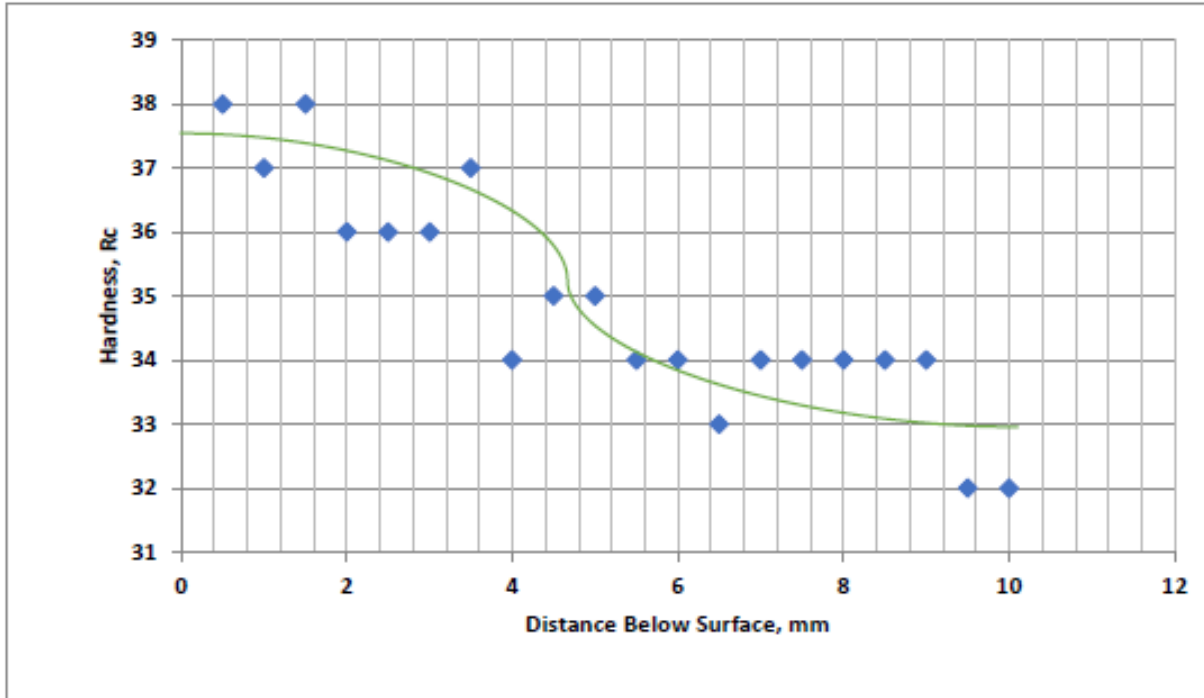
Microhardness measurements were performed on a specimen cut adjacent to the fractured area, in the radial direction from the surface to a depth of half an inch. The results of the measurements of hardness versus depth suggest in Figure A-21 the possible presence of an area of work softening.

Figure A-21. BNSF3 Microhardness Variation from Surface, Shell Crack Depth is Between 3.5 and 4 mm

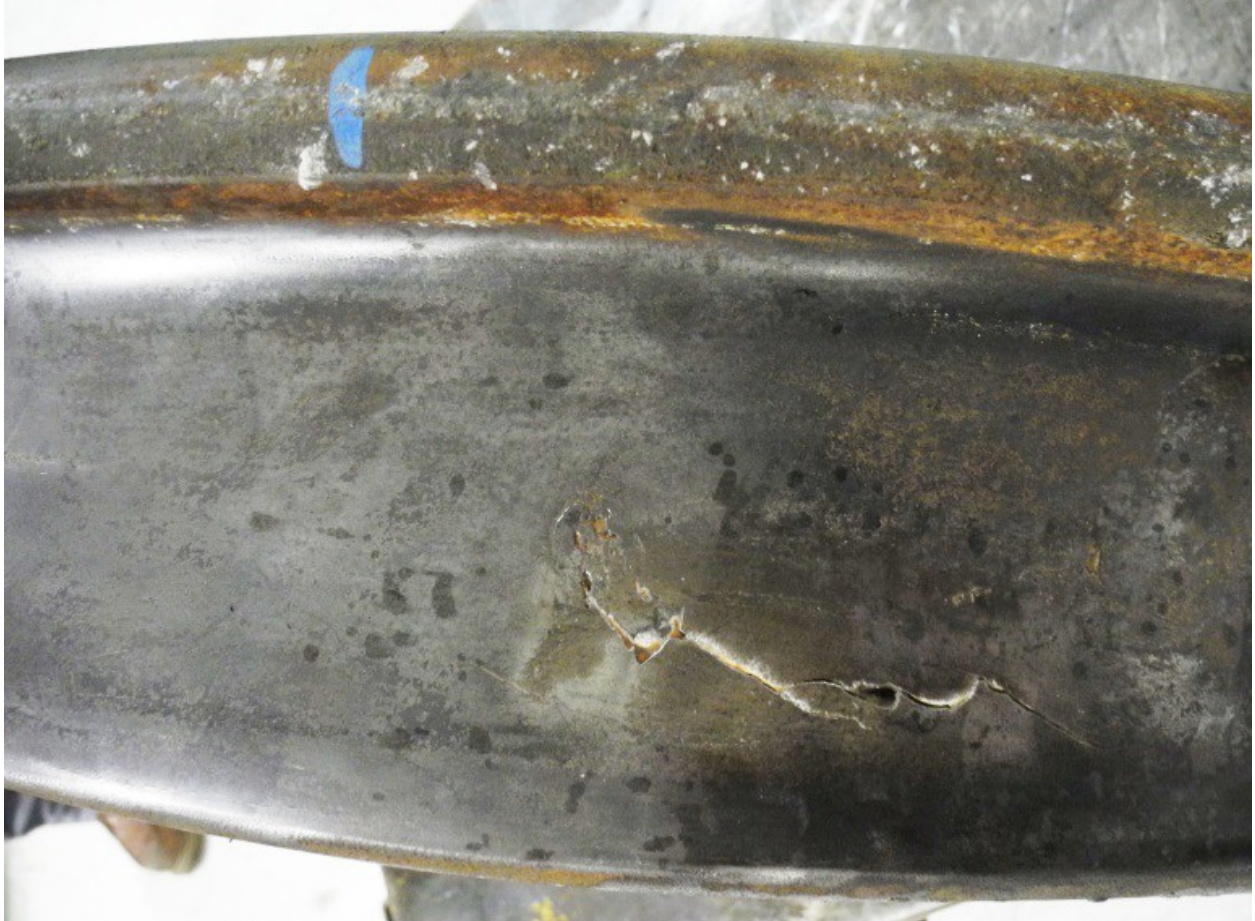
The wheel contained a VSR that had not separated, as shown in Figure A-22 and Figure A-23. The failure occurred in two steps. First, a large shell or delamination defect grew approximately a quarter of an inch below the tread surface and formed an VSR that grew from the tread shell, as shown in Figure A-24. The transition from delamination to VSR shows that the delamination was formed from multiple fatigue cracks, Figure A-25.

Figure A-22. Tread Crack in Wheel BNSF4

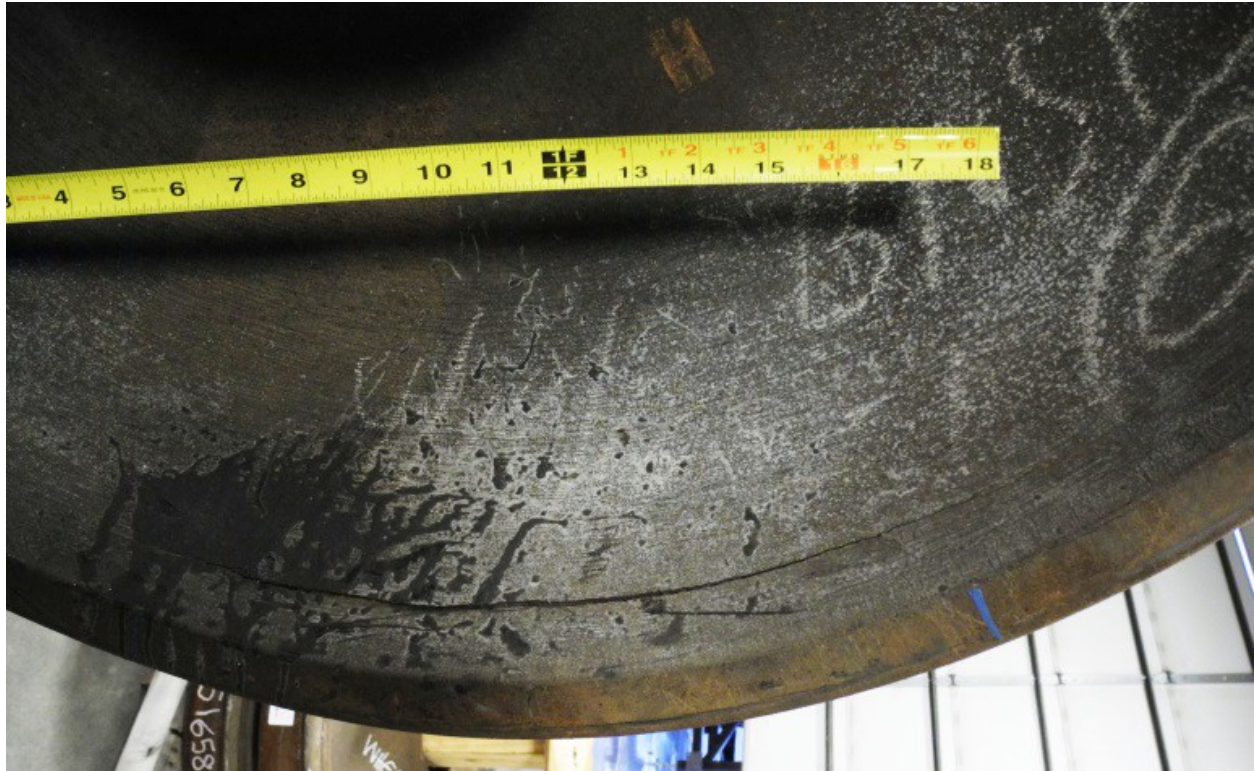
Figure A-23. VSR Crack in Wheel BNSF4 that Extended into Plate

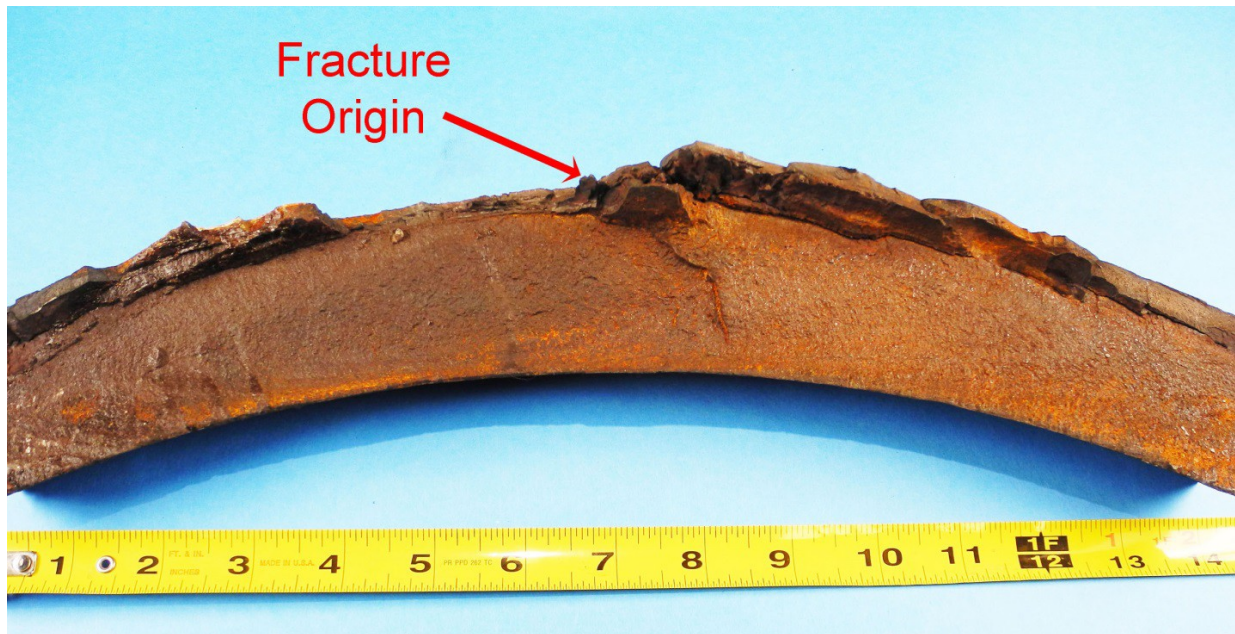
Figure A-24. Initial Fracture Location on Wheel BNSF4

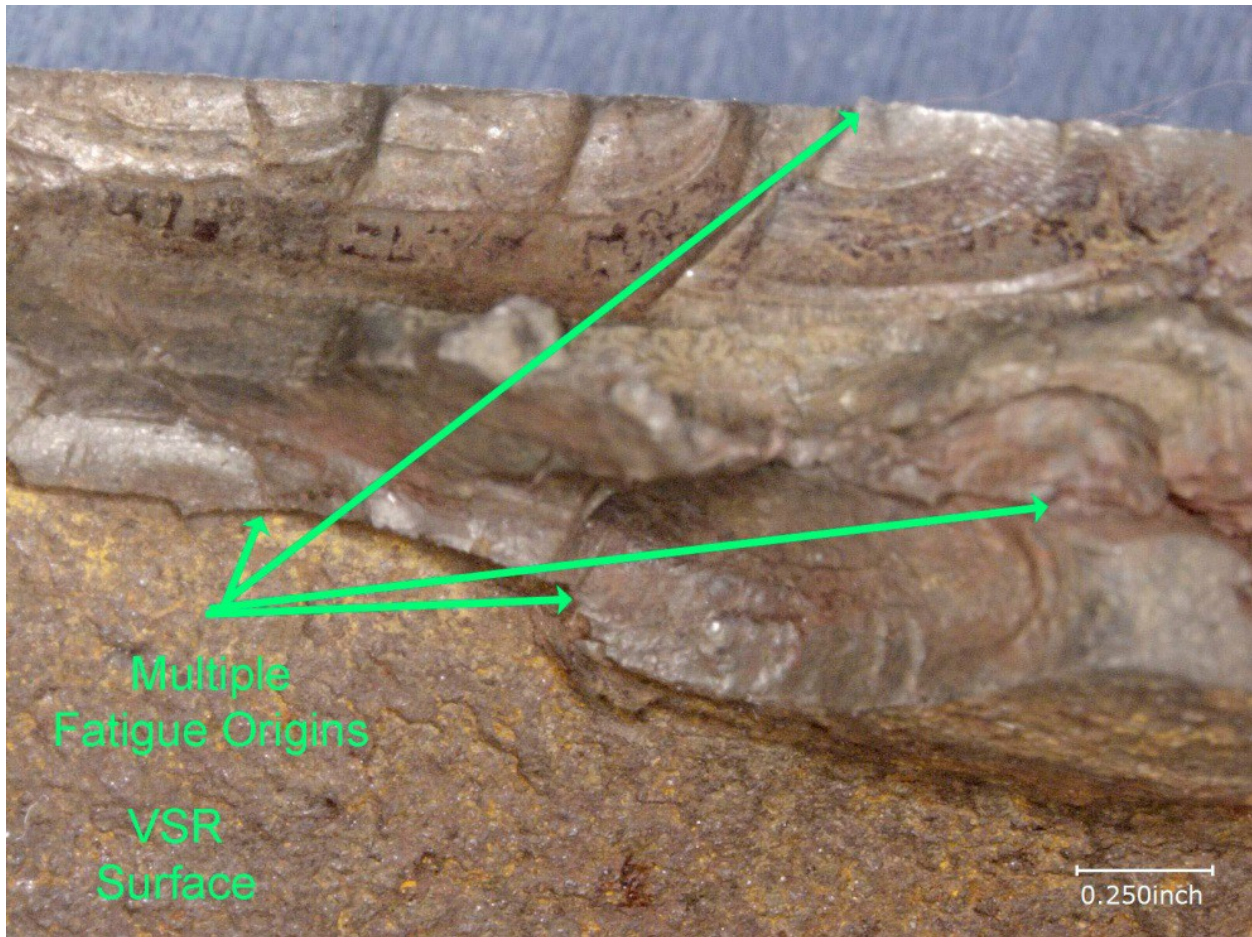
Figure A-25. Oblique View of Delamination and VSR on BNSF4, Original Magnification x10
