U.S. Department
of Transportation
Federal Railroad
Administration

Wheel Failure Investigation Program: Phase 2

1. REPORT DATE (DD-MM-YYYY) December 2021		2. REPORT TYPE Technical Report		3. DATES COVERED (From - To) September 2017 – March 2020	
4. TITLE AND SUBTITLE Wheel Failure Investigation Program: Phase 2				5a. CONTRACT NUMBER DTFR53-12-D-00001L	
				5b. GRANT NUMBER	
				5c. PROGRAM ELEMENT NUMBER

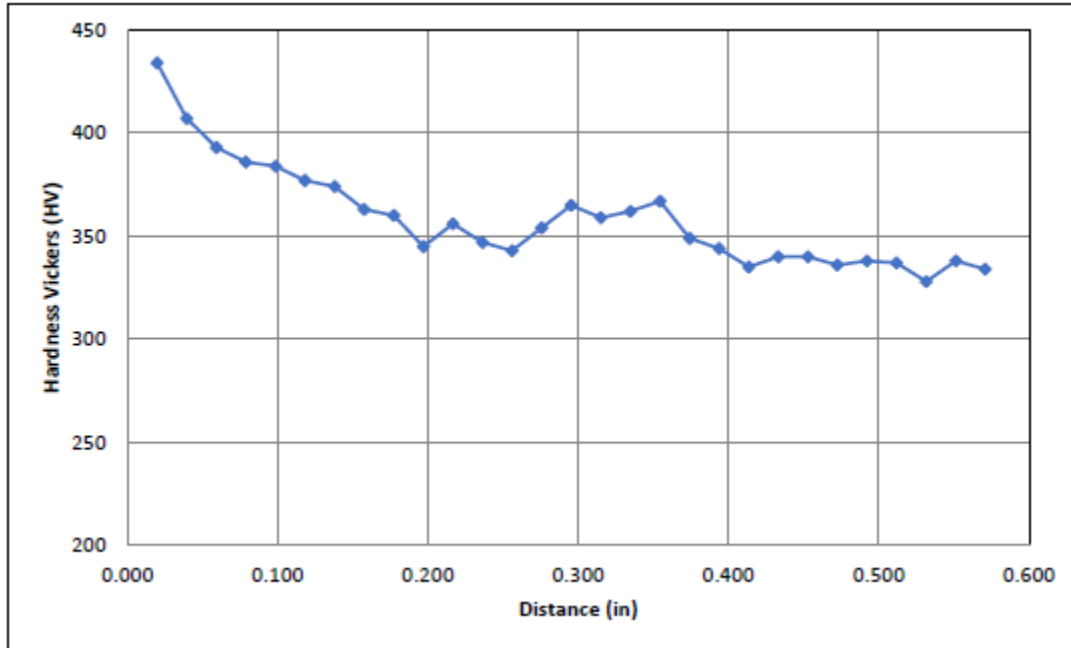
Microhardness measurements were performed on a specimen cut adjacent to the fractured area, in the radial direction from the surface to a depth of half of an inch. The results of the measurements versus depth shown in Figure A-26 suggest the possible presence of an area of work softening.

Figure A-26. BNSF4 Microhardness Variation from Surface

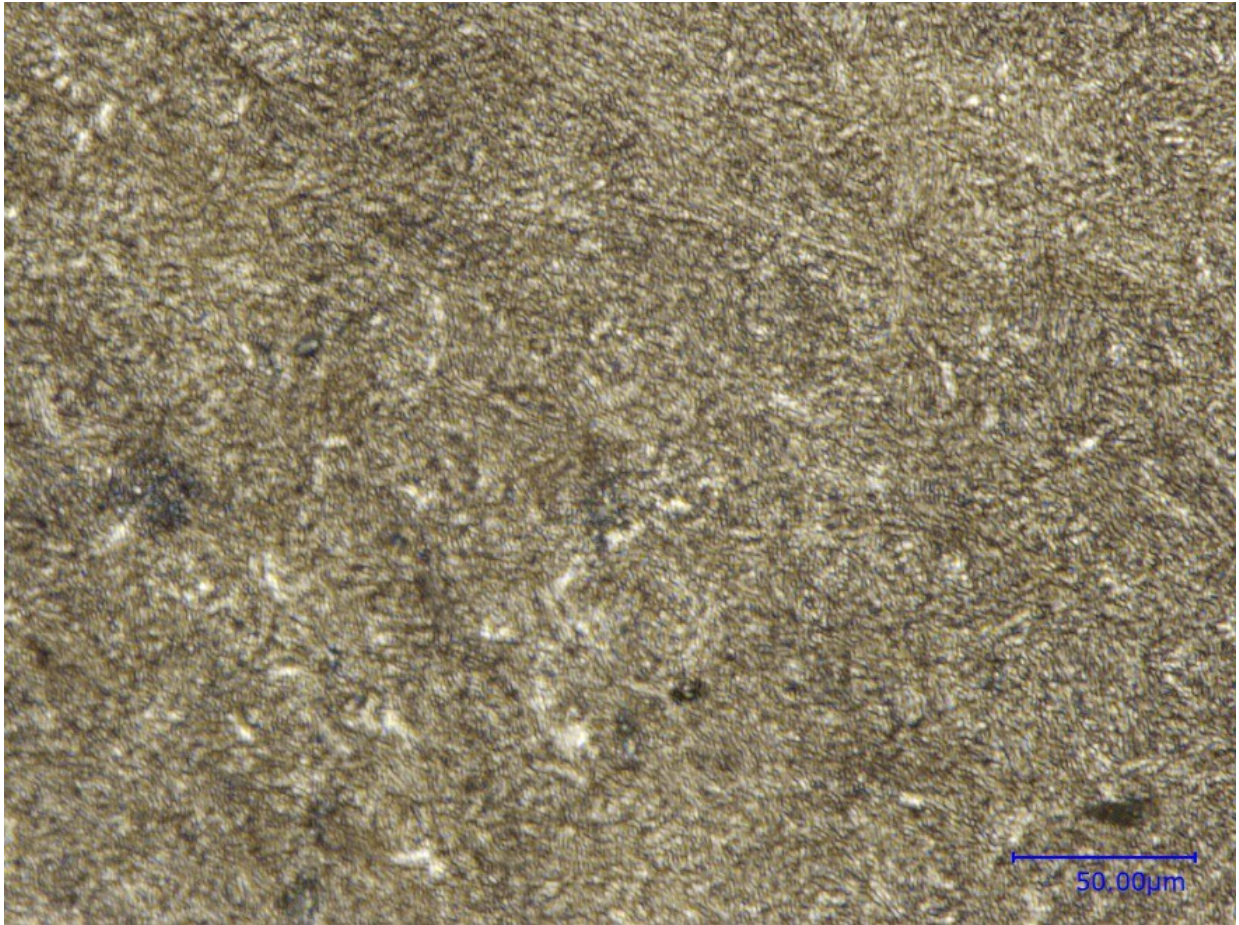
Metallographic analysis of the areas above the shell crack cast structure shows dissolved proeutectoid ferrite and almost complete spheroidization of the pearlitic structure. These changes, shown in Figure A-27, indicate a short time exposure of temperatures in the range of 1,400 °F. In Figure A-28, the area below the shell crack has retained its normal dendritic structure. The microstructure at the transition from shelling or delamination in Figure A-29 shows that the crack surfaces contain a grey oxide coating, indicating exposure greater than 1,000 °F.

Figure A-27. BNSF4 Microstructure Above Shell Crack, Original Magnification x1,000, Nital Etch

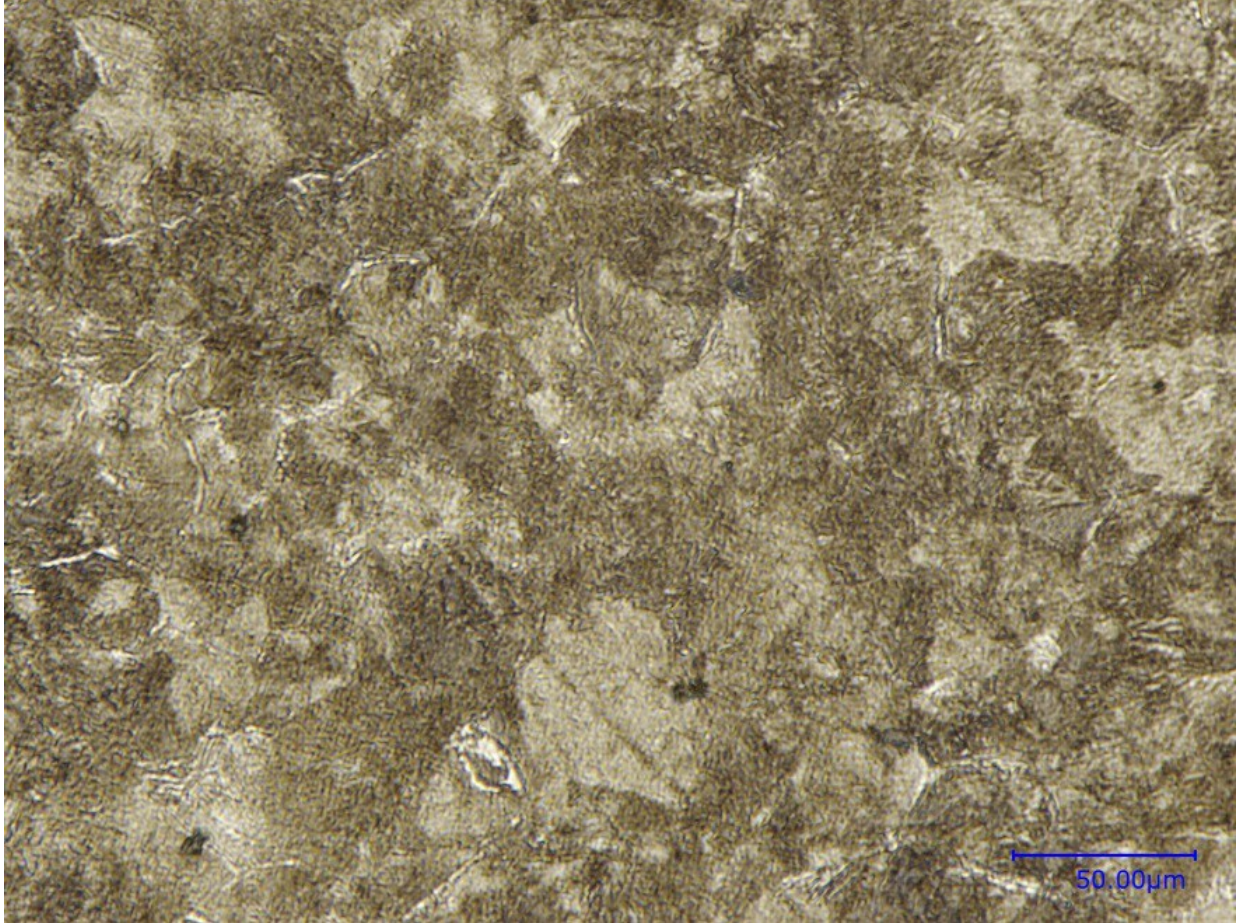
Figure A-28. BNSF4 Microstructure Below Shell Crack Showing Typical Grain Structure, Original Magnification x1,000

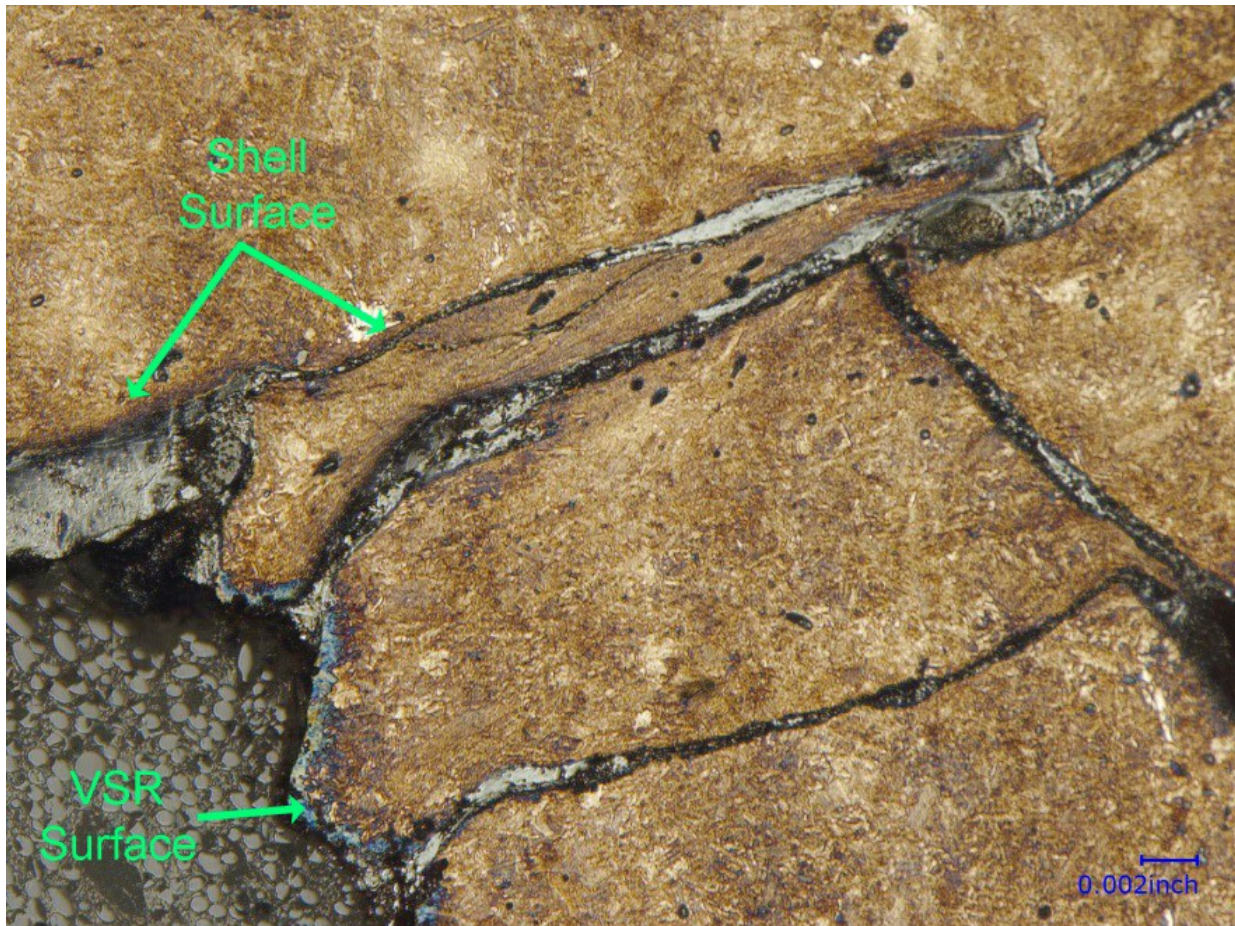
Figure A-29. Transition from Shell Crack to VSR on BNSF4 with Oxidized Crack Surfaces, Original Magnification x300, Nital Etch

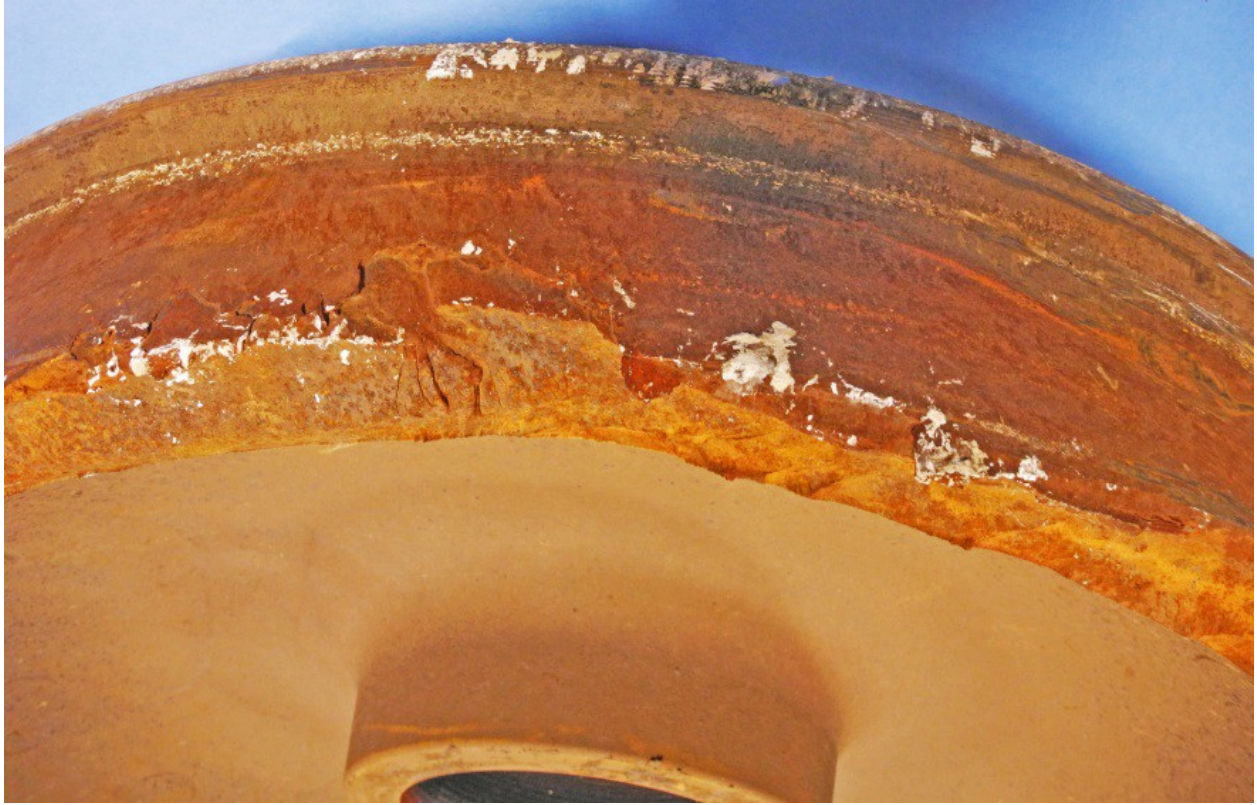
The front rim VSR had separated, as shown in Figure A-30 and Figure A-31. The failure occurred in two steps. First, a large shell defect grew approximately 1/8 of an inch below the tread surface and formed a VSR that grew from the tread shell, as shown in Figure A-31. Metallographic analysis of the areas above and below the shell crack shows flowed and deformed grains, while the area below the crack appears unaffected with a layer of high-temperature oxide within the crack (Figure A-32). Figure A-33 shows the surface of the VSR origin with oxide in secondary cracking.

Figure A-30. Cracking on Tread of Wheel BNSF6

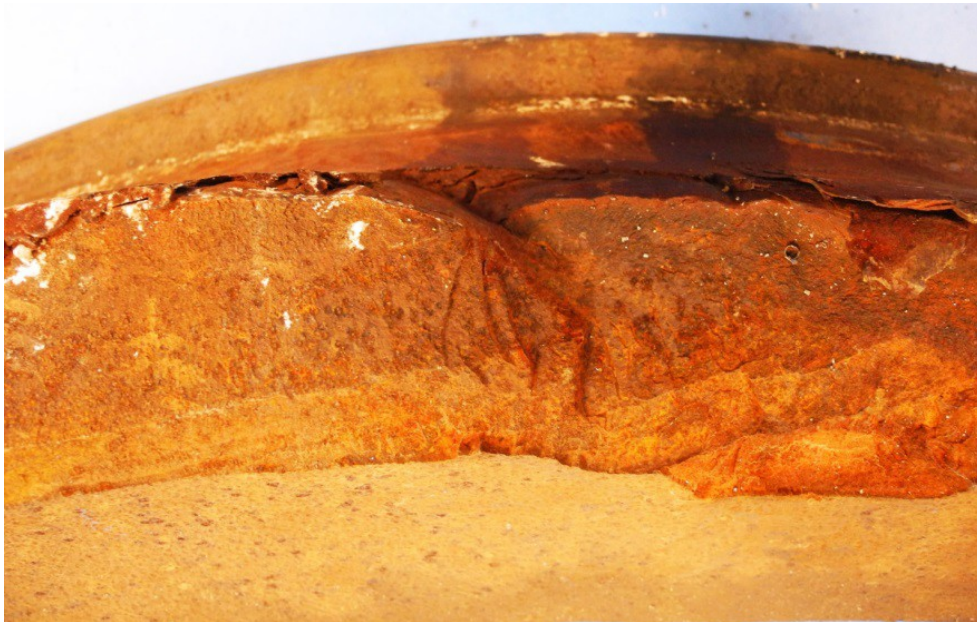
Figure A-31. Termination of VSR on BNSF6 at Rim Plate Fillet

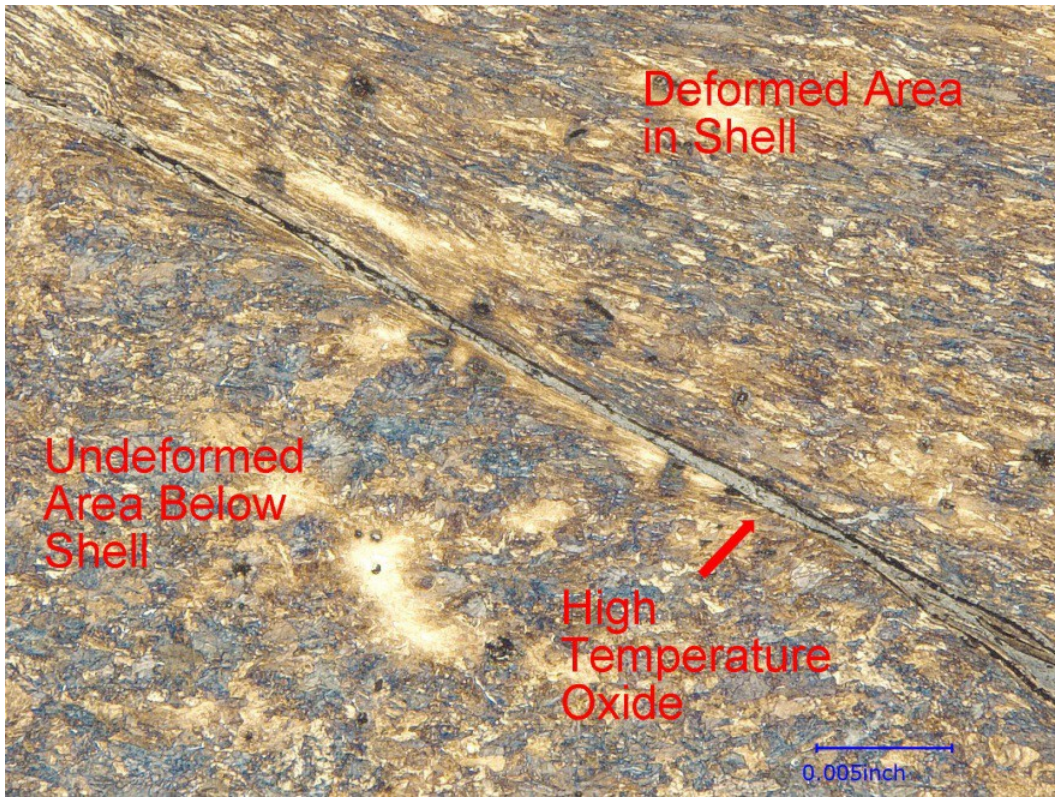
Figure A-32. BNSF6 Microstructure Above and Below Shell Crack, Original Magnification x200, Nital Etch

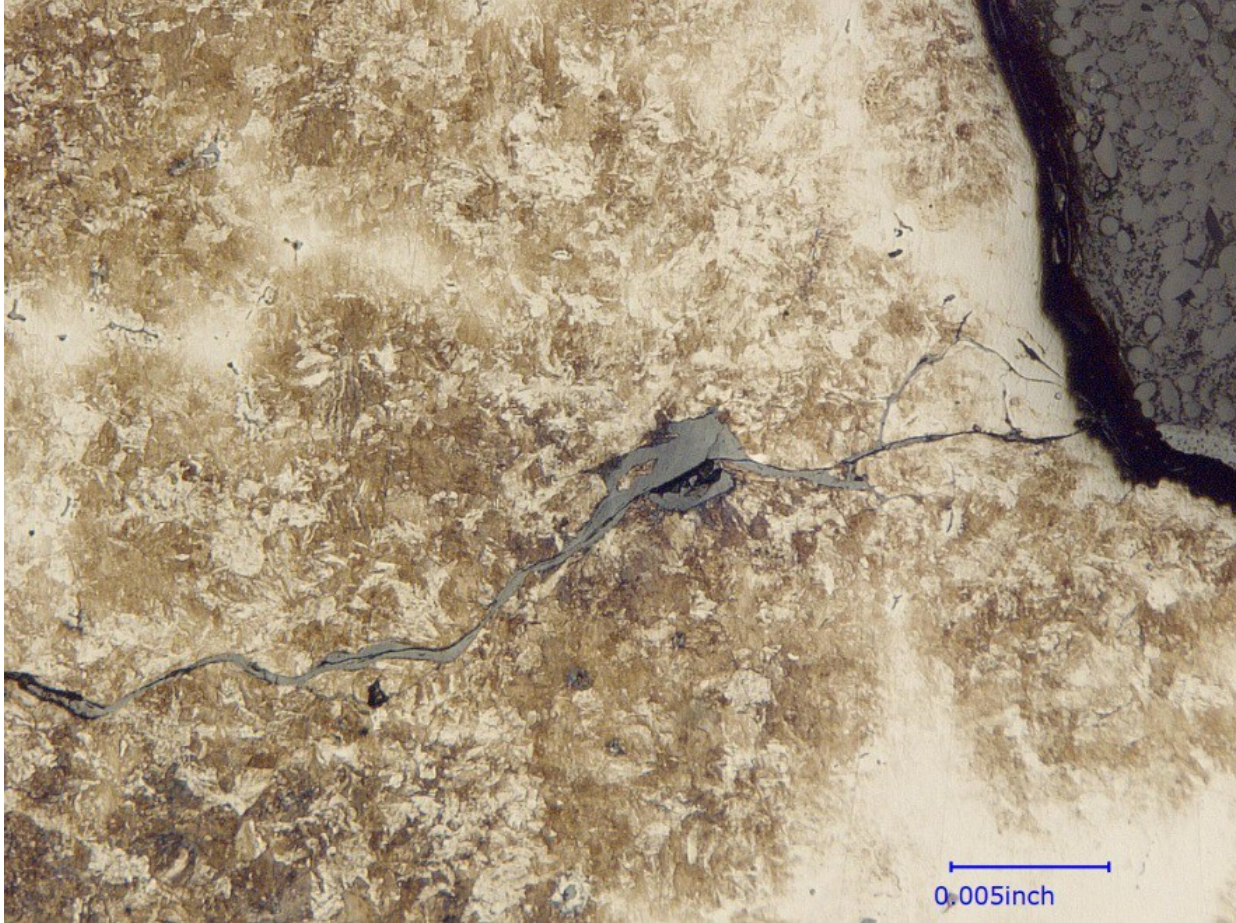
Figure A-33. Secondary Crack from BNSF6 VSR Face with Oxide, Original Magnification x200, Nital Etch

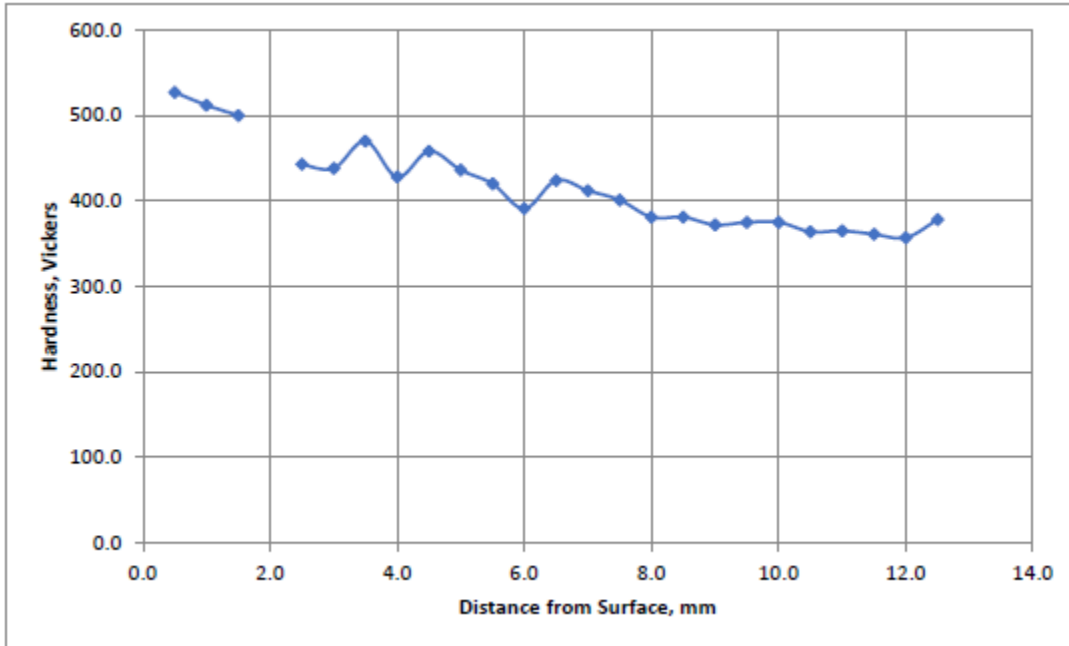
Microhardness measurements were made on a specimen cut adjacent to fractured area in the radial direction from the tread surface to a depth of 1/2 of an inch. The results of the measurements versus depth suggest the possible presence of an area work softening, Figure A-34.

Figure A-34. BNSF6 Microhardness vs. Depth, Discontinuity is Location of Crack

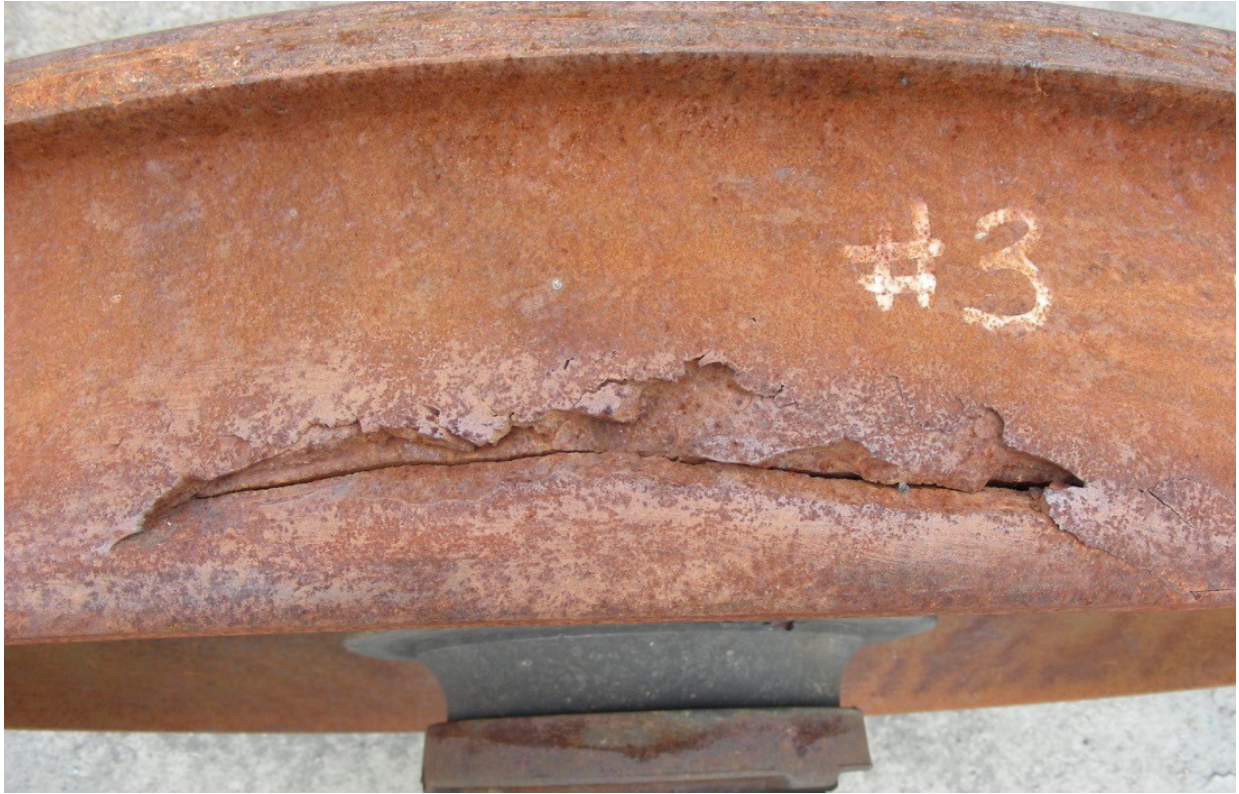
The wheel contained a VSR that had developed for a distance of approximately 10 inches around the tread toward the front rim face of the wheel, as shown in Figure A-35. The VSR had extended completely through the rim, Figure A-36. The wheel tread contained discontinuous shelling around the circumference. Figure A-37 shows the fracture surface of the VSR after numerous attempts to remove the as-received rust layer.

Figure A-35. VSR on Tread of Wheel BNSF7, BNSF Tread Photograph

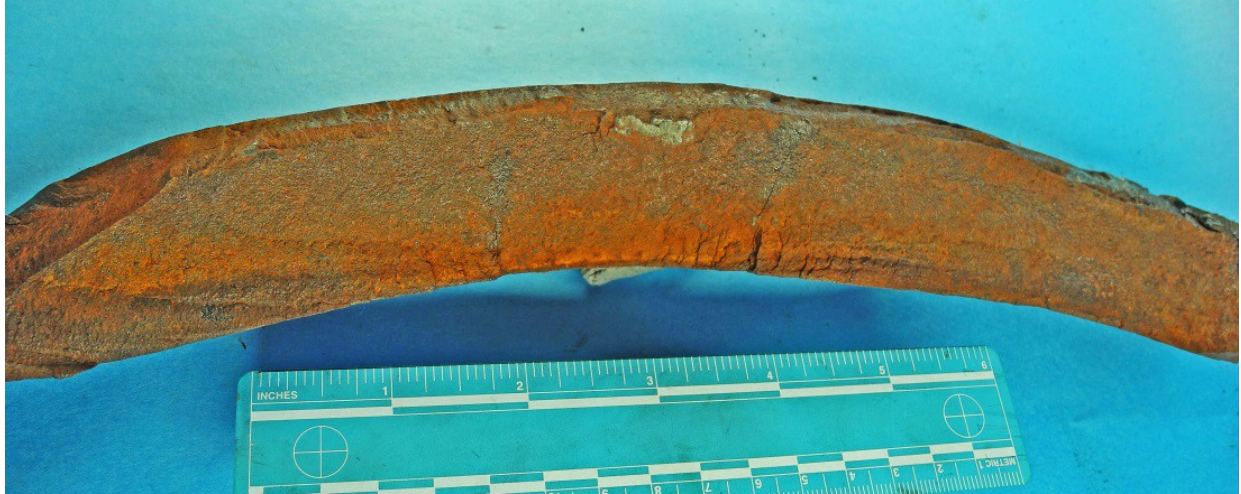
Figure A-37. Fracture Face of Wheel BNSF7 VSR

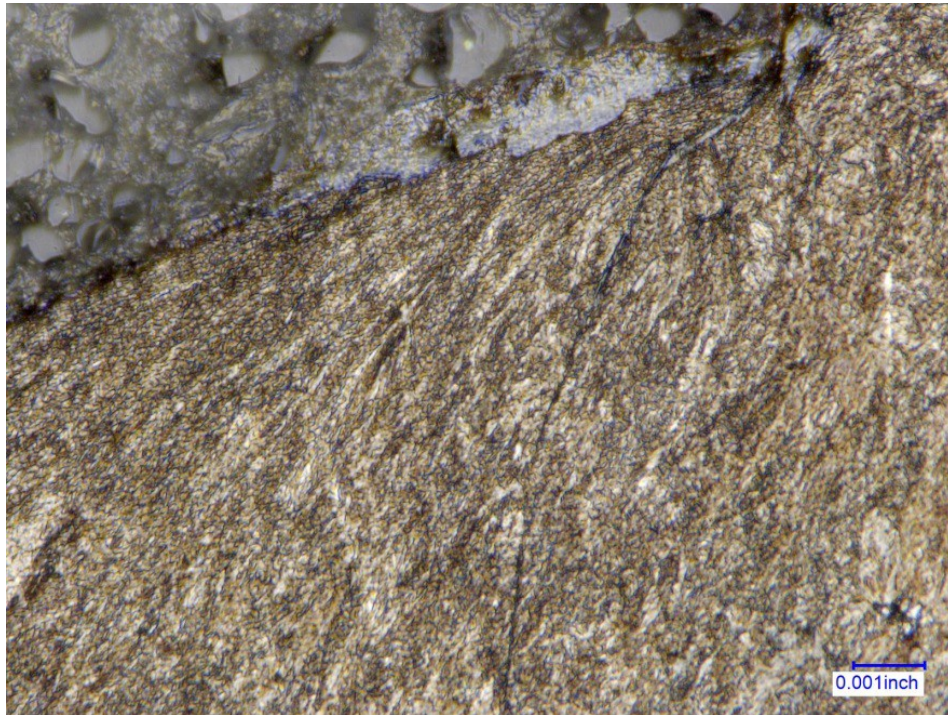
Metallographic analysis of the areas above and below the shell crack (Figure A-38) shows flowed and deformed grains, while the area below the crack appears unaffected with a layer of high temperature oxide within the crack. Figure A-39 shows the surface of the VSR origin with oxide in secondary cracking.

Figure A-38. Microstructure at Tread Surface of Wheel BNSF7 with Crack in Flowed Structure, Original Magnification x1,000, Nital Etch

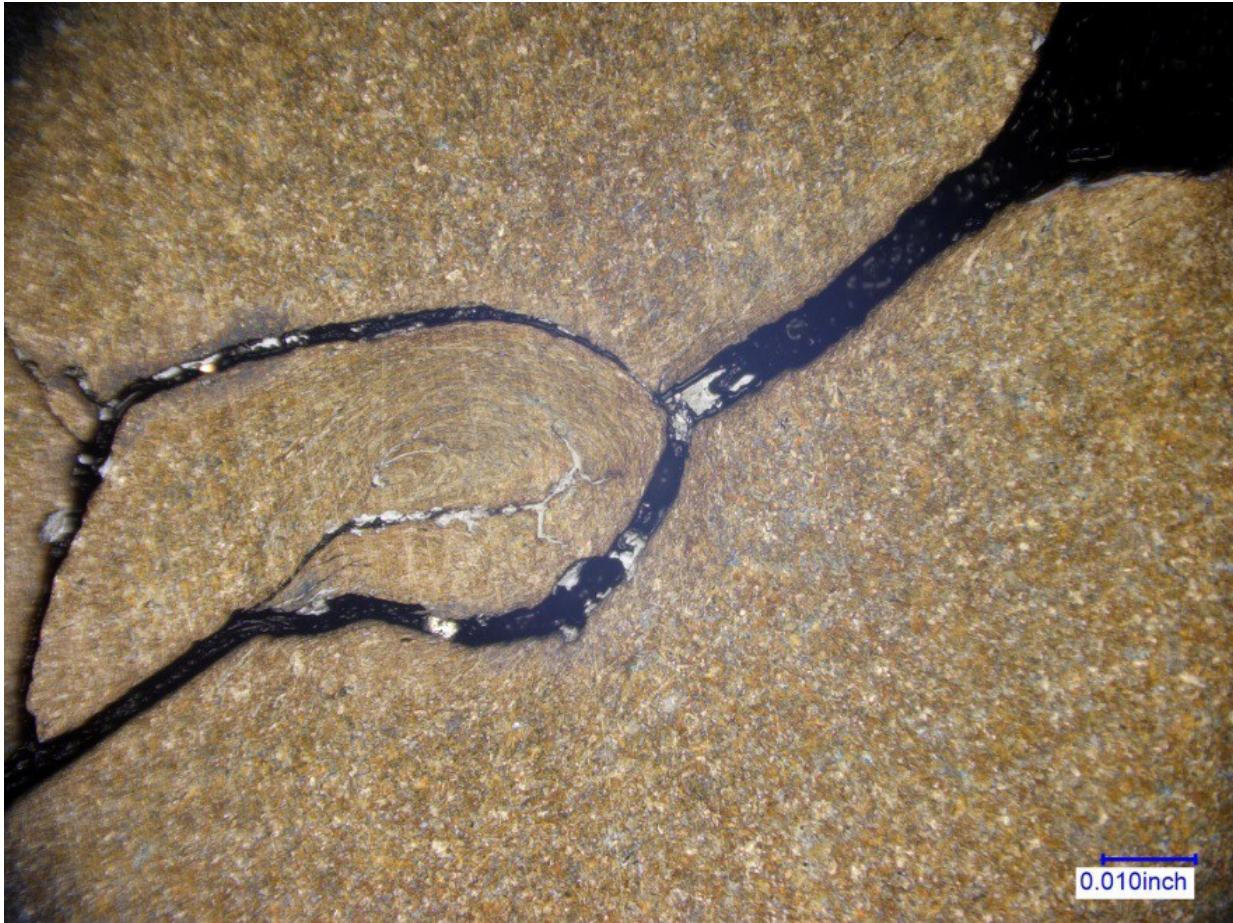
Figure A-39. Crack from Shelling in Wheel BNSF7, Original Magnification x100, Nital Etch

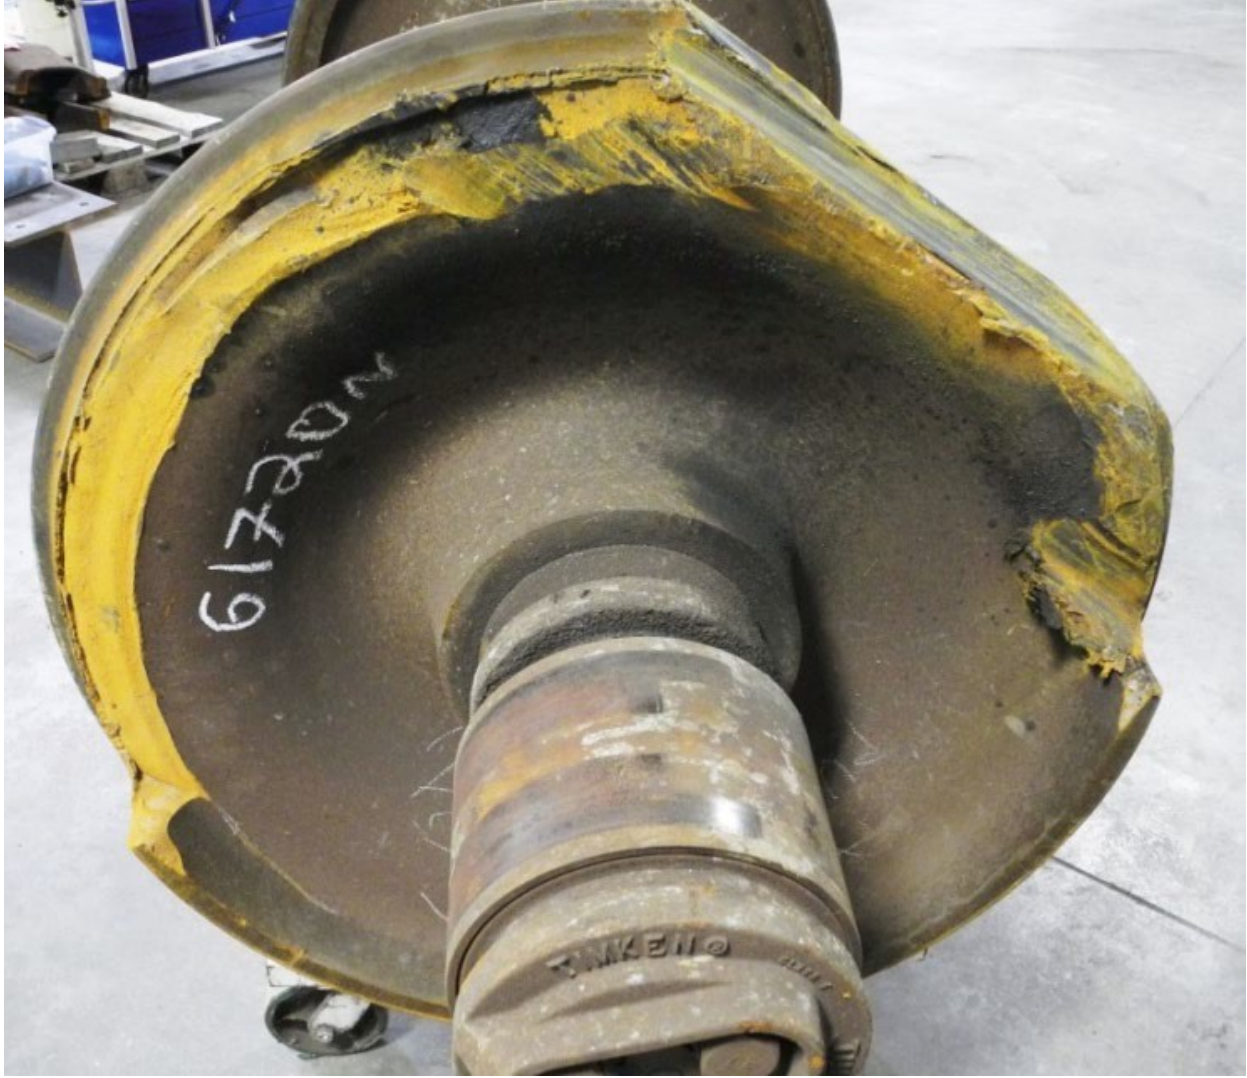
Figure A-41. Fractured Wheel CSX8, as Received

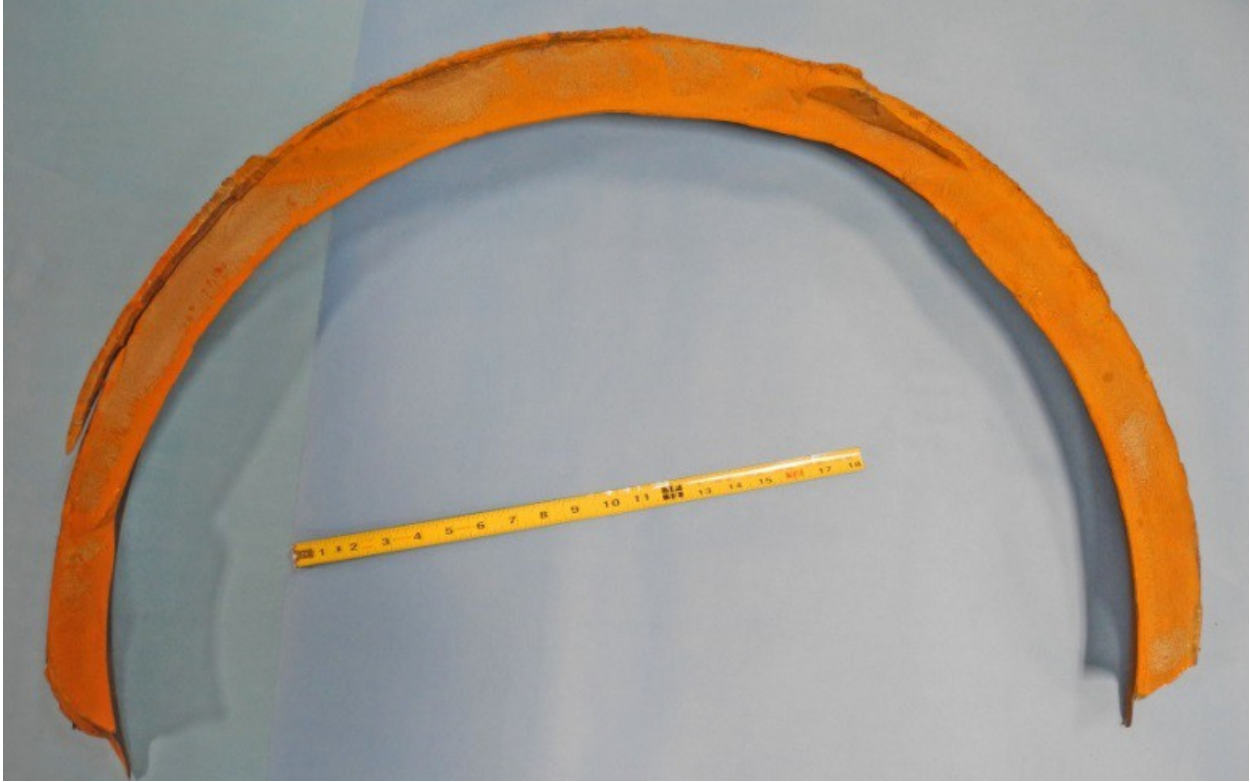
Figure A-42. Front Rim Section that Separated from Wheel CSX8

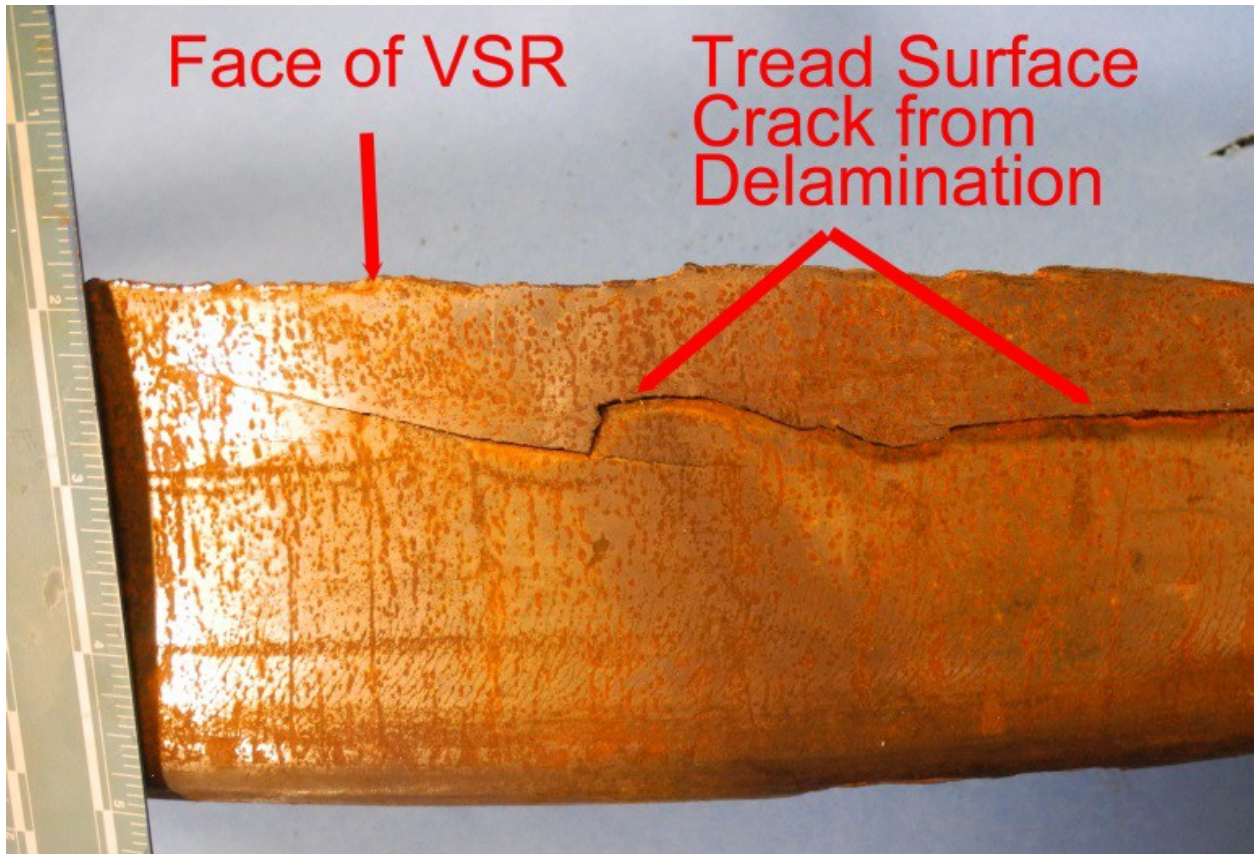
Figure A-44. CSX8 Tread Surface Exit Crack from Delamination

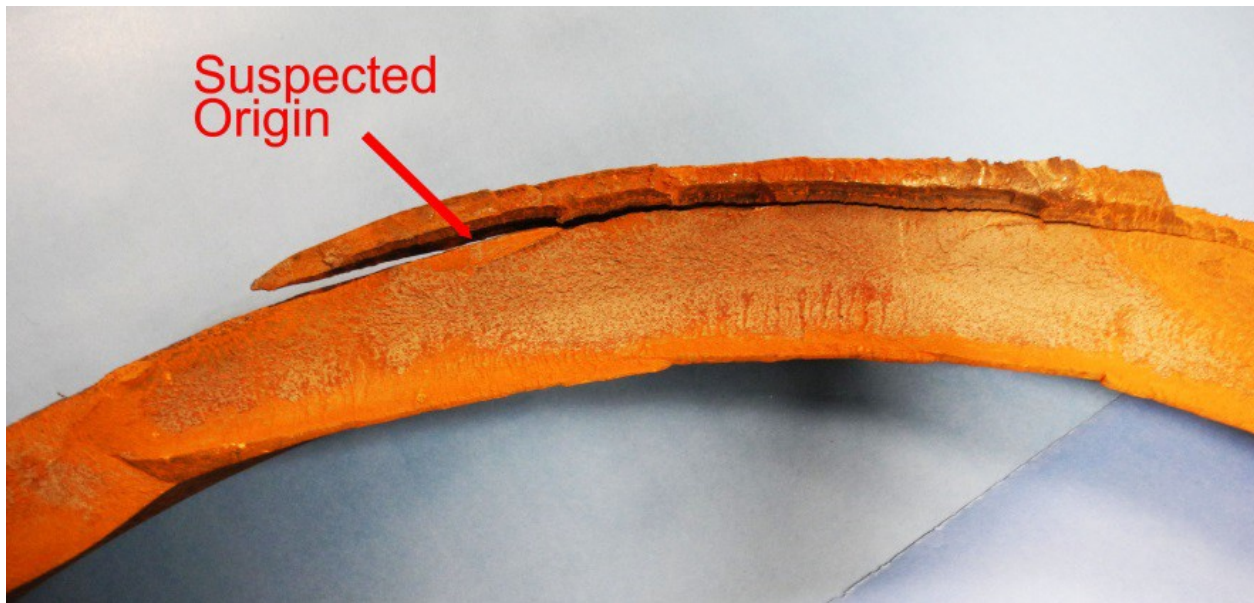
Figure A-45. Fracture Surface of CSX8 VSR with Suspected Origin

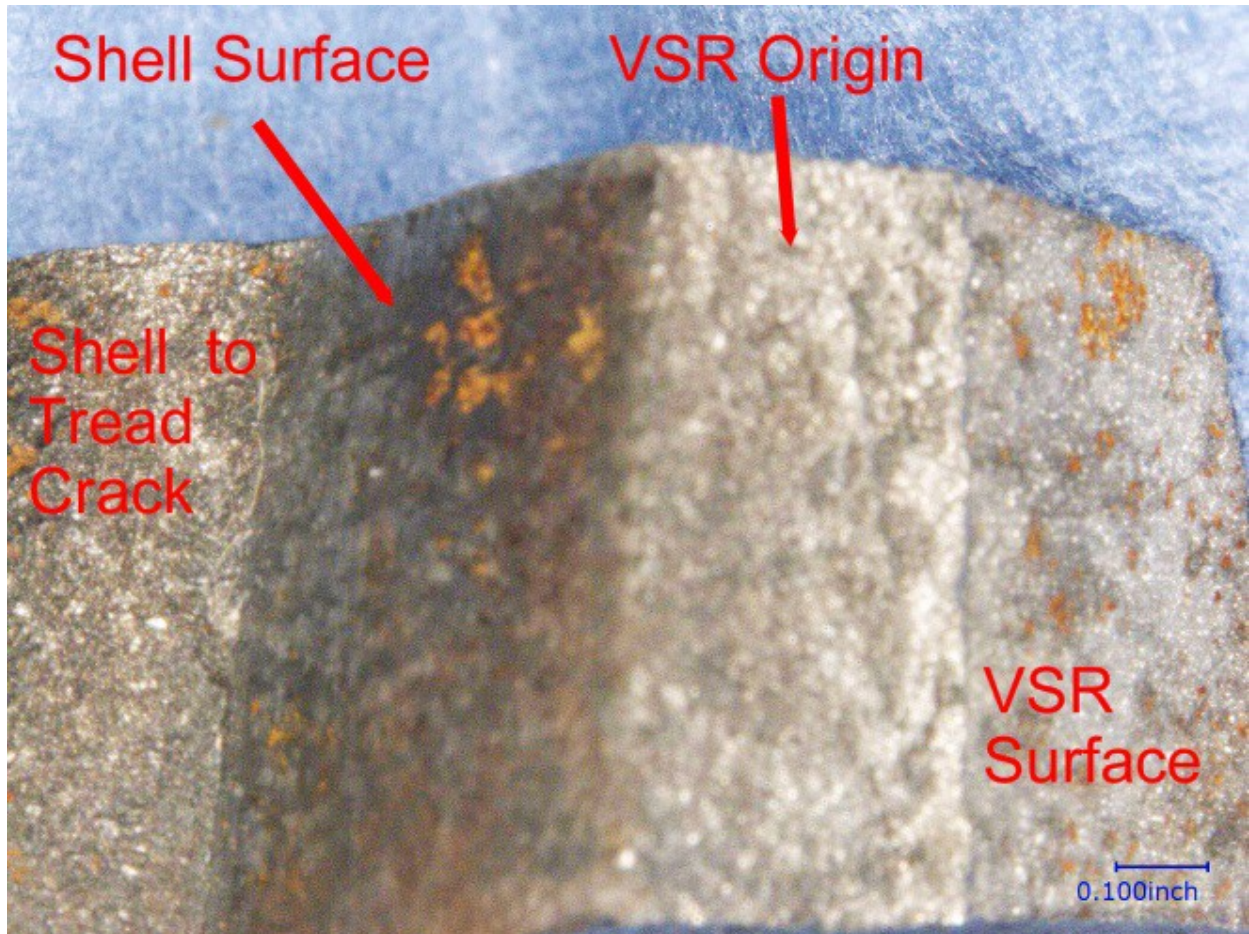
Figure A-46. Fracture Surfaces of CSX8 Through Shelling, VSR Origin, and VSR, Original Magnification x15

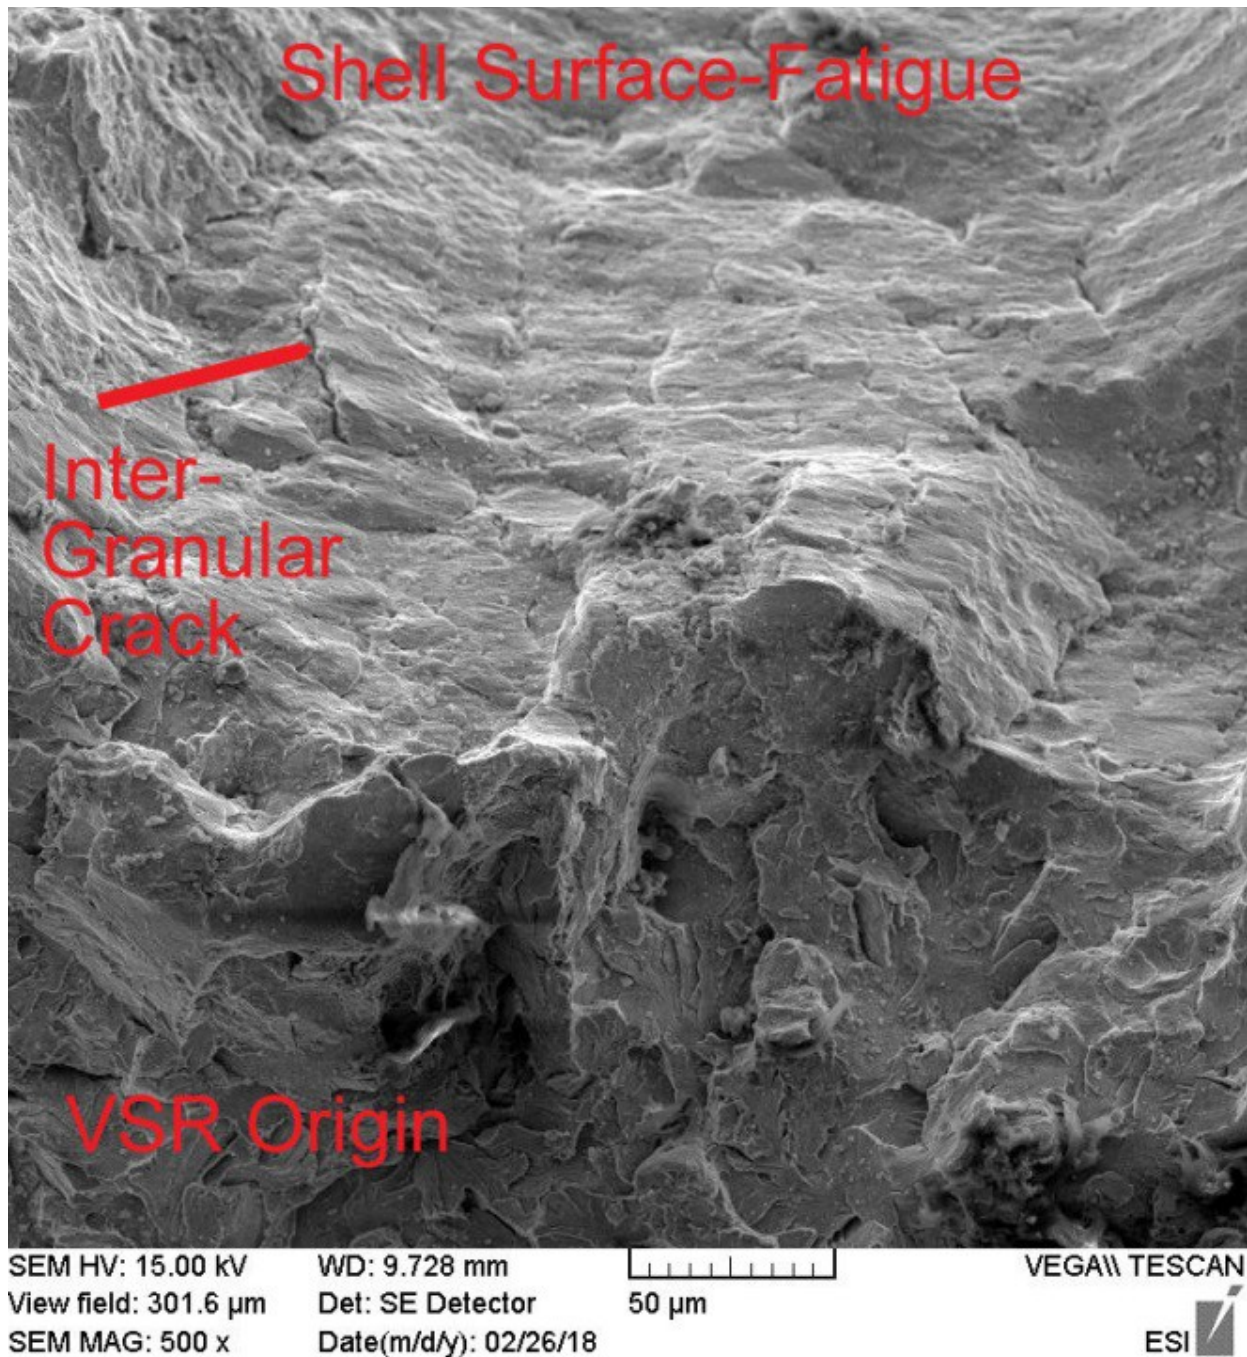
Figure A-49. Transition from Shell Surface Fatigue to CSX8 VSR Initiation, Original Magnification x500

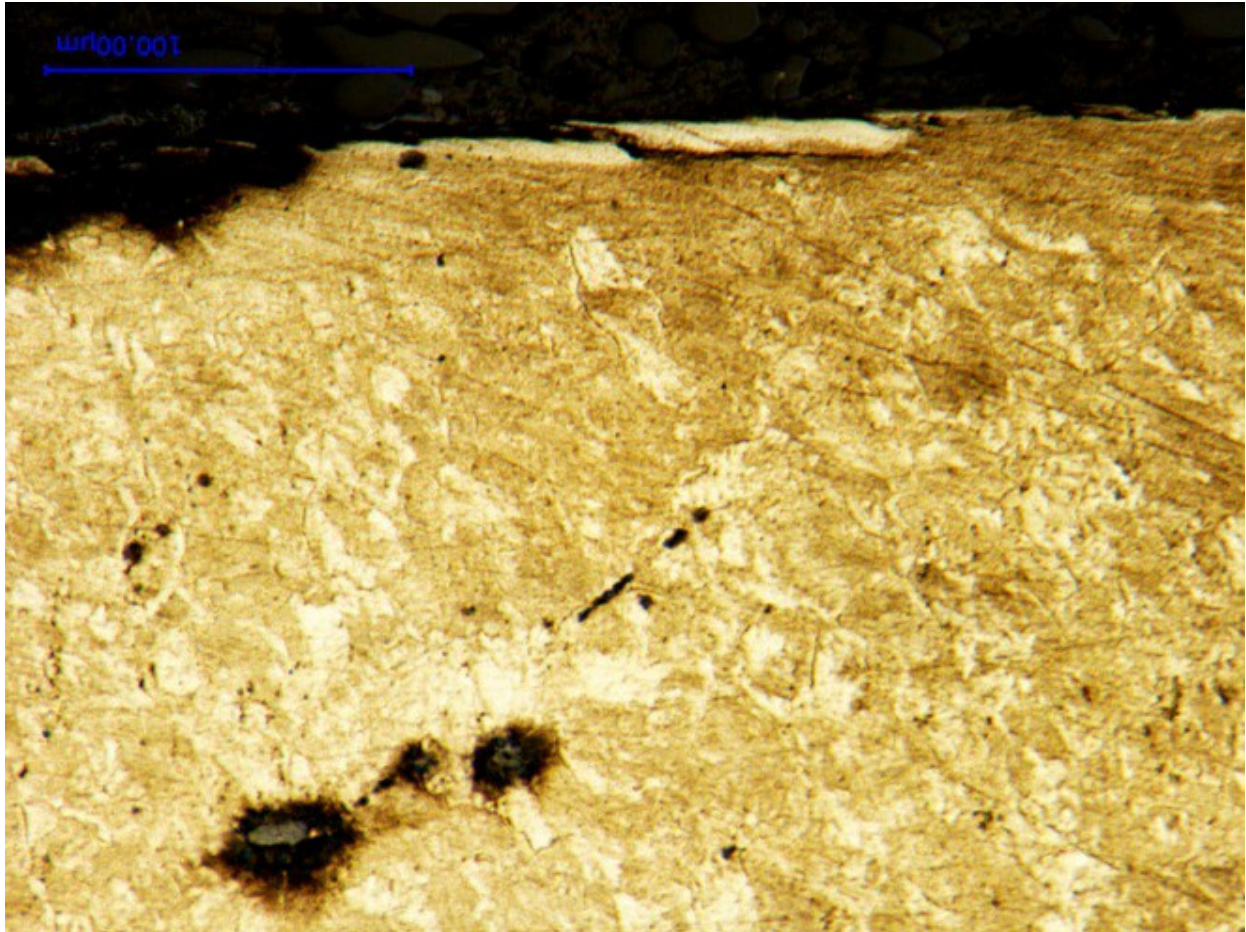
Figure A-50. Microstructure of CSX8 Tread Surface with Martensite Layer, Nital Etch, Original Magnification x1,000

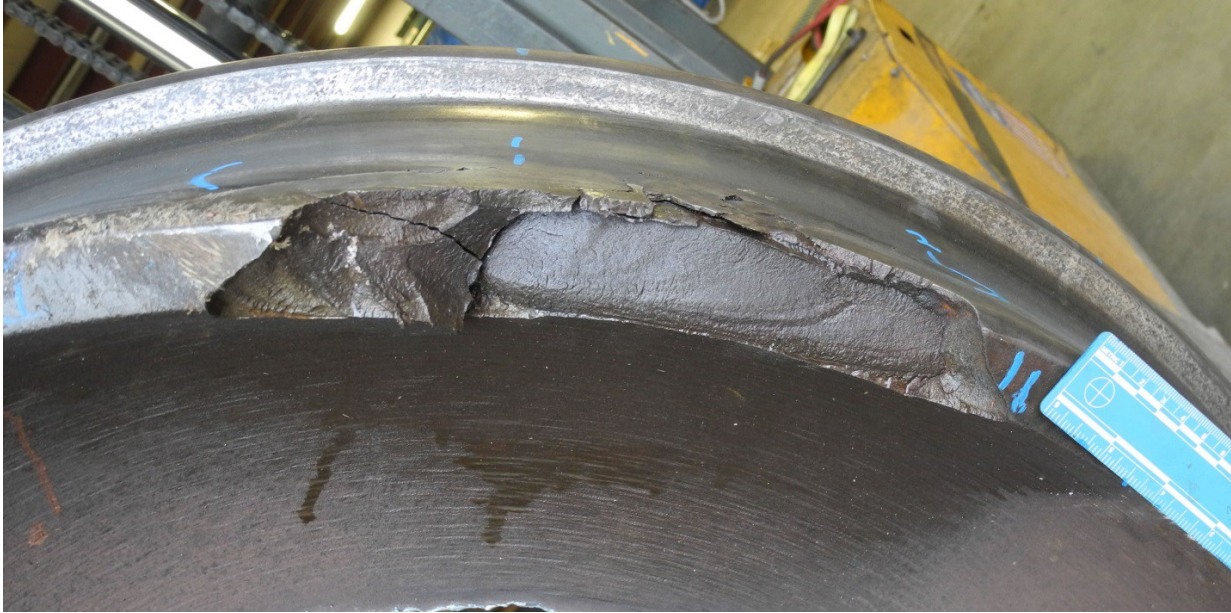
Figure A-52. Vertical Split Rim in Wheel UP9

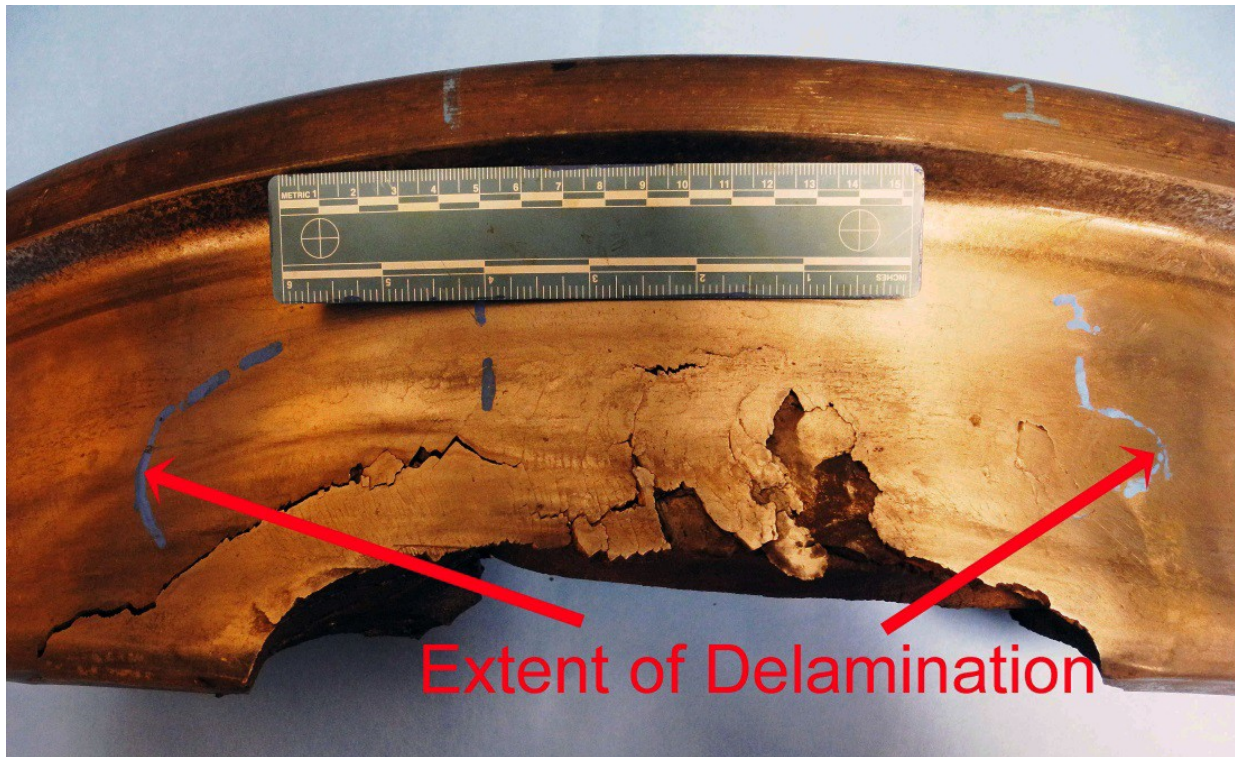
Figure A-53. Extent of Delamination on Failed Wheel UP9, as Revealed by Ultrasonic Inspection
