U.S. Department
of Transportation
Federal Railroad
Administration

Wheel Failure Investigation Program: Phase 2

1. REPORT DATE (DD-MM-YYYY) December 2021		2. REPORT TYPE Technical Report		3. DATES COVERED (From - To) September 2017 – March 2020	
4. TITLE AND SUBTITLE Wheel Failure Investigation Program: Phase 2				5a. CONTRACT NUMBER DTFR53-12-D-00001L	
				5b. GRANT NUMBER	
				5c. PROGRAM ELEMENT NUMBER

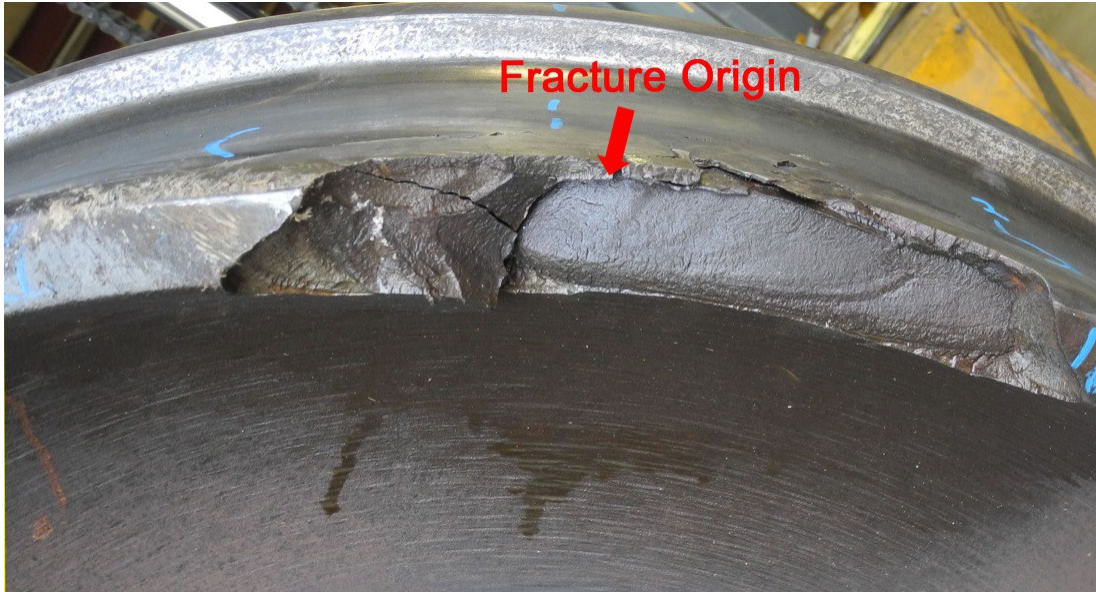
Figure A-55. Fracture Origin of Wheel UP9

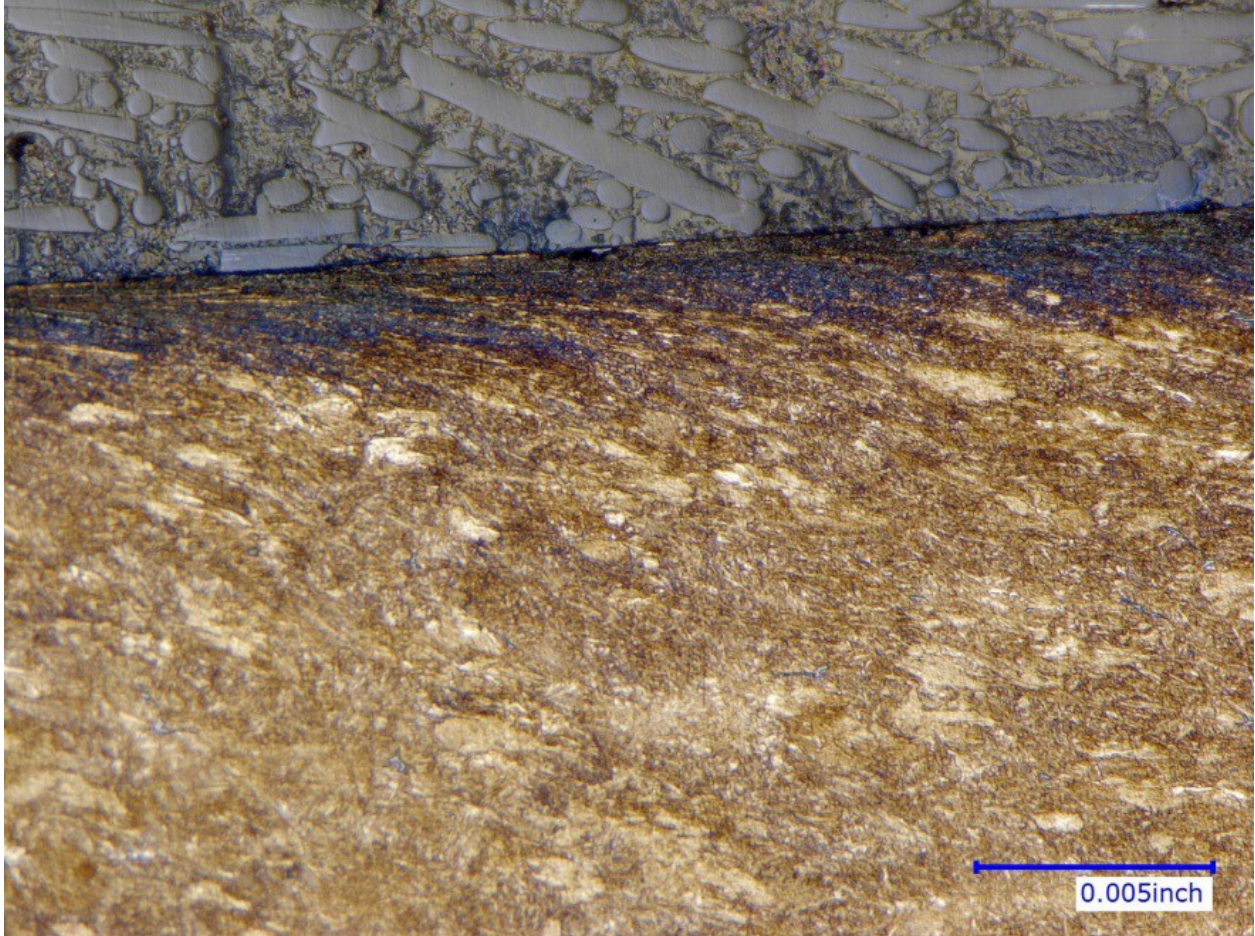
Figure A-56. Microstructure of Failed Wheel UP9 Tread Surface with Plastic Flow to a Depth of Approximately 0.005-Inch, Original Magnification x500, Nital Etch

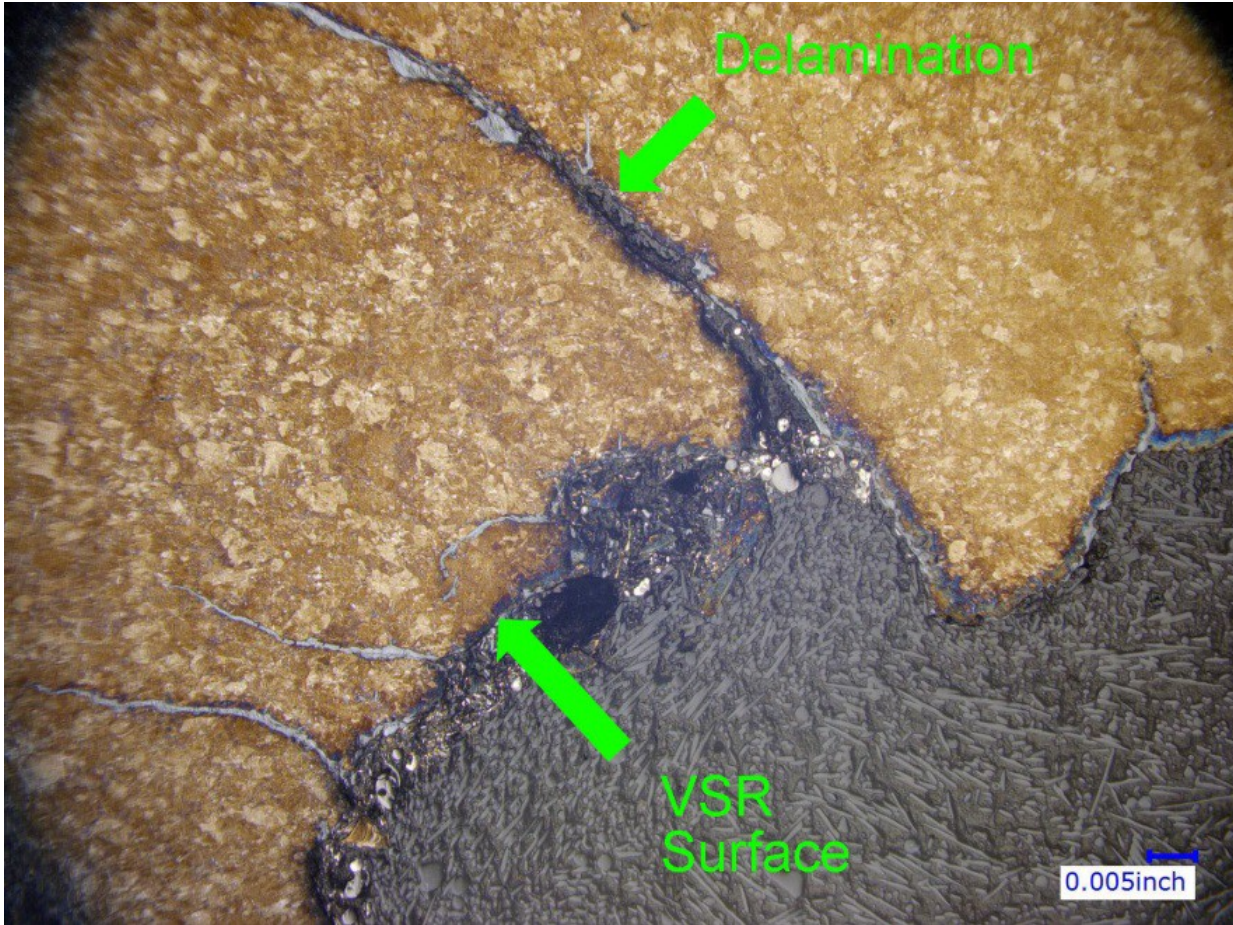
Figure A-58. Transition from Shell to VSR on UP9 with Associated Oxides Within Cracks, Original Magnification x100
