Fouled Ballast Waiver Operations and Results

1. REPORT DATE January 2022		2. REPORT TYPE Technical Report		3. DATES COVERED June 12, 2017–January 31, 2019	
4. TITLE AND SUBTITLE Fouled Ballast Waiver Operations and Results			5a. CONTRACT NUMBER 693JJ6-18-D-000005		
			5b. GRANT NUMBER		
			5c. PROGRAM ELEMENT NUMBER

11. SPONSOR/MONITOR'S REPORT NUMBER(S) DOT/FRA/ORD-22/01	
12. DISTRIBUTION/AVAILABILITY STATEMENT This document is available to the public through the FRA website .

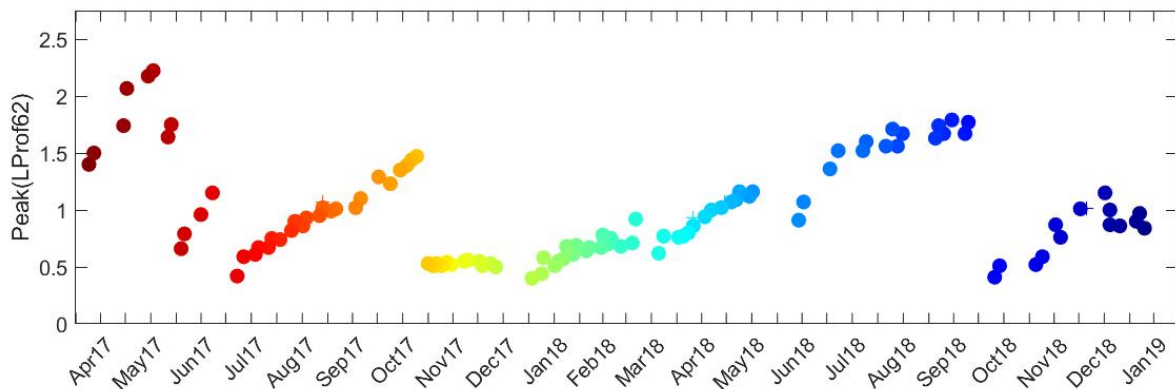
Figure 24 shows two typical examples of time histories of peaks in the Profile 62 parameter. The upper example is for a location of fouled ballast that is 12 feet long. The lower example is for one that is 8 feet long.

a) 12-foot Section of Fouled Ballast at MP 84
