***Federal Railroad Administration  
Office of Railroad Safety***

***Accident Investigation Report  
HQ-2020-1388***

***Union Pacific Railroad (UP)  
Bancroft, Idaho, June 17, 2020***

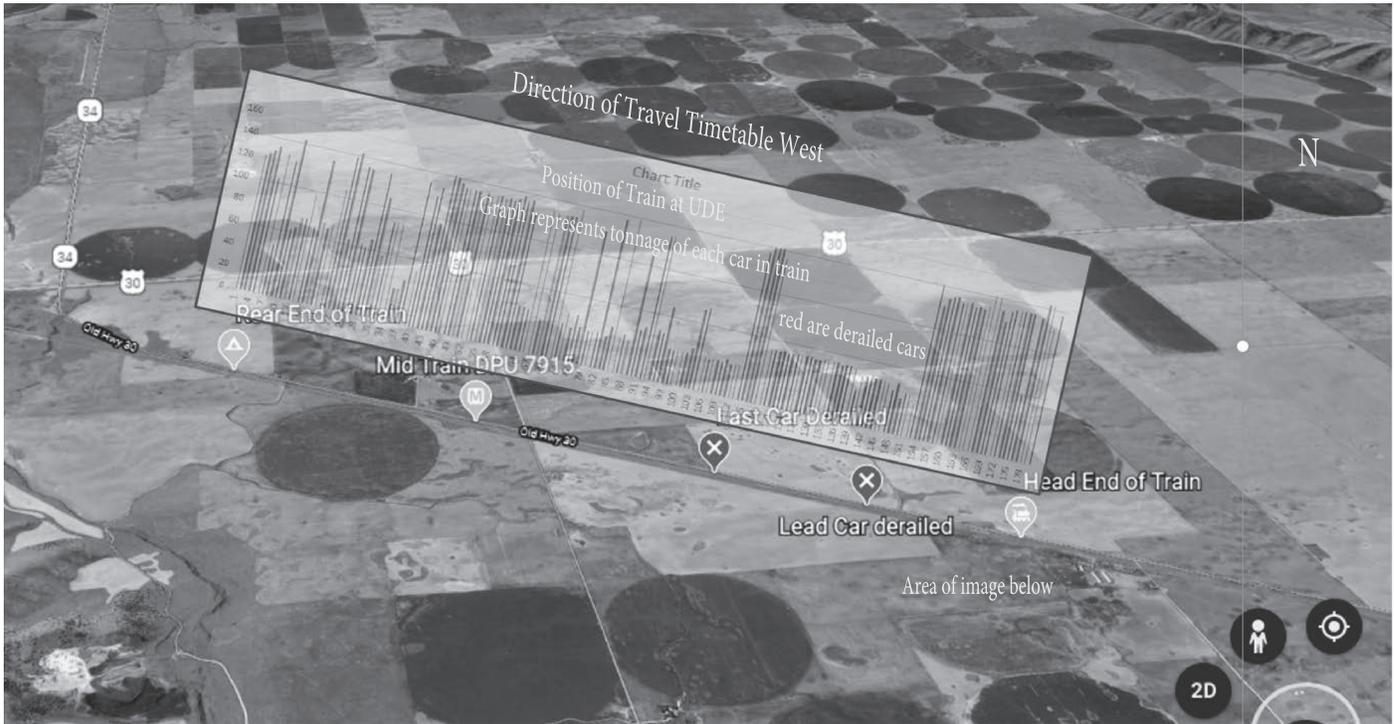
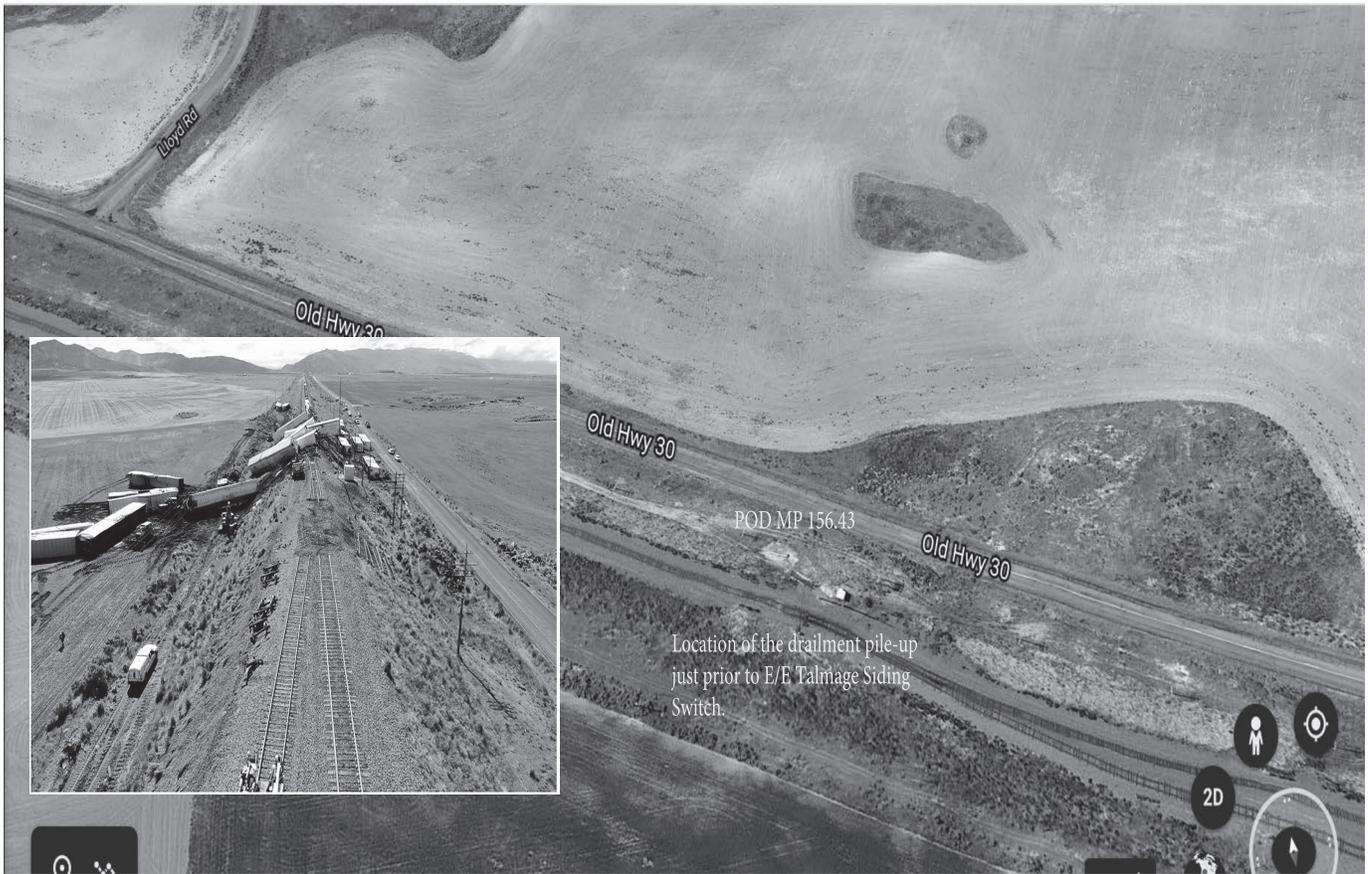
Sketch - Sketch

The method of operation at the accident site is traffic control system (TCS) single main track. The point of derailment was at milepost (MP) 156.43. The 31 derailed cars were located at positions 34 through 64 from the head-end of the train and contained a mix of boxcars, refrigerated cars, and covered hoppers. The train consist included 105 loads, 76 empties, 13,107 feet and 15,560 tons, with 4 locomotives (two locomotives in the head end consist, one mid-train distributive power unit [DPU] and one rear DPU locomotive).

As the in-train forces created by the slowing head end tonnage and the rear end tonnage moving 5 mph faster, these two opposing forces met in the block of empty cars between the lead locomotives and mid train DPU, creating the force necessary to squeeze and lift one of the empty car's wheels off its running path and leading to the derailment and pile up of empty cars lines 34 to 64 behind the lead locomotives and up to, but not including, the mid train DPU locomotive.
