***Federal Railroad Administration
Office of Railroad Safety***

***Accident Investigation Report
HQ-2020-1389***

***BNSF Railway
Winslow, Arizona
July 6, 2020***

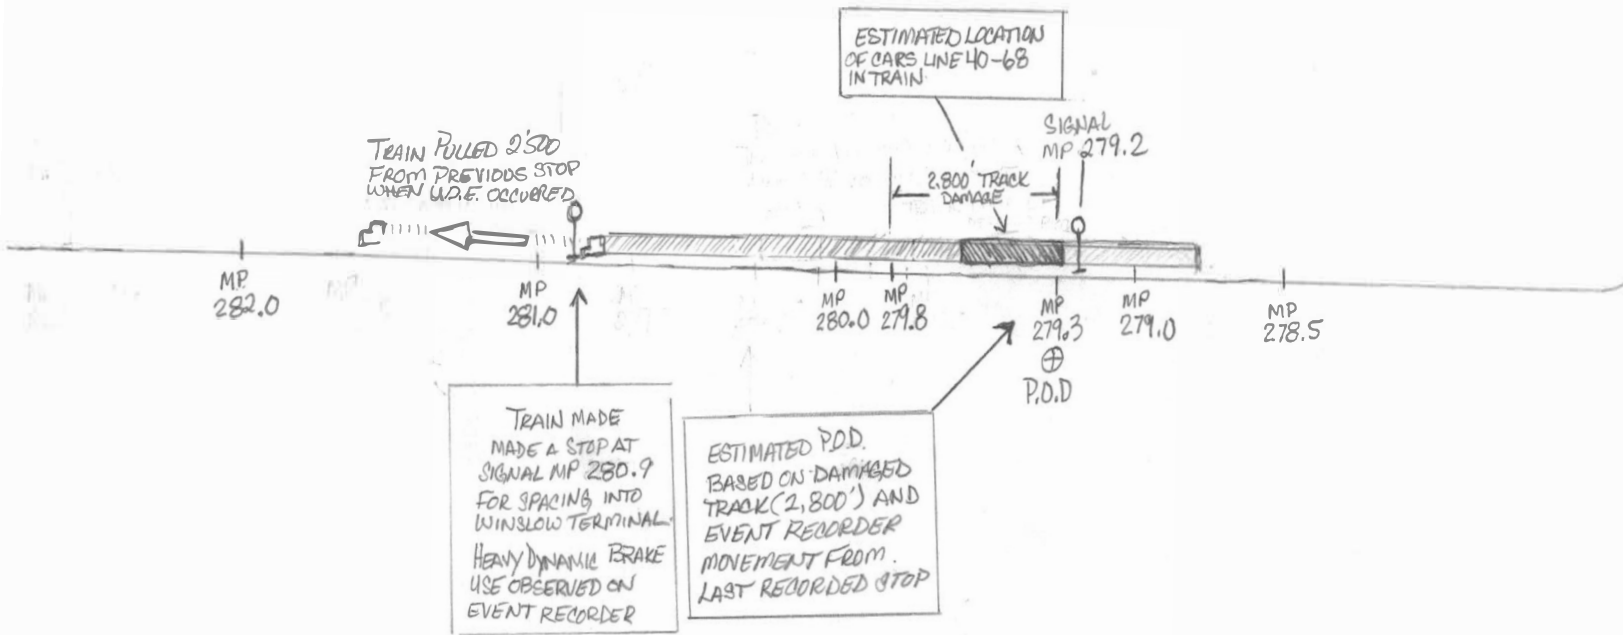
Sketch - Sketch

BNSF
Winslow, AZ HQ-2020-1389
SKK&COI-04 TRAVELING
WESTBOUND AT 11 MPH WHEN
UNDESIRED EMERGENCY BRAKE (U.D.E.)
APPLICATION OCCURRED.

TRAIN CONSIST
4 LOADS H/E
2 DPU'S BETWEEN LINE 33+34
TRAIN LENGTH 11,393 (w/LOADS)
TONNAGE 14,497 TONS
CARS IN TRAIN 143
LOADS 119
EMPTIES 24
CARS DERAILED LINES 40 TO 68
