***Federal Railroad Administration
Office of Railroad Safety***

***Accident Investigation Report
HQ-2021-1459***

***National Railroad Passenger Corporation (ATK) Hwy-rail GX
Collision
North Charleston, SC
October 30, 2021***

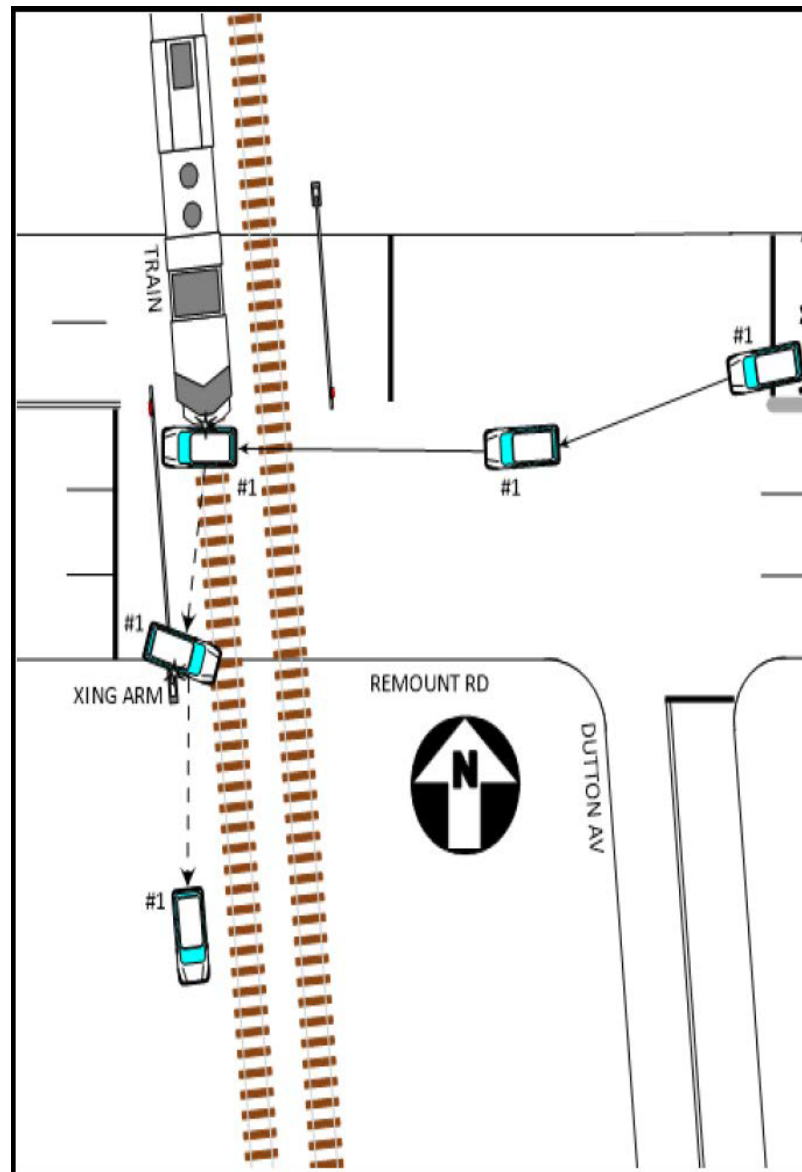
Sketch - Sketch

ATK Hwy-Rail
GX Collision HQ-
CSX-2021-
1030-1459 North
Charleston, South
Carolina, October
30, 2021, 2:36
a.m., EDT
