***Federal Railroad Administration  
Office of Railroad Safety***

***Accident Investigation Report  
HQ-BNSF-2021-0303-1417***

***BNSF Railway (BNSF)  
Ludlow, California  
March 03, 2021***

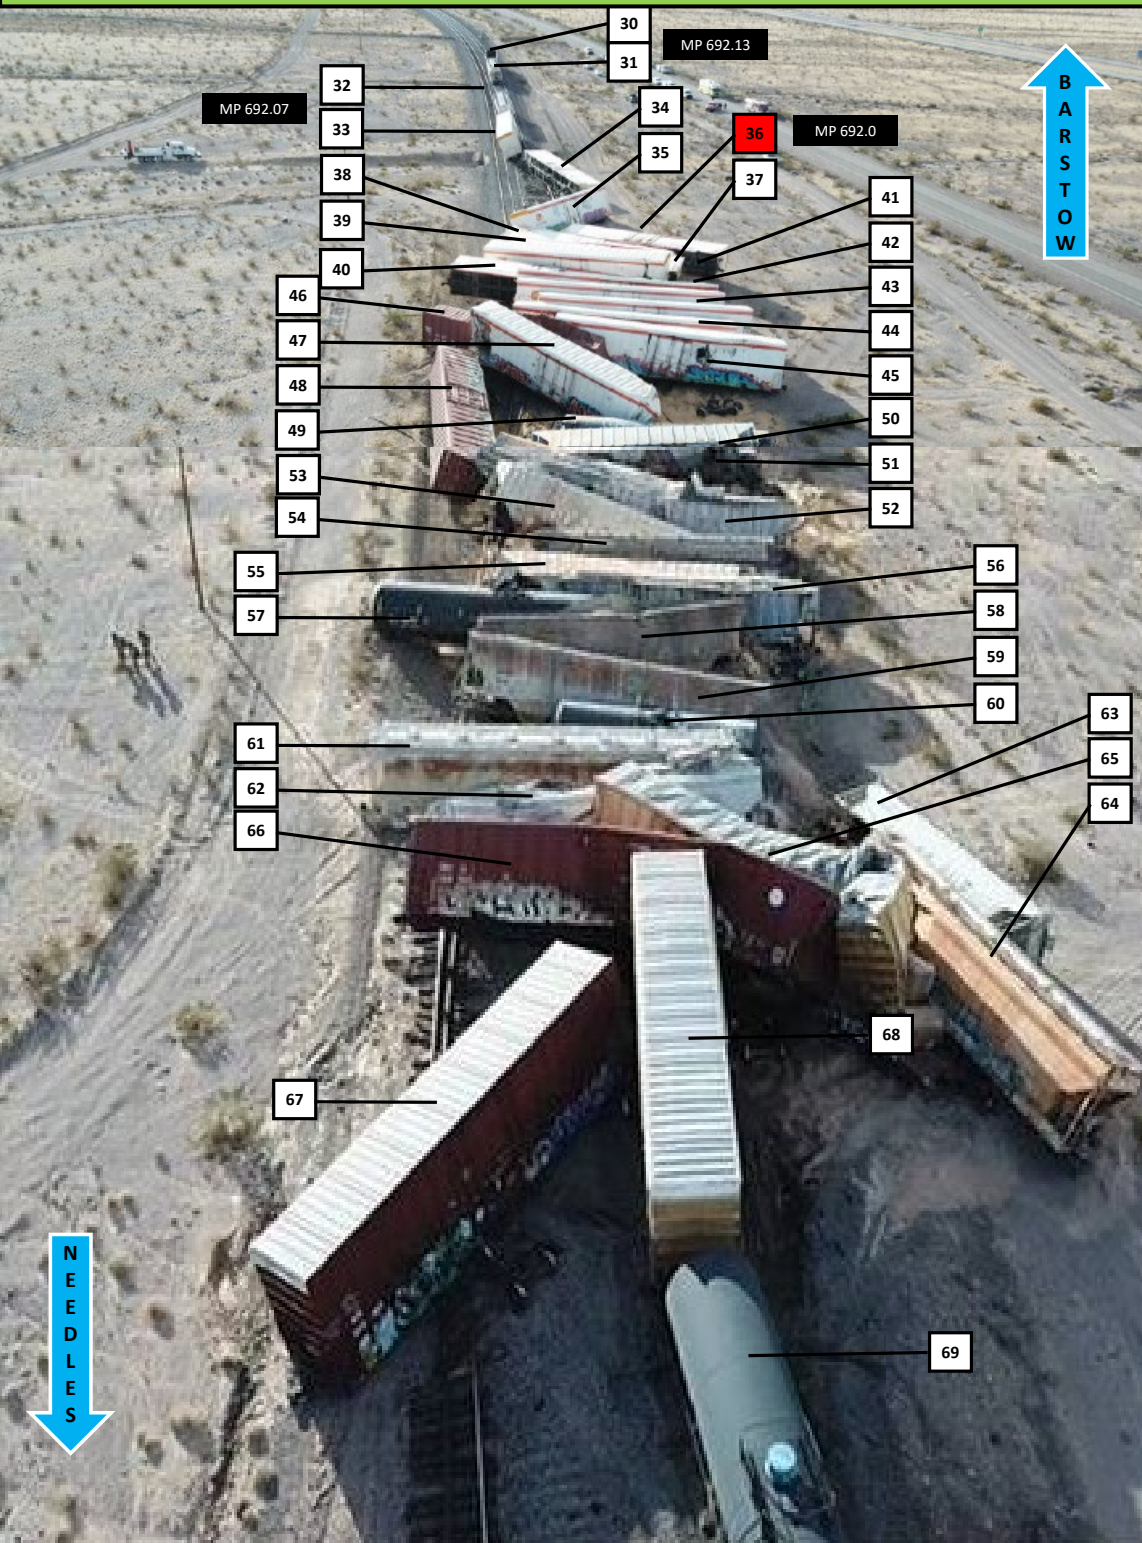
# DERAILMENT SKETCH

These cars were still coupled to head end portion of the train at MP 692.40.

Cars 71 through 100 were still coupled to the rear portion of the train.

*Conclusion:* FRA determined that car CRYX 8332 (Line No. 36) was the first empty car to derail, resulting in the UDE and general pile-up due to in-train forces generated by the tonnage at the rear end of the train. The exact point of the derailment was never determined due to the extensive debris pile and the carriers' clearing of the wreckage to return the tracks to service. Evidence gathered at the derailment site supports the derailment originating in the block of empty cars; with 13 of the derailed cars being identified as empty boxcars equipped with end-of-cushion drawbars. The end-of-cushion drawbar design allows for additional free travel (additional 26-inch per car) which can substantially amplify train induced forces. Excessive in-train forces were then generated as the rear end of Train 1 identified as Block 3, had accelerating tonnage running in on the slowing head end tonnage of Block 1, compressing Block 2, characterized by an accordion-style pile-up in the mid-section of the train.
