U.S. Department
of Transportation
Federal Railroad
Administration

Locomotive Crash Energy Management Vehicle-to-Vehicle Tests 1 & 2: Analyses and Test Results

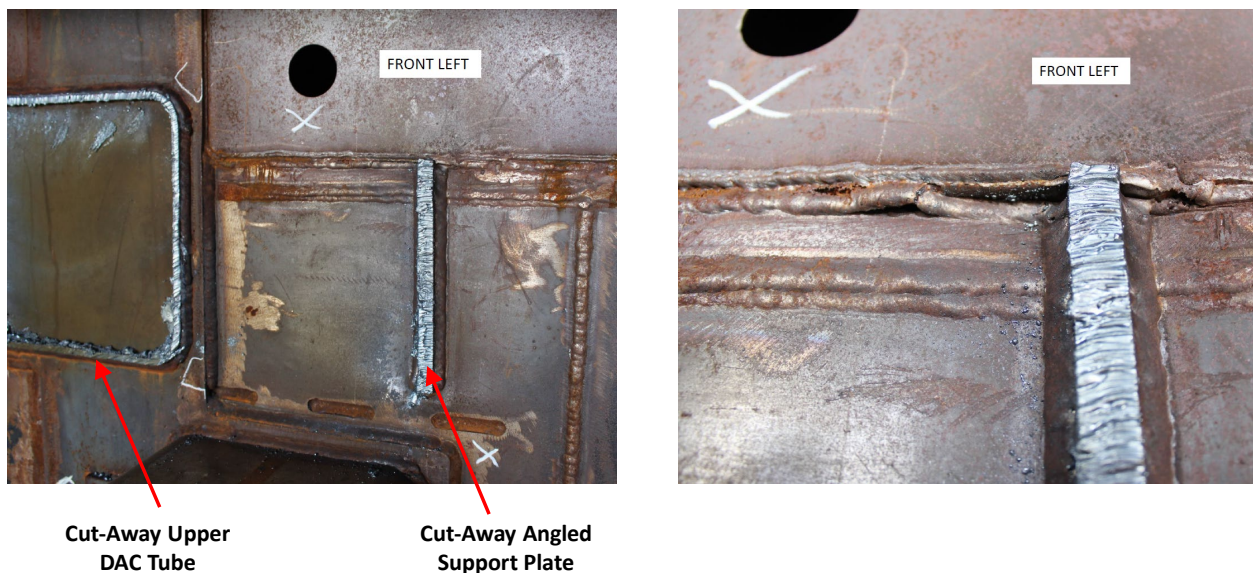
Figure 50. Left — photograph showing cut-away left upper DAC tube and angled support plate; right — detail showing damage at top of connection between angled support plate and front plate

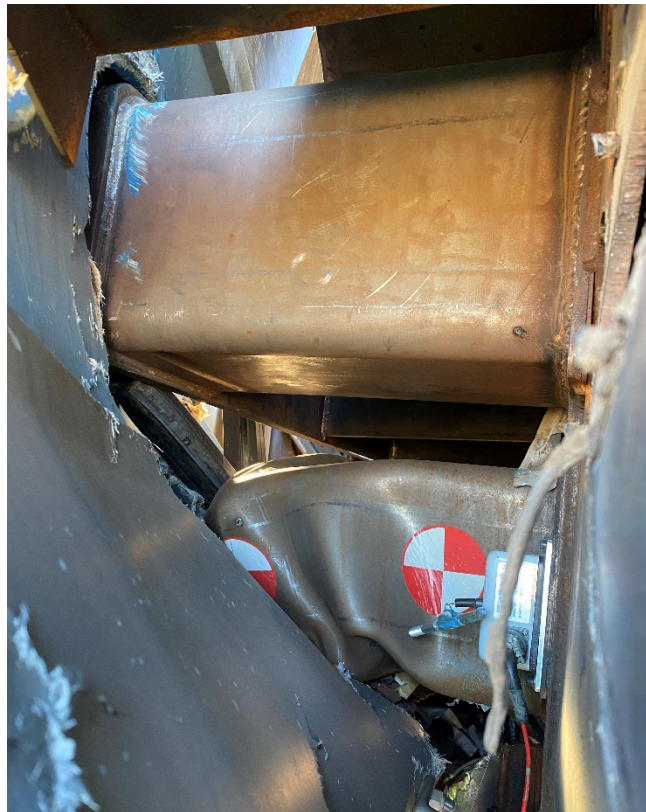
Figure 66. DAC tubes after impact, before the vehicles were separated

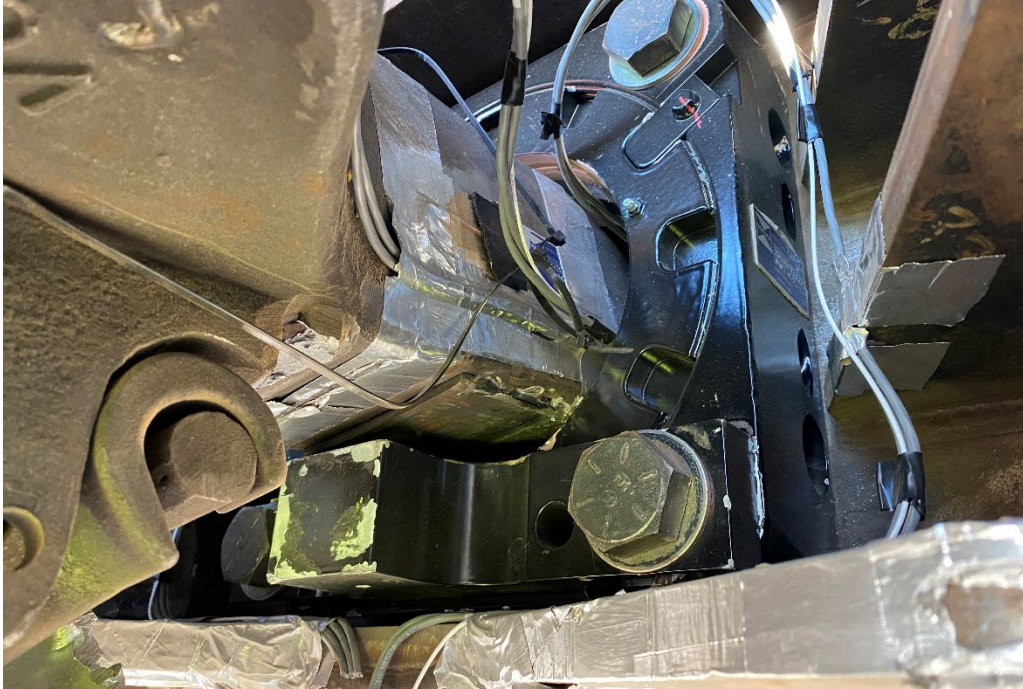
Figure 70. Damage to the limit stop mounted to the front of the sliding lug due to contact by the back of the PBC coupler head

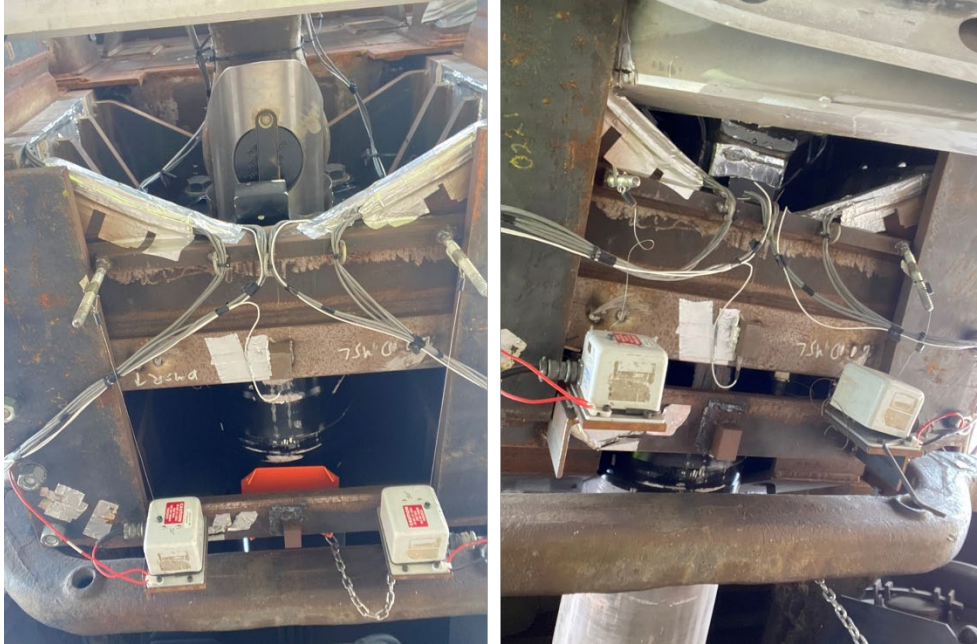
Figure 71. Sliding lug position before (left) and after (right) the impact

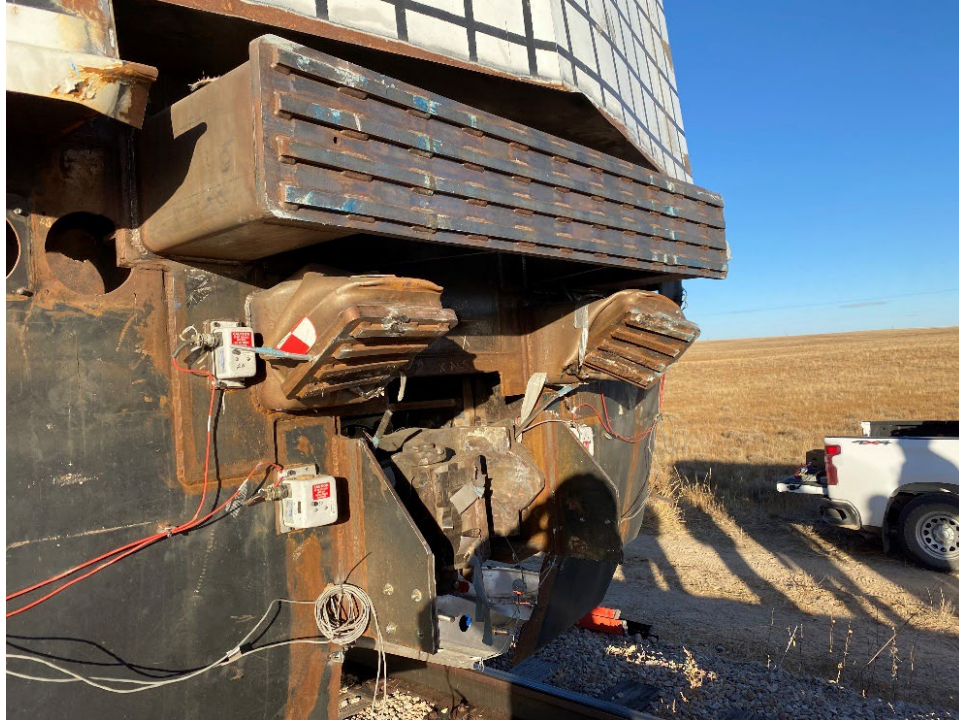
Figure 73. Upper and lower DAC tubes, post-test

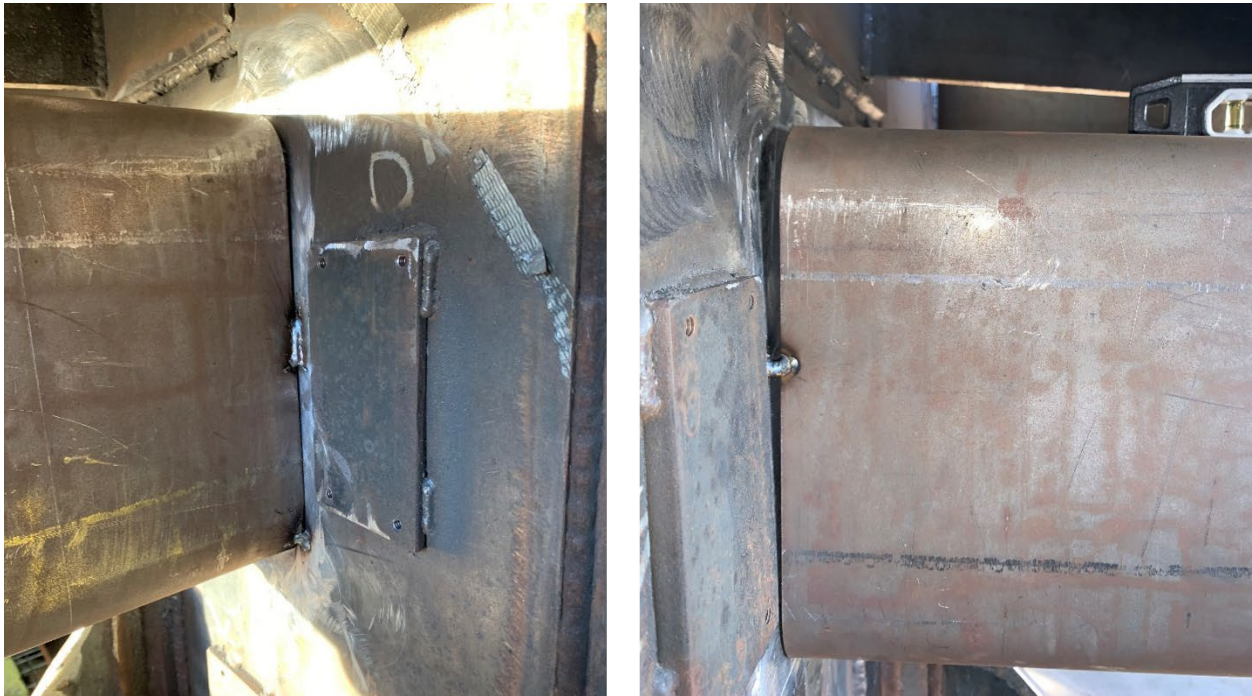
Figure 74. Post-impact deformation of bottom DAC tubes support plate, left (left) and right (right) sides

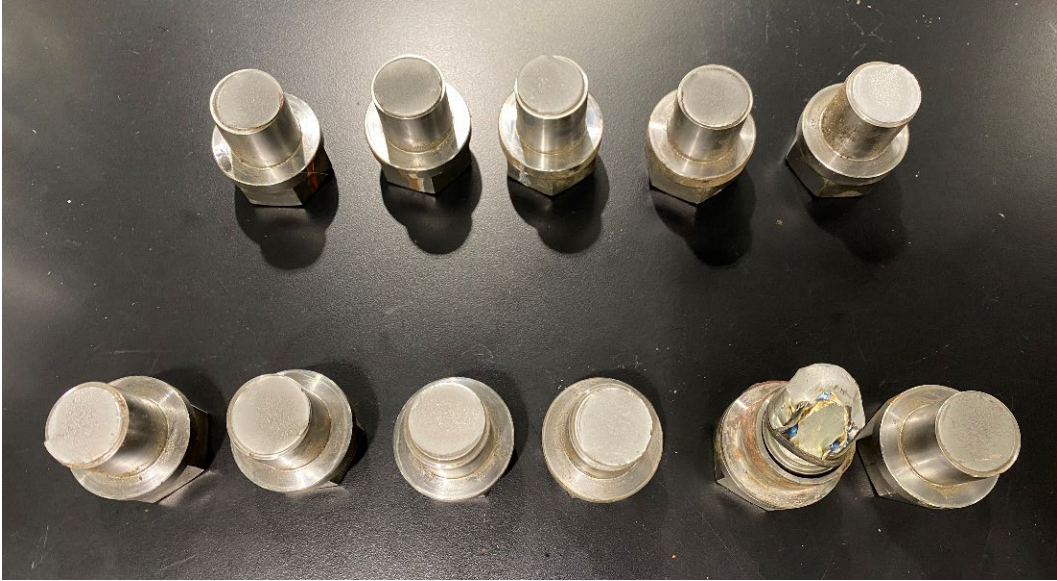
Figure 75. All shear bolts broke cleanly, except #5 (bottom row, second from right)

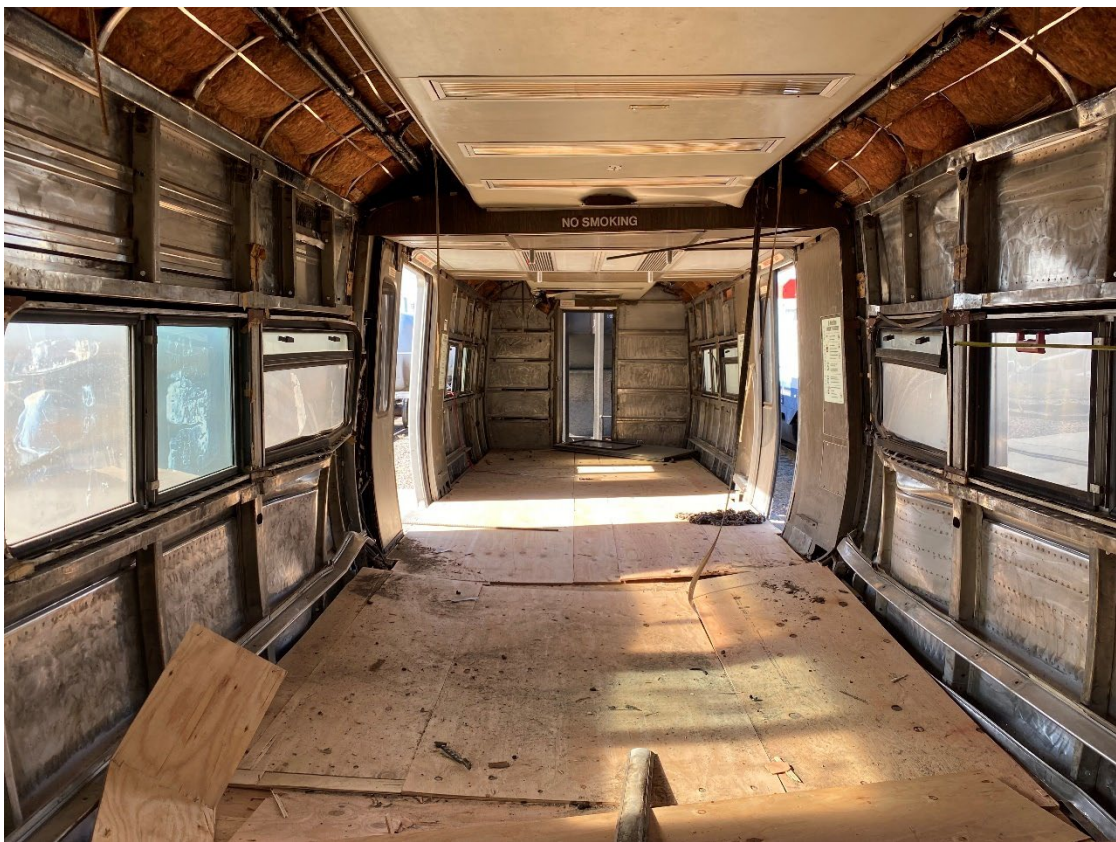
Figure 83. M1 interior damage, buckle at rear door
