TESTS TO CREATE BROKEN RIMS IN RAILROAD WHEELS

SUMMARY

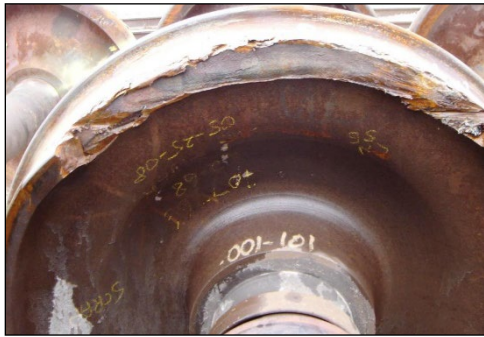
Though relatively rare, broken wheel failures are of concern to the railroad industry due to potential safety implications and expense. Vertical split rim (VSR) cracks usually propagate to the front rim fillet, but can sometimes propagate to the back rim fillet, resulting in a broken flange. [Figure 1](#) shows an example of a VSR failure.

Figure 1. Vertical Split Wheel Rim

VSRs are thought to be the result of tread damage on the wheel surface in the form of a shell or spall that initiates cracking in the rim and produces impact loads when it comes in contact with the rail. If the crack propagates vertically into an area of tensile residual stress in the wheel rim, further crack growth is encouraged until a portion of the rim breaks free from the wheel.

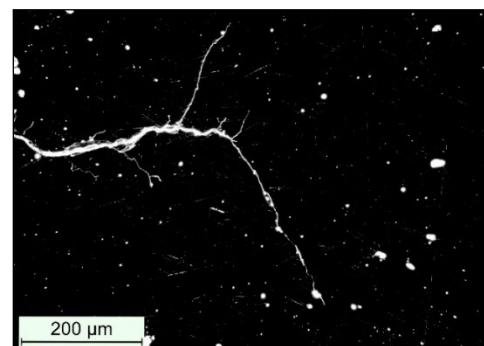
Following the tests on the rolling load machine, each wheel was sectioned, and the cracks were viewed under a microscope. Horizontal cracks were found at a typical radial depth of 0.15 inch – similar to the radial depth of the VSR crack origins identified during wheel inspections. Multiple, short vertical branches were found stemming from the main horizontal cracks. [Figure 2](#) shows the longest vertical branch, about 350 μm at the end of a horizontal crack.

Figure 2. Dark Field Optical Microscopy Shows a Horizontal Crack with Multiple Vertical Branches

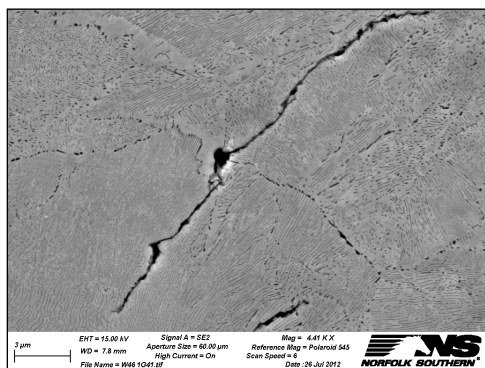
further investigated using a scanning electron microscope (SEM). Understanding the propagation path of a crack can help define the relative influence of high stress levels and localized material weaknesses. The polished samples were etched with a saturated solution of picric acid to show the microstructure, including the boundaries between prior austenite grains. The horizontal cracks and the vertical crack branches examined in the samples removed from the two wheels that failed to develop VSR cracks all showed crack propagation through the middle of the grains (transgranular) rather than between prior austenite grain boundaries (intergranular). This was a strong indication that high stress levels were the main driving force in the crack propagation of these two wheels. If the cracks had followed prior austenite grain boundaries, it would have indicated that material weakness played a large role in the crack development. Figure 3 shows a typical example of a crack in one of the test wheels as viewed through the SEM.

Figure 3. Transgranular Crack Propagation

conditions. In each case, the test machine failed after about 7 million load cycles and the test was stopped. Neither test wheel developed a VSR crack, although post-test destructive evaluation revealed short vertical crack branches in both wheels. SEM analysis showed that the cracks propagated in a transgranular fashion, indicating that material weakness was not a primary cause for the crack development in these two wheels.
