U.S. Department  
of Transportation  
**Federal Railroad  
Administration**

RR 23-13 | August 2023

## INVESTIGATION OF RADIOGRAPHY TECHNOLOGY FOR BOLSTER AND SIDE FRAME INSPECTIONS

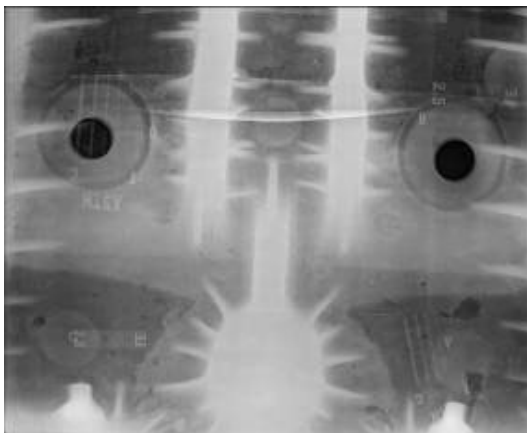
Figure 1: Radiograph of a Bolster with Defects

Using radiography, defects, including hot tears, shrinkage, porosity, and voids, were identified in several bolsters.

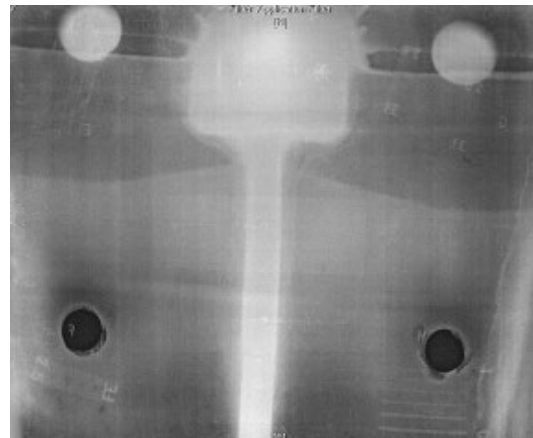
Figure 2: Radiograph of a Bolster with Minimal Defects

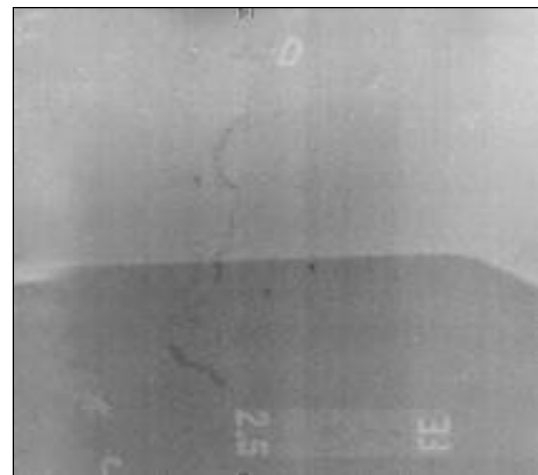
A hot tear can be caused by thermal effects, casting restraints, material composition, and by two physical factors in the partially solidified zone: tensile loading and insufficient liquid feeding (2). If the hot tear is oriented in a direction of high stress, the tear could propagate and cause a failure. Small hot tears were found in six of the seven bolsters; Figure 4 shows one such defect.

**Figure 4: Example of a Hot Tear in Location A of a Bolster**

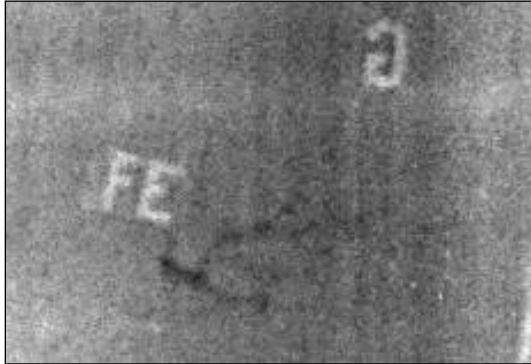
Shrinkage was found in all of the castings examined. Using sample radiographs of cast materials, levels of shrinkage and porosity were assigned to each bolster. Two of the castings had shrinkage levels of 4 and 5 in concentrated areas. For the entire bolster, shrinkage levels of 3 and 4 were assigned. The other five bolsters had lower shrinkage levels. Shrinkage is mainly caused by restriction of feeding in the cast structure assisted by differential cooling in areas of the casting. Shrinkage was found on the both the upper and lower areas of Location A. Figure 5 shows an example of filamentary shrinkage in one of the castings. Figure 6 is an example of

**Figure 5: Example of Shrinkage in Location A of a Bolster**

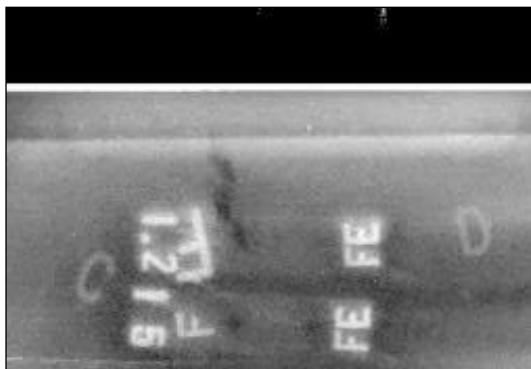
However, problems were encountered when examining the pedestal jaw of the side frames. The geometry between the diagonal tension member and the spring seat made it difficult to get the imaging plate near the area of interest.

shrinkage in the pedestal jaw radius of a side frame.

**Figure 6: Shrinkage in Location C of a Side Frame**

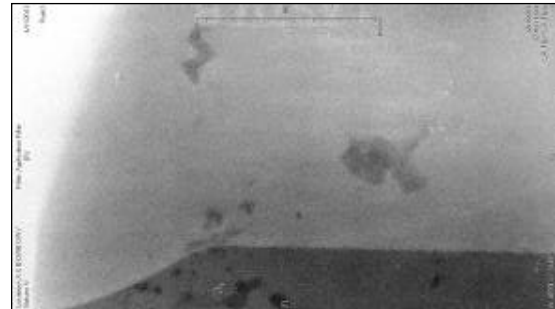
Evidence of porosity and voids were also found in some of the bolsters tested. Voids will occur when the casting feeding is inadequate for the local volume. Porosity is usually caused by gas that has been trapped in the casting. Gas can be trapped because the risers are too small for the it to escape – or the sand in the mold is too fine or wet. [Figure 7](#) shows both voids and porosity in a bolster. Porosity levels were assigned to each bolster. The same two bolsters with high levels of shrinkage also had level 4 porosity.

**Figure 7: Example Porosity and Voids in Location A of a Bolster**
