TENSILE TEST RESULTS OF SAMPLES TAKEN FROM CRITICAL AREAS OF RAILCAR BOLSTERS

SUMMARY

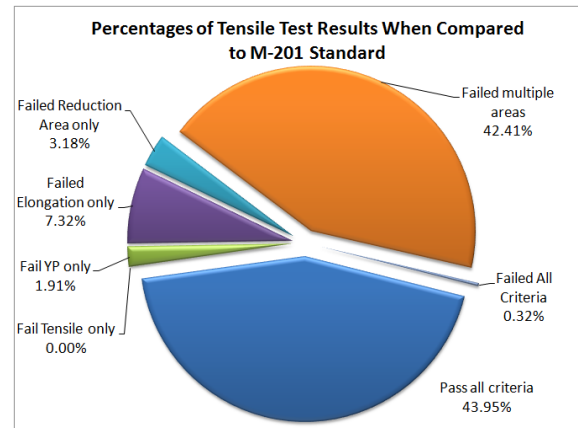
Of the 313 samples studied, over 50 percent failed one or more tensile test criteria specified for Grade B+ material performance. Figure 1 shows the generalized results for the samples, which were taken from the cast body and the keel block. For the samples taken from the body of the casting, the criteria most often not met were elongation and area reduction. For the keel block samples, yield point was the most failed criterion.

Figure 1: Pass/Fail Chart for All Samples with Failure Criteria

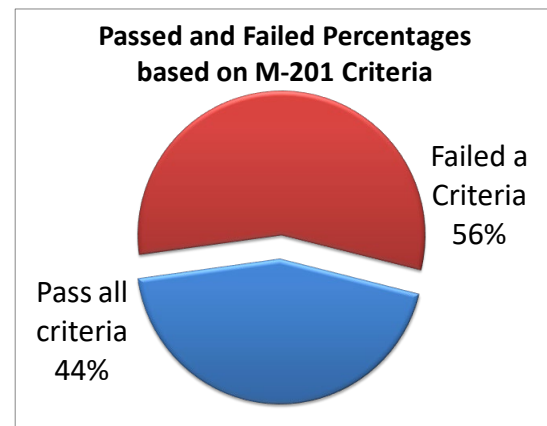
For the 313 samples tested, including 20 keel block samples, Figure 2 shows 44 percent fulfilled all criteria specified in AAR M201 standard.

Figure 2: Pass Fail Chart for All Samples

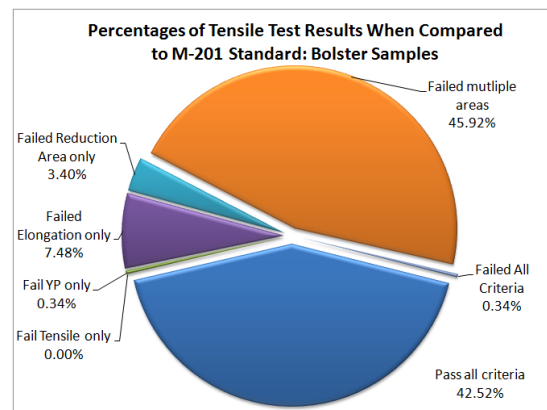
For samples cut from the bolsters, only one failed the yield point criteria. Samples that failed the tensile criteria also failed the elongation or area reduction criteria. Two samples failed all criteria, one of which was discarded from the sample population because of a surface defect. Figure 3 shows the bolster samples' tensile test results.

Figure 3: Pass/Fail Chart for Bolster Samples with Failure Criteria

The tensile test results showed that even at a moderate temperature, the material may have been more rigid than desirable. The samples cut from the bolster did have a low occurrence of tensile and yield point failures when the elongation and area reduction criteria were met.

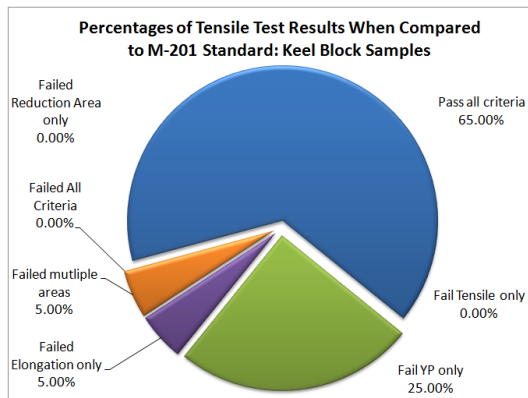
For the samples cut from the keel blocks, five failed the yield strength criteria, one failed the elongation criteria, and one failed multiple areas. Figure 4 shows a breakdown of the keel block samples' tensile test results.

Figure 4: Pass/Fail Chart for Keel Block Samples with Failure Criteria

Also note that not all the samples taken from the keel block passed all the criteria. The relatively high number of yield point failures was noteworthy, but not necessarily alarming, because it was not displayed in the matching bolster samples.

The difference in material properties could have been due to the solidification of the casting

where the samples were taken. Because the keel block is smaller, it tends to have more uniform properties during the cooling cycle, and therefore, it may have had higher ductile properties.
