## ANALYSIS OF TREAD BUILDUP ON RAILROAD WHEELS

### SUMMARY

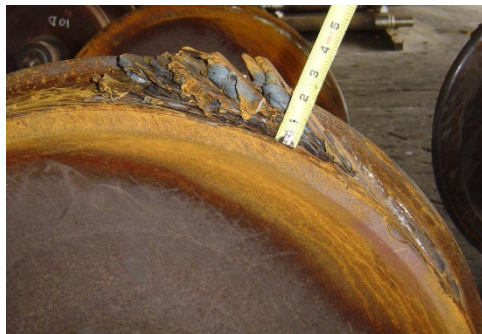
Tread buildup (TBU) is the formation of metallic material on the tread surface of a railroad wheel. In extreme cases, the resulting impact loads and reduction in relative flange height can result in broken rails and train accidents. [Figure 1](#) shows an example of a wheel with an extreme case of TBU.

**Figure 1. Wheel with TBU Extending 3 in. Radially from the Tread Surface**

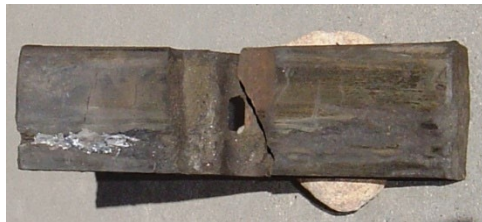
Significant sources of metal in modern brake shoes include “pickup” metal and tread conditioning brake shoes manufactured with either an iron insert or a high metal powder content. Figure 2 shows an example of a brake shoe with metal pickup composed of metallic wear particles embedded in the composition material.

Figure 2. Composition Brake Shoe with Embedded Pickup Metal

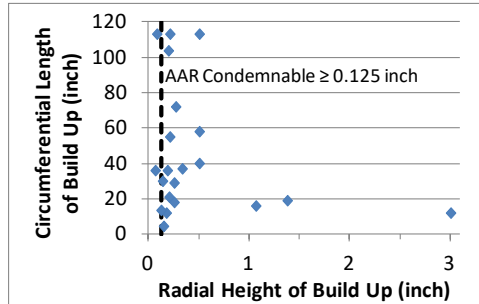
From a safety standpoint, the radial height of the TBU material was of primary concern. The three wheels with TBU in excess of 1-inch radial height all showed obvious signs of a wheel slide immediately adjacent to the TBU and a circumferential TBU length less than 20 inches. The root cause of the TBU on these three wheels was clearly a wheel slide event. Figure 3

shows the circumferential length and radial height of TBU on each wheel.

**Figure 3. Dimensions of TBU**
