## TESTS TO CREATE TREAD BUILDUP ON RAILROAD WHEELS

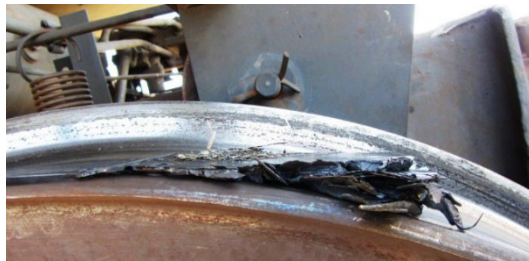
Tread buildup (TBU) is the formation of metallic material on the tread surface of a railroad wheel. In extreme cases (Figure 1), the resulting impact loads and reduction in relative flange height can result in train accidents.

**Figure 1. Wheel with TBU Extending 1 inch Radially from the Tread Surface as a Result of a Wheel Slide Test**

By inspecting wheels with TBU and the results of wheel slide tests, TTCI researchers determined the root cause of TBU of significant height to be wheel slide caused by excessive brake force.

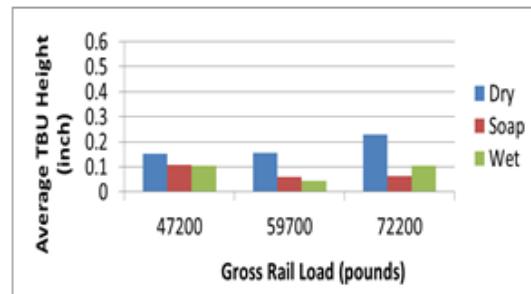
**Figure 2. TBU Height as a Function of Gross Rail Load**

Three wheel/rail friction conditions and three car weights were tested during the 54 short-distance (4,000 feet) wheel slide tests at speeds ranging from 5 to 30 mph. Dry, wet, and lubricated were the three friction conditions. A water-spray system was used to continually cover the rails with either water or a mixture of water and soap. The average TBU was highest when the rail was dry and the car loaded to its heaviest test condition (72,200 lbs gross rail load). [Figure 2](#) shows the average TBU height from the short wheel slide tests.

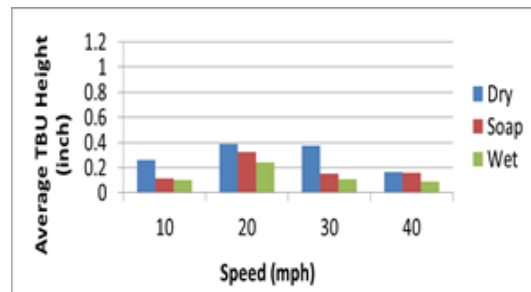
**Figure 3. TBU Height as a Function of Speed**

TTCI conducted 36 wheel slide tests with an empty car (47,200 lbs gross rail load) over longer distances to investigate the effect of increased slide distance. Between one and three laps were completed on a track loop approximately 9 miles long. The laps were made at four speeds: 10, 20, 30, and 40 mph. [Figure 3](#) shows the average TBU separated by speed and wheel/rail friction condition.

The highest average values of TBU height occurred during the 20 and 30 mph runs. [Figure 4](#) shows the average TBU heights recorded at each wheel slide distance. In general, the TBU

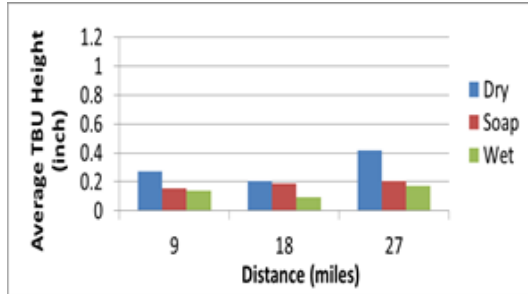
**Figure 4. TBU Height as a Function of Slide Distance**

heights were greatest when the rail was dry and after the longest wheel slide distance (27 miles).
