Safety Advisory 2023-05; King Pin Assemblies in Highway-Rail Grade Crossing Warning Systems

ACTION: Notice of safety advisory.

SUMMARY: FRA is issuing Safety Advisory 2023-05 to heighten awareness within the railroad industry of the potential failure of king pin assemblies in highway-rail grade crossing warning systems equipped with breakaway gates. This Safety Advisory recommends that railroads inspect and replace all worn components in king pin assemblies. This Safety Advisory also recommends that railroads develop inspection and

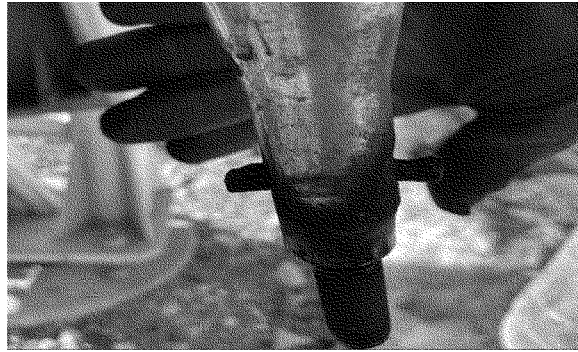
However, the king pin assembly can be damaged under normal operating conditions by vehicle strikes, high winds, rust, worn gate boot(s), and corrosion. If the highway-rail grade crossing gate is being held in place by a worn or damaged king pin assembly, the crossing gate may drop off the king pin and post pin tabs. When this occurs, the crossing gate may be held in place by only the shear bolts, which are not designed to hold the weight of the crossing gate. Therefore, if relied upon to hold the crossing gate in place, the shear bolts could stretch and break unexpectedly, allowing the crossing gate to fall. This could happen very quickly, potentially causing injury to railroad employees or members of the general public in close proximity to the crossing gate.

Figures 4,5,6-Heavily oxidized and worn king pin tabs

(1) Inspect king pin assemblies in highway-rail grade crossing warning systems and replace all worn components.

(2) Develop inspection and maintenance programs for king pin assemblies that incorporate maintenance procedures recommended by the manufacturer (if applicable), including lubrication of king pin assemblies to reduce wear and tear on the components. These inspection and maintenance programs should include periodic inspections of the king pin assembly with the crossing gate removed, as well as inspection of the king pin assembly each time the crossing gate is re-hung or replaced. These inspection and maintenance programs should also address the replacement of worn components and give special consideration to highway-

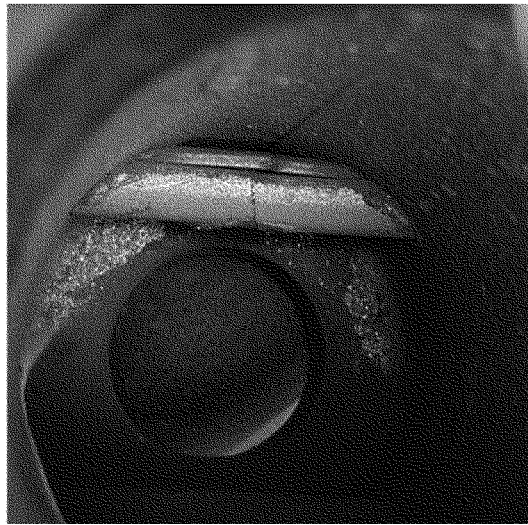
Figure 7-Roll pin crack on king pin
