Federal Railroad Administration, Office of Railroad Safety

Accident Investigation Summary Report FE-2021-20

WATCO Rail Services (WATX) Employee Fatality
Houston, Texas
October 29, 2021

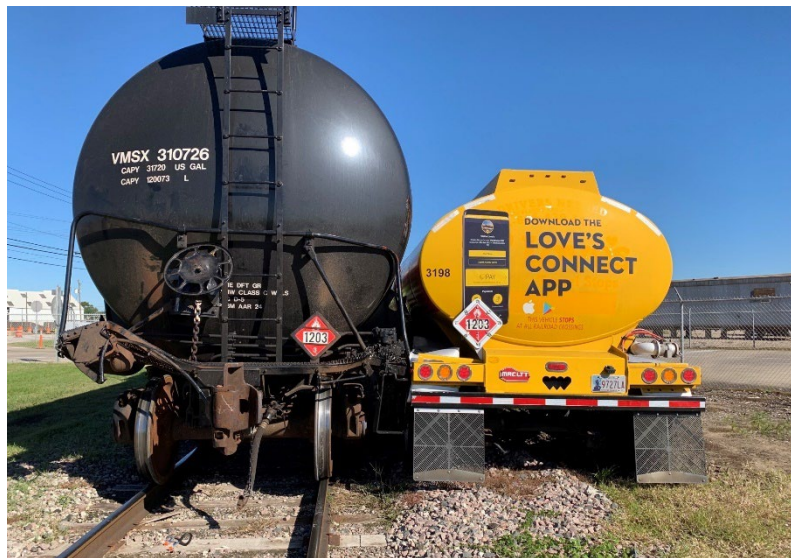
A few seconds after that communication, a semi-trailer tanker truck traveling southbound on Federal Road made a left-hand turn and drove into the entrance to Greens Port Industrial Park. Upon reaching the entrance to the park, the semi-truck did not stop at the stop sign or crossbucks and yield to the moving train, and instead entered the private highway-rail grade crossing and caused a collision with the lead railcar of the shove movement, where the brakeman was riding (Figure 2 and Figure 3). The brakeman was fatally injured in the impact.

Figure 2: The position of the impacted railcar and the semi-truck after the accident and the train stopped.

FRA's investigation and analysis concluded that this accident was caused by the semi-truck failing to stop and yield to the train moving through the private highway-rail grade crossing, resulting in a collision with the train and the fatality of the brakeman.

1. On each side of the grade crossing, WATX installed Hi-Viz yellow railroad crossing signs outlined with flashing LED lights. Before future crews enter the grade crossing with a train, they will turn the flashing lights on with a switch at the gate.
2. WATX redesigned the rail gate at the grade crossing to swing out into the road and restrict vehicle access to the grade crossing when it is in use by a train crew. A stop sign on the gate will alert any vehicles approaching the grade crossing, and red flashing strobe lights are attached to the top posts of the gate.

3. WATX issued a general order that requires train crew members to stop and protect all grade crossings, including private crossings, before entering.

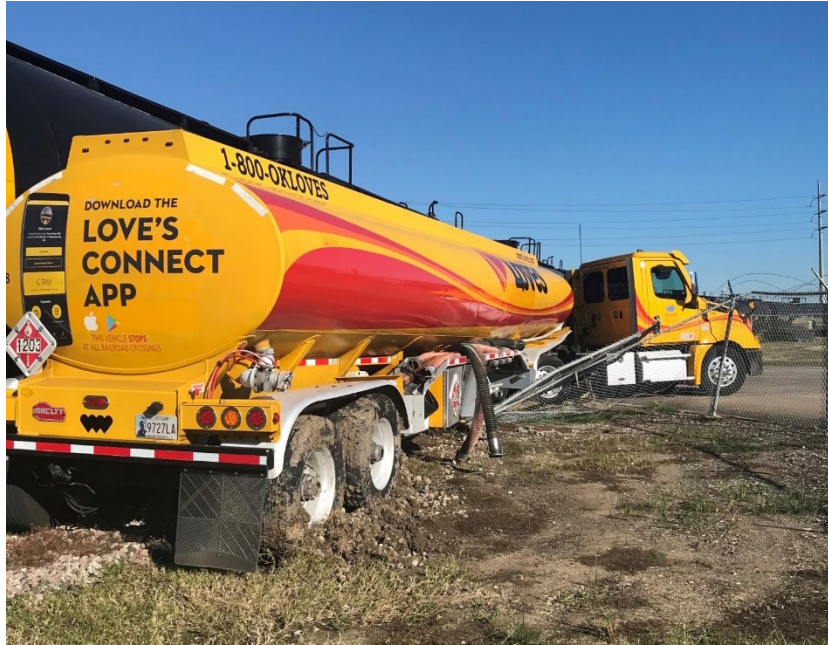
Figure 3: Another view of the semi-truck after the accident and the train stopped.
