Federal Railroad Administration, Office of Railroad Safety

Accident Investigation Summary Report HQ-2023-1843

BNSF Railway
De Soto, Wisconsin
April 27, 2023

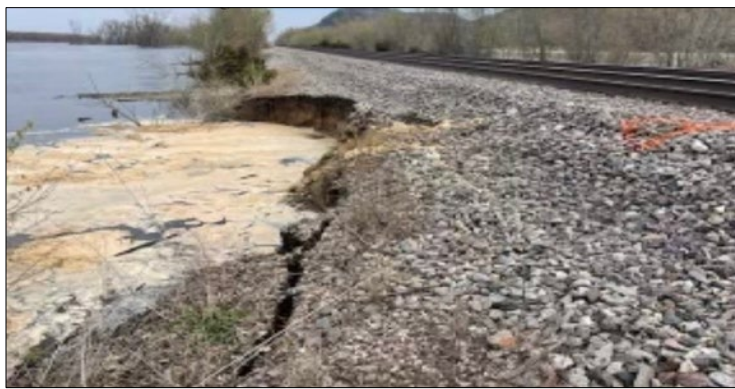
The WG established working limits between MP 267.0 and MP 270.2 and at 10:30 am, RW1 contacted RW3 to clear the track for train traffic. RW3 then sent RW1 a photograph of the area (Figure 1) and advised him that additional ballast would be needed because the river was washing it away as they dumped. When interviewed, RW1 indicated that after receiving the photo he walked 7/10th of a mile to within 50-100 yards of the derailment site and assessed that its condition had not changed, and it was safe for traffic.

Figure 1: Photo from April 27, 2023, of the derailment area taken by RW3 who was placing stone to stabilize the bank of the river before the derailment. RW1 received the photo at approximately 10:30 am.

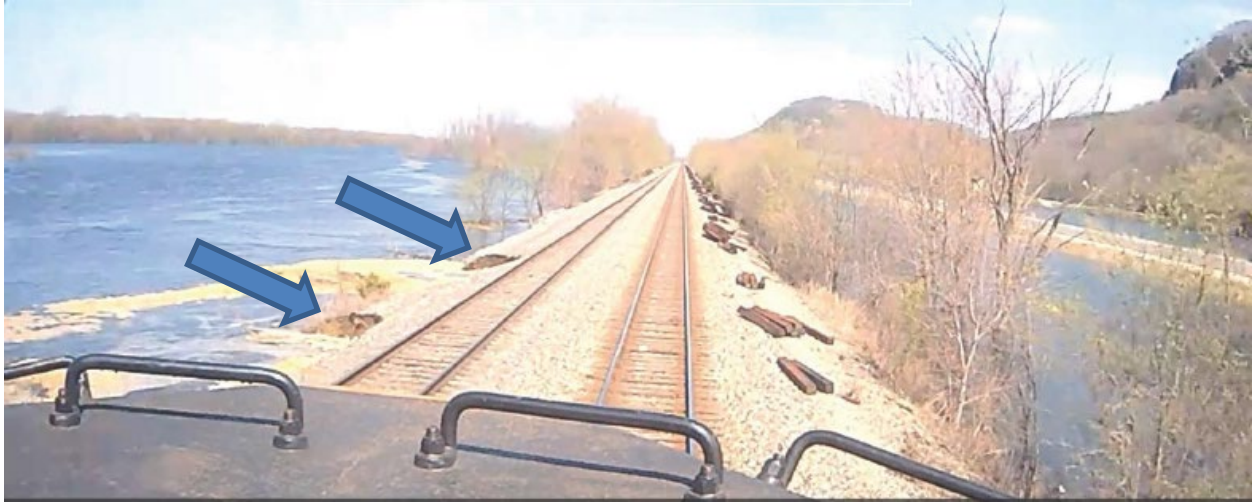
At approximately 11:00 am, RW1 gave permission for BNSF Train-53, to enter and proceed through the entirety of the WG's limits on Main-1. At 11:13 am, the crew of that train informed RW1 there was ballast falling into the river at MP 268.8 on Main-2, with the scour only two feet away from the ends of the crossties. (Figure 2). RW1 informed Train-53 that they were currently dumping riprap to fix the problem at that location.

Figure 2: Photo from the rear Distributed Power Unit on Train-53 at MP 268.8. Note the two areas of erosion adjacent to Main-2 (arrows).

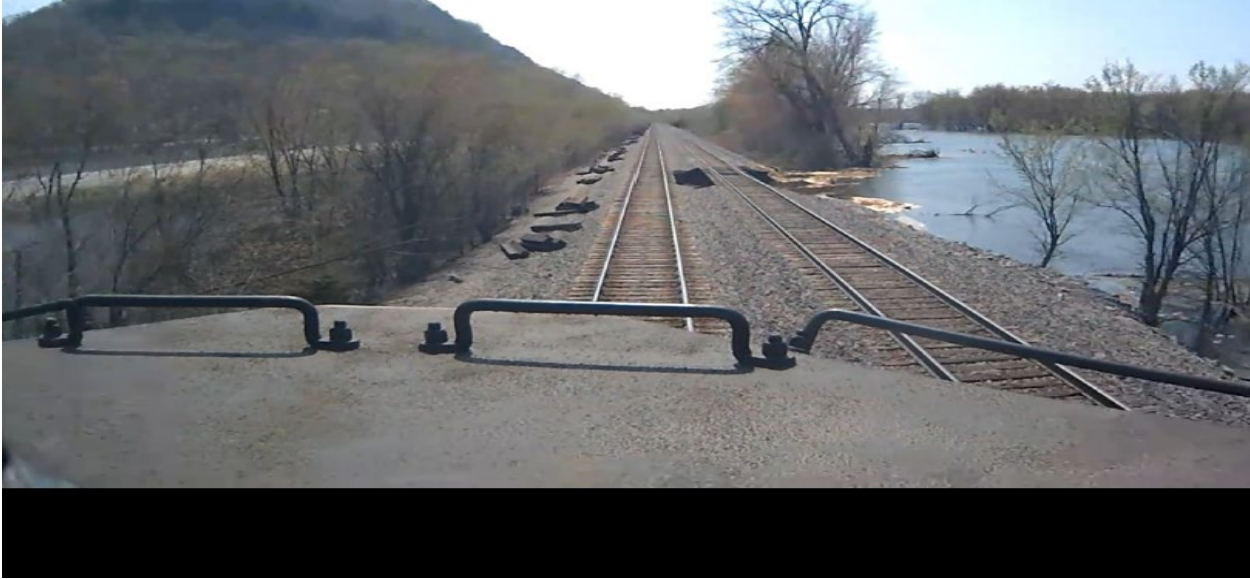
At 11:55 am, RW1 then gave permission to a second train, Train-25, to enter and proceed through the entirety of the WG's limits on Main-1. At 12:01 pm, the crew of Train-25 notified the dispatcher that they experienced an undesired emergency brake application and derailed near MP 268.8. Train-25 derailed at 52 miles per hour and the crew observed a large void under the tracks of Main-2. The subgrade was completely missing under Main-2, with a noticeable dip in the unsupported area under the track and a clear indication that the void had progressed to the end of the crossties of Main-1 as evidenced by a large hole visible from the lead locomotive's camera of Train-25. See Figure 3.

Figure 3: A photo from Train-25 locomotive camera recording shows the degradation of the track structure under Main-2 as it approaches the area of concern.

FRA conducted interviews with crew members of Train-53 and Train-25, the dispatchers involved, the track inspector who initially identified the scouring and erosion of the track, RW1, and RW2. FRA also analyzed the relevant dispatcher recordings and reviewed all pertinent track inspection records. Based on this review and analysis, FRA concluded that the probable cause of this accident was saturation of the subgrade under the track (a washout of the track).

In response to this accident, BNSF reinforced and retrained employees on the requirements of SSI 33 and revised that rule to include specific procedures to ensure concerns about track communicated by train crews are adequately investigated and evaluated before train traffic is allowed to continue over the subject track. Additionally, FRA is pursuing appropriate enforcement action. Additionally, although not specifically in response to this accident, FRA issued Safety Advisory 2023-07, recommending that railroads review existing policies, procedures, and operating rules related to predicting, monitoring, communicating, and operating during severe weather conditions or subsequent to extreme weather conditions.⁴
