Federal Railroad Administration, Office of Railroad Safety

Accident Investigation Summary Report HQ-2021-1437

Norfolk Southern Railway Company - Employee Injury (Amputation)
Burns Harbor, Indiana
July 13, 2021

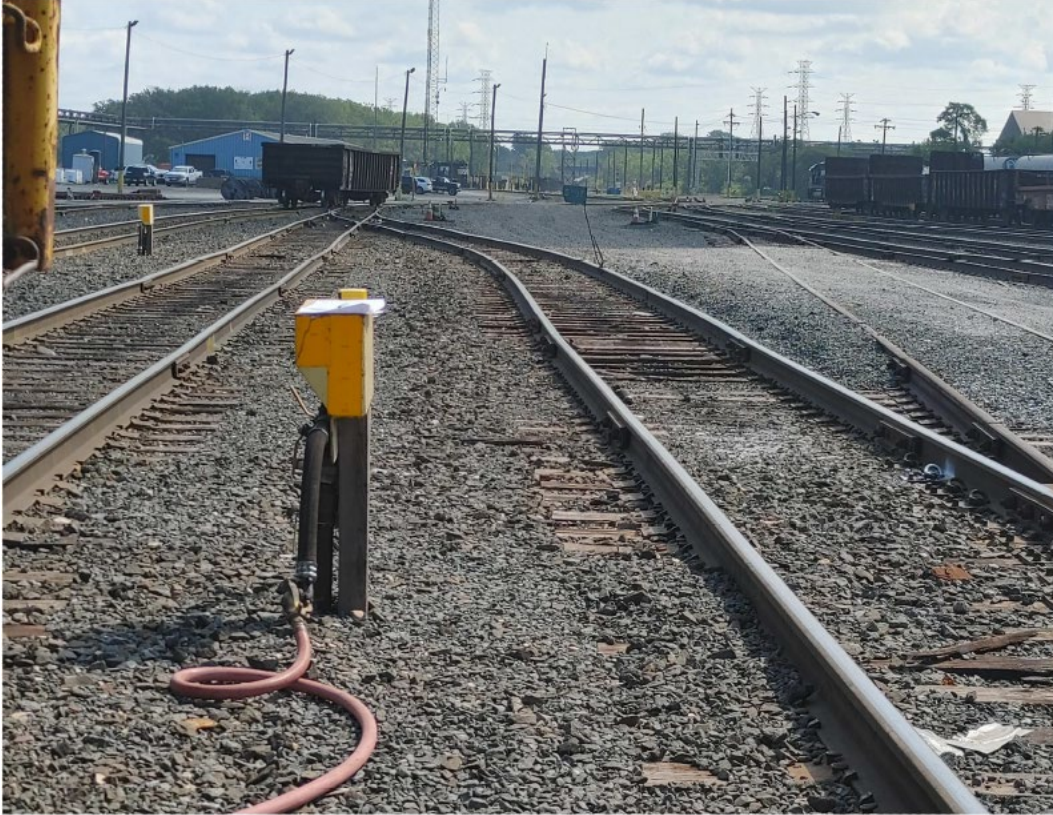
Figure 1: Air Hose Stand

- As the conductor grabbed the ladder on the west end of the car and placed his foot in the ladder stirrup to pull himself up, the movement of the train carried him east where he struck a stationary hose stand¹ positioned on the center line between tracks 15 and 16 (see *Figure 1*).

The strike from the air hose stand knocked the conductor to the ground where his left arm landed in the fowl of track 15 and was severed by the leading wheels of the car behind the car he was attempting to mount.

¹ Air hose stands are metal posts approximately 3.5 feet tall that provide mounting and support for compressed air lines used to connect rail cars to an air source for testing and inspections of rail equipment. These air lines are mounted above ground and were placed between tracks at the east end of the yard to provide access to the air lines during snow accumulation during winter.

FRA's investigation and analysis concluded that this accident was caused by human error. The conductor's failure to comply with the NS Safety Rule for mounting moving equipment led to the employee striking a stationary air hose stand and falling to the ground where his arm landed in the fowl of the moving equipment.
