Federal Railroad Administration, Office of Railroad Safety

Accident Investigation Summary Report FE-2023-04

Norfolk Southern Railway Company (NS) Fatality
Cleveland, Ohio
March 6, 2023

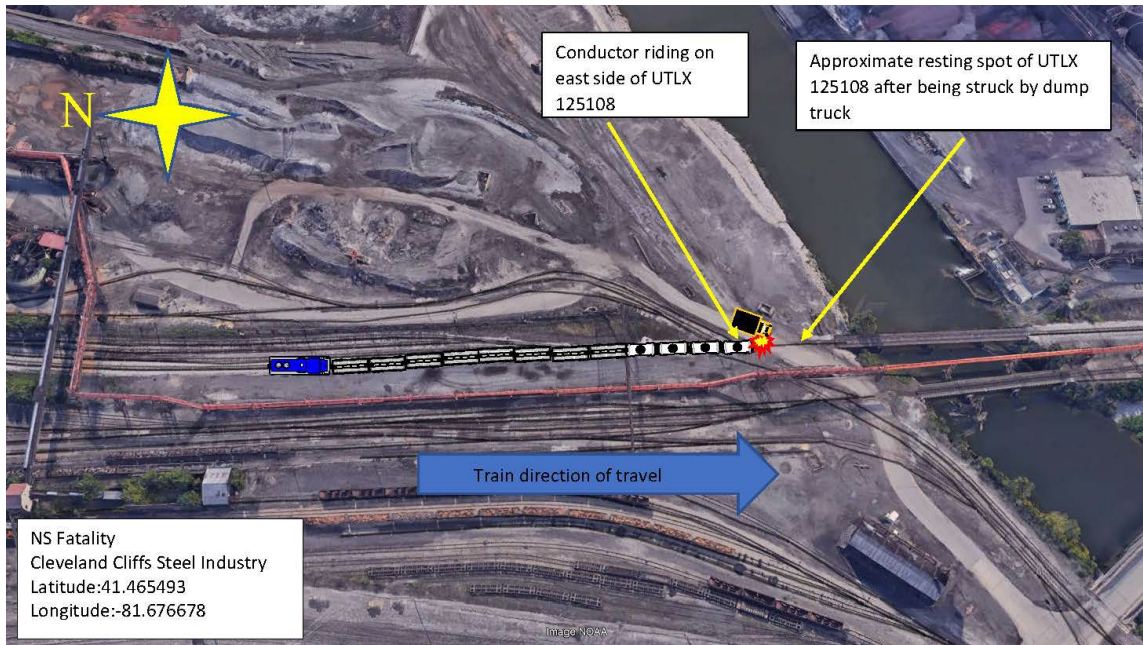
Figure 1 - Diagram of Accident location

FRA conducted a sight distance analysis and partial reenactment. During the sight distance analysis/partial reenactment, a member of the FRA's investigation team climbed into the cab of the dump truck involved in the accident. The private road crossed the tracks on a 45-degree angle to the left (southwest) resulting in 135 degree viewing angle to the right (northeast) for the driver. In addition to the 135-degree viewing angle, the driver's view was partially restricted due to the truck's exhaust pipe and muffler. Overall, FRA determined that the dump truck driver had a sight distance of approximately 38 feet down the track towards the direction of the approaching train. The dump truck driver stated in his interview that did not see the approaching train, and therefore proceeded across the tracks after stopping at the stop sign.

FRA determined that the limited sight distance of the dump truck driver, down the track towards the direction of the approaching train contributed to the accident.

NS also issued a safety notice to all operating employees following the accident. Additionally, Cleveland-Cliffs and Stein, LLC (the dump truck driver's employer) barricaded the crossing with concrete barriers and reconfigured the direction of traffic to allow vehicles to cross at a 90-degree angle. This gives drivers the ability to have greater sight distance down the track, when approaching from either side of the crossing.
