Federal Railroad Administration, Office of Railroad Safety

Accident Investigation Summary Report HQ-2023-1847

Norfolk Southern Railway Company (NS) Derailment
New Castle, Pennsylvania
May 10, 2023

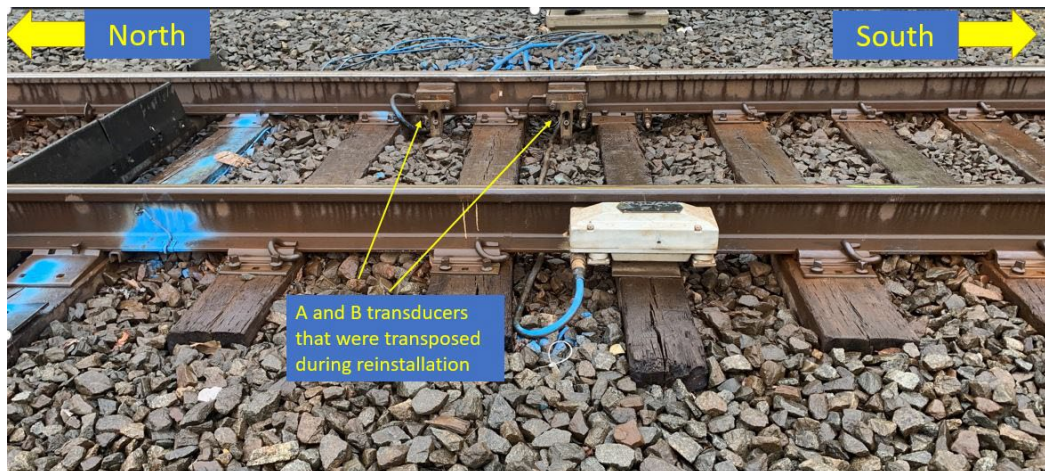
Figure 1: Vale HBD

On May 8, 2023, NS signal maintainers removed the Vale HBD to facilitate track work in the area. After completion of the track work, the Vale HBD was reinstalled with the wheel transducers transposed. This incorrect installation reversed the perceived direction of the trains as they passed over the Vale HBD.

Further, the software logic associated with transmitting alerts to the ATC desk was configured to match HBD data with other data stored on NS back-office computers, including expected train direction. On May 10, 2023, when Train 1 traversed the Vale HBD traveling north, the system recognized the hot axle and transmitted the radio message as intended; however, it thought the train was traveling south. Because the recorded travel direction perceived by the Vale HBD did not match the train's expected travel direction, the NS back-office software logic associated with transmitting HBD alerts dismissed the critical warning as "junk," and the alert was not forwarded to the ATC desk analyst.

FRA determined that the incorrect reinstallation of the Vale HBD, in conjunction with the design of the NS back-office software logic, prevented the ATC desk analyst from receiving the alert and possibly contributed to the cause of the accident.
