## Federal Railroad Administration, Office of Railroad Safety

### Accident Investigation Summary Report CFE-2021-16

*Union Pacific Railroad Company (UP)*

*Castroville, Texas*

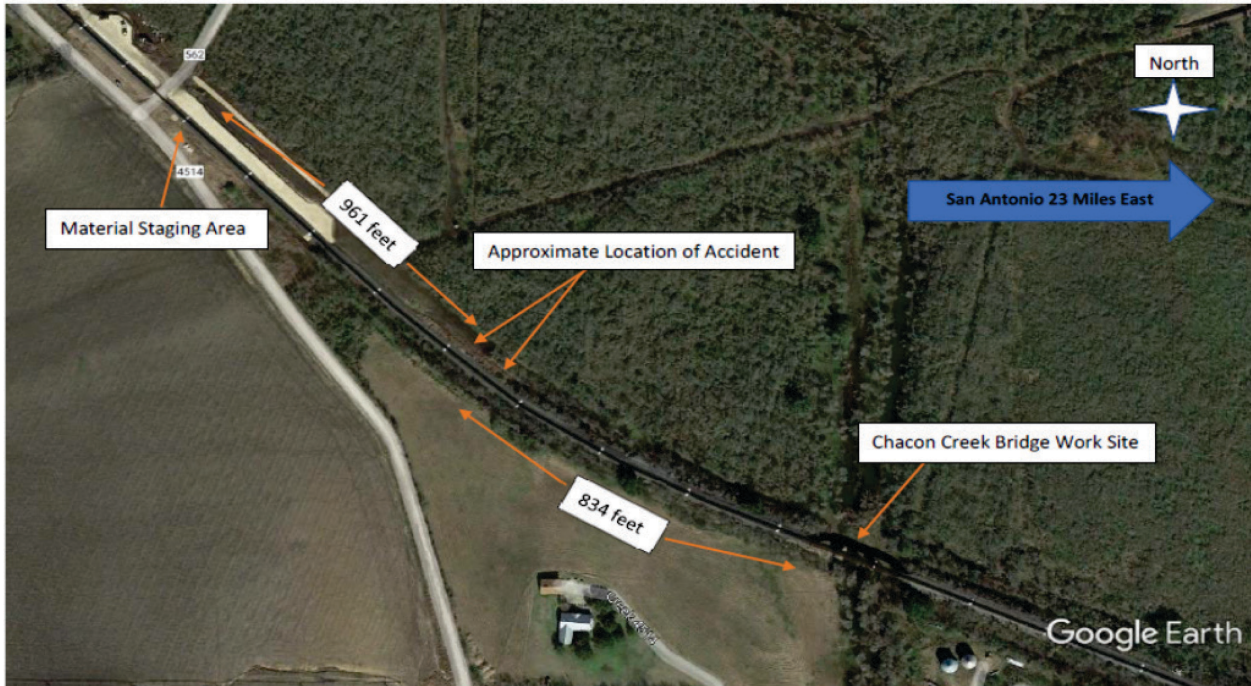
On September 22, 2021, at approximately 7:00 a.m., CDT, Contractor 1 reported for work at the material staging area near MP 240.76 where the bridge work was to be performed that day. Contractor 1 was charged with removing bridge walkway grating panels, staging them at the west end of the bridge and then moving them to the material staging area located 1,795 feet west of the bridge. See Figure 1.

*Figure 1: Aerial photograph of the incident location near MP 240.37 of the Del Rio Subdivision*
