Federal Railroad Administration, Office of Railroad Safety

Accident Investigation Summary Report HQ-2021-1445

Canadian Pacific Railway Company (CP) – Collision and Derailment
St. Paul, Minnesota
August 25, 2021

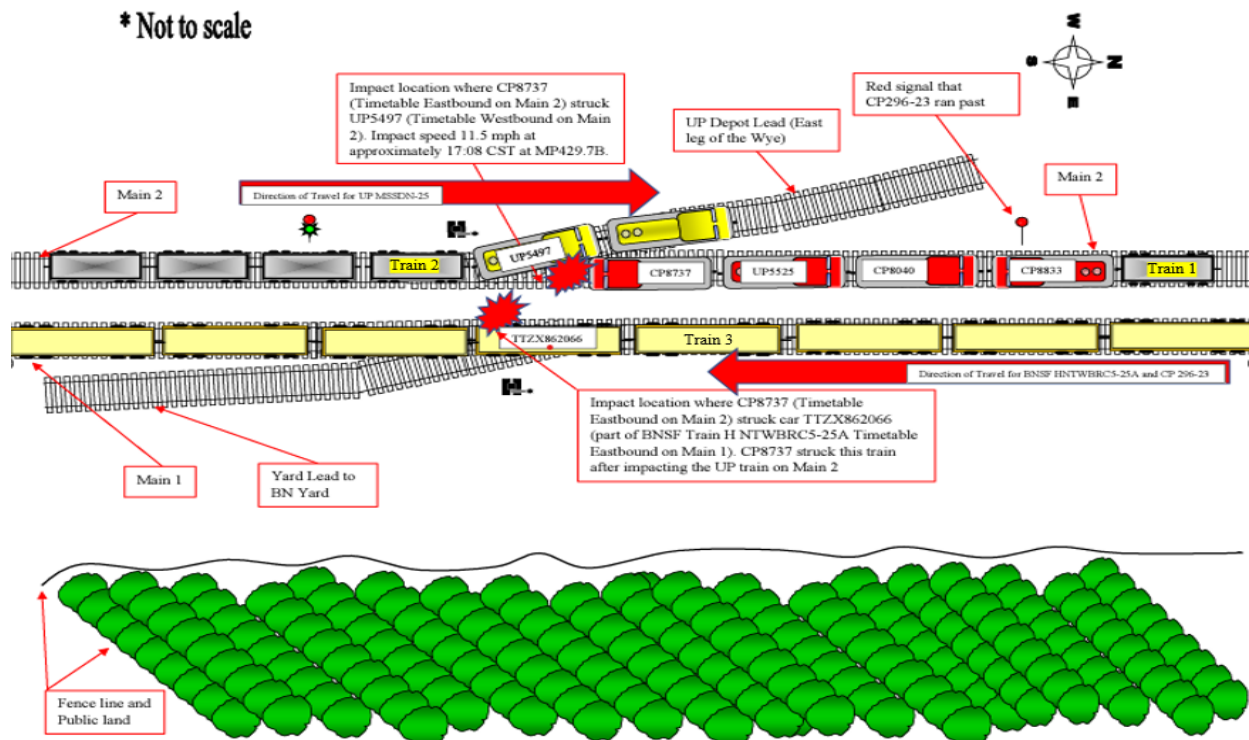
Figure 1: Collision Sketch

The view of the signal at Control Point Division Street was obstructed by Train 3 on Main Track 1, complicating the situation. As Train 1 navigated a curve approaching Control Point Division Street, the signal came in view. The engineer saw the stop signal and applied the emergency brakes while traveling at 19.9 mph.

Train 1 continued past the signal, colliding with Train 2 at 7.4 mph, striking its second locomotive. The impact then caused Train 1 to hit Train 3, resulting in the derailment of the 26th car from the locomotive.
