Federal Railroad Administration, Office of Railroad Safety

Accident Investigation Summary Report HQ-2022-1548

Caltrain Commuter Railroad Co. (PCMZ) – Collision and Derailment
San Bruno, California
March 10, 2022

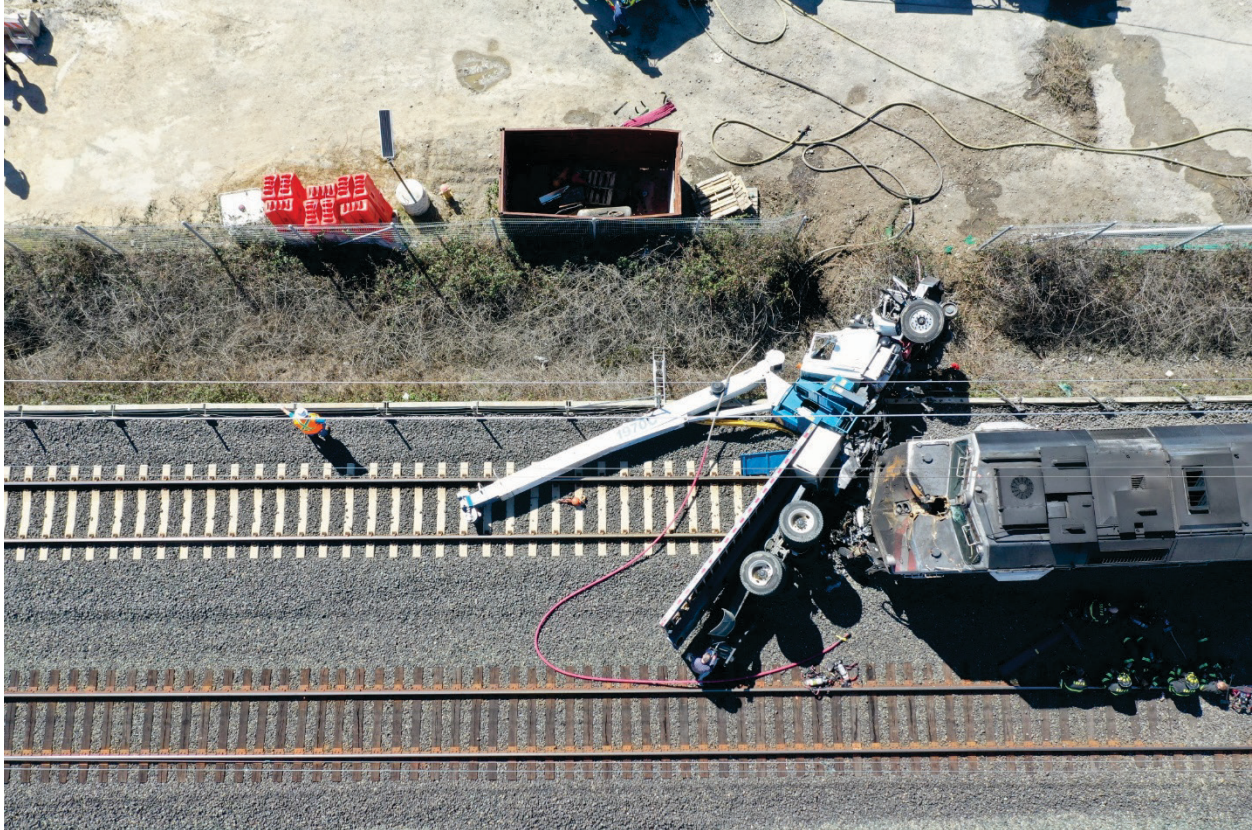
At approximately 10:33 a.m., PDT, Train 1, traveling at 63 mph on MT-2, collided with 3 stationary on-track maintenance vehicles at MP 11.6. The maintenance vehicles included two flatbed trucks with telescopic boom cranes and one heavy-duty pickup truck. Fuel spillage from the damaged vehicles ignited a fire that spread to the first passenger car (3819) in the train consist. The collision resulted in the destruction of all maintenance vehicles and the derailment of the front truck of locomotive 919. All passenger cars remained on the rails.

Figure 1: One of the maintenance vehicles and the locomotive following the collision.

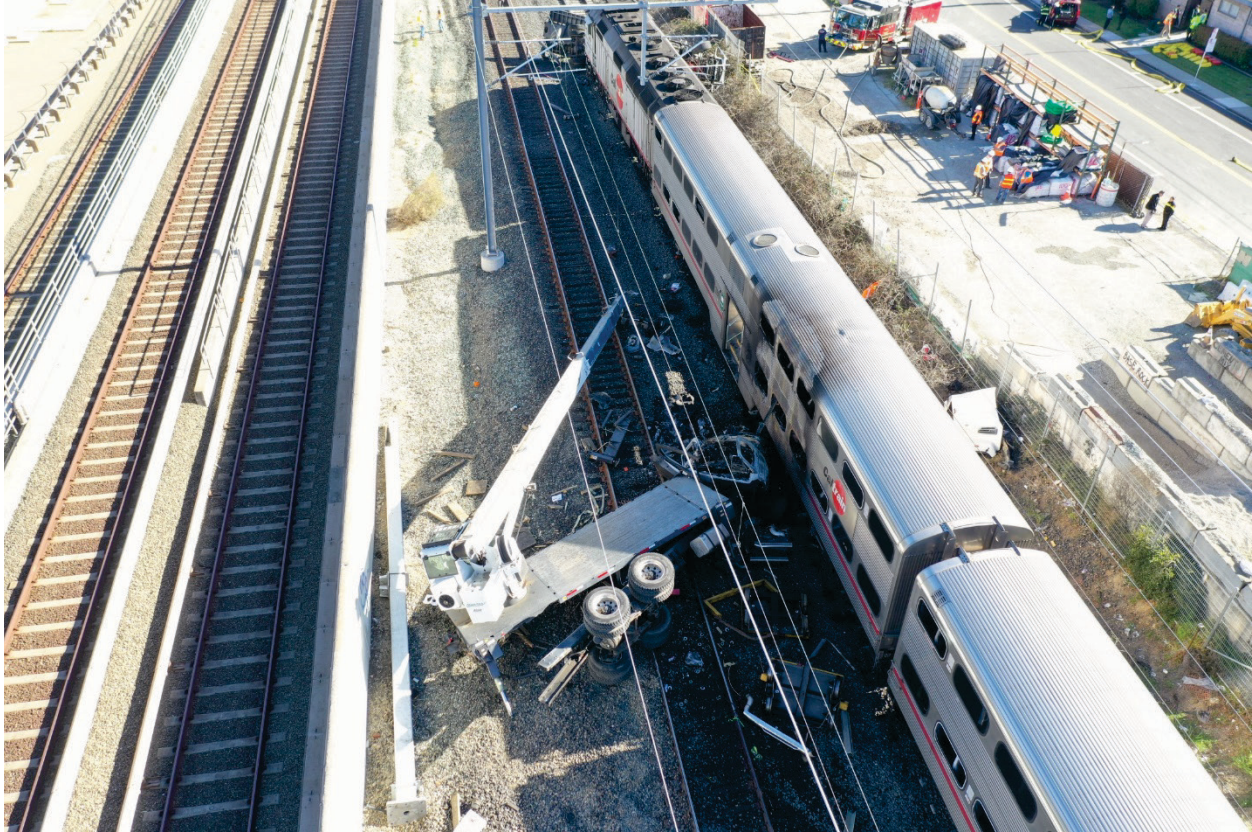
Damage estimates include \$2,000,000 for equipment and \$168,955 for track and associated structures. No other hazardous materials were involved, and no further evacuations were required.

Figure 2: Damaged Equipment
