# Federal Railroad Administration, Office of Railroad Safety

## Accident Investigation Summary Report HQ-2022-1643

Union Pacific Railroad Company (UP) – Derailment  
Gothenburg, Nebraska  
May 26, 2022

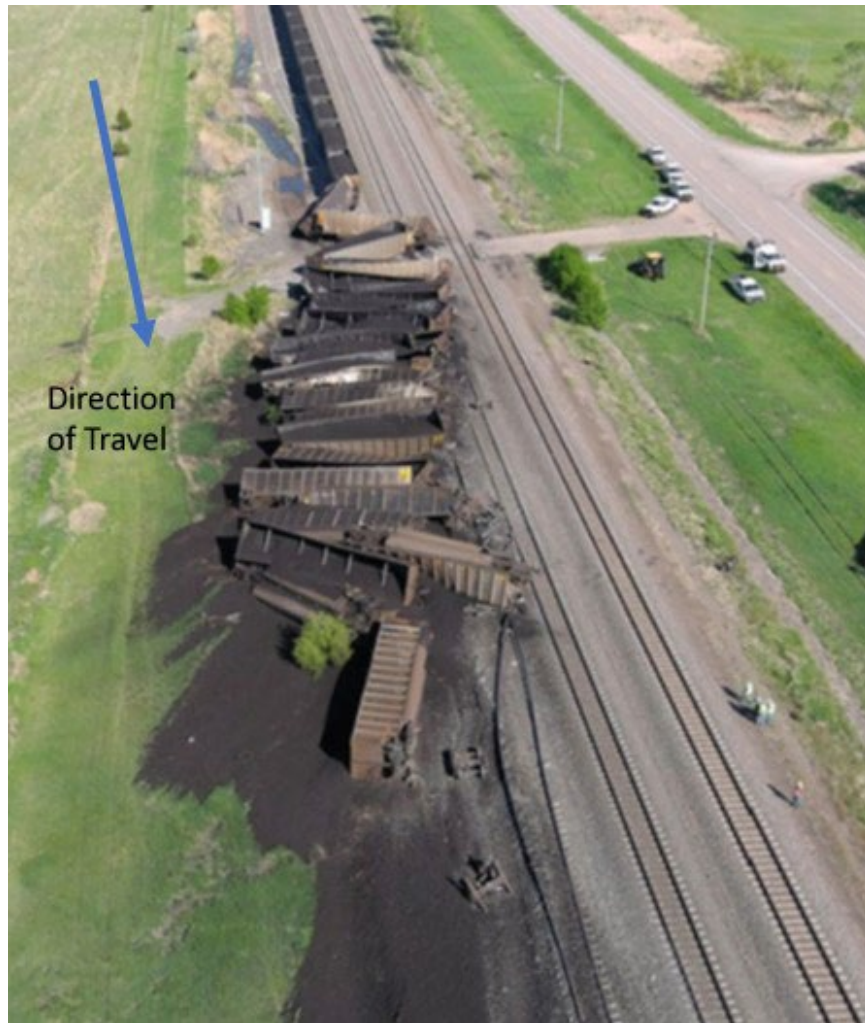
Lines 45-48 derailed upright, Lines 41-44 derailed and lay on their sides on the south side of Main Track 3, while lines 15-40 piled up, blocking Main Tracks 2 and 3 (Figure 1). Main Track 1 remained clear.

*Figure 1: Derailment Site*

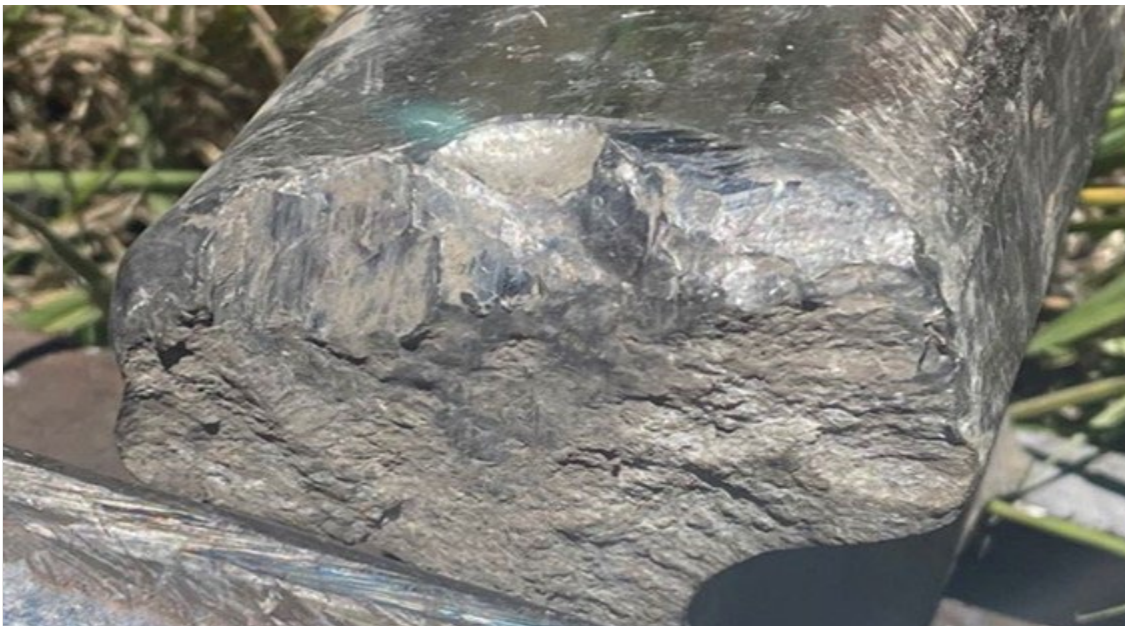
*Figure 2: Batter marks on the broken rail*

FRA identified batter marks on the receiving rail face that is consistent with the wheels traversing a broken rail (Figure 2). The rail failure was attributed to a weak structure that was foundational to the surface profile condition unable to properly support the load. As a result, the

rail at the POD suffered a sudden break under load as the equipment moved from a stiff track modulus<sup>2</sup> to a softer modulus with indication of a failing support structure at the profile location. The fracture face and chevrons present at the POD are indicative of a rail failure under extreme forces typically exhibited during derailment events.
