Federal Railroad Administration, Office of Railroad Safety

Accident Investigation Summary Report HQ-2022-1777

Norfolk Southern Railway Corporation (NS) Derailment
Sandusky, Ohio
October 8, 2022

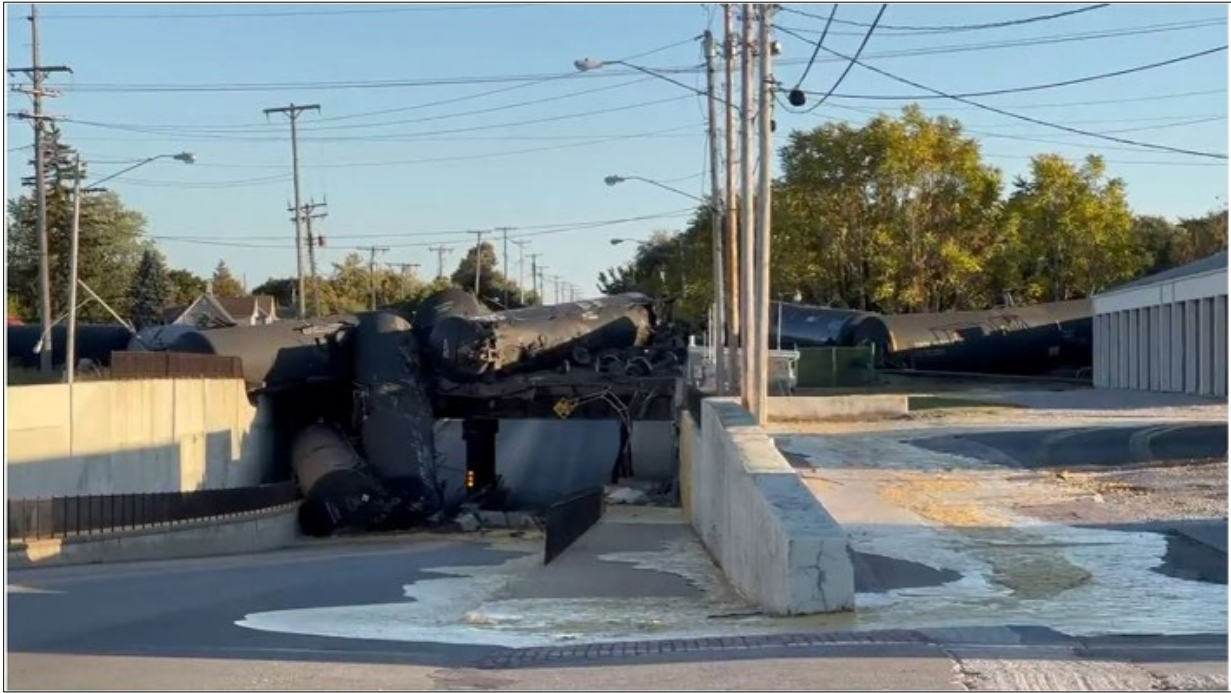
Figure 1: Derailment Site

Lines 7 through 26 of the train consist derailed, with some of the cars coming to rest hanging over, and falling from, the Columbus Avenue overpass onto the roadway below. One of the cars carrying paraffin wax was breached, resulting in a release of wax.

At 4:19 p.m., EDT, near MP CD240.7, the train line between locomotive HZRX 187 and car TATX 117047 (lines 6 and 7, respectively) separated, resulting in an undesired emergency brake application.² Lines 7 through 26 of the train's consist derailed, with some of the cars coming to rest hanging over, and falling from, the Columbus Avenue overpass onto the roadway below. Of the derailed equipment, 19 cars contained paraffin wax, and 1 car contained hydrogen peroxide. One of the cars carrying paraffin wax was breached, resulting in a release of wax.

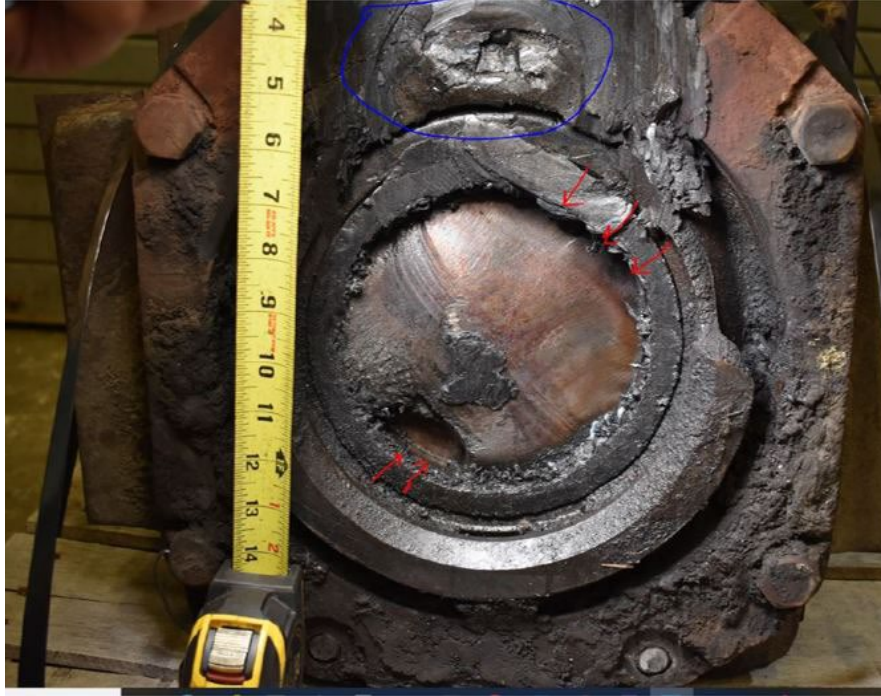
Figure 2: HZRX 187 No. 3 axle

The root cause of the axle failure was metal fatigue of the No. 3 axle installed on HZRX 187. The axle failed due to fatigue initiating in the outside areas of the axle. The crack propagated by fatigue across 85 percent of the axle cross-section before the final “fast fracture,” which occurred while the train was moving. The axle crack was located between the R3 wheel and bearing journal box.

The area in which the crack on the R3 axle was located would have been extremely difficult to see while inspecting HZRX 187 trackside. On HZRX 187, there was very little room between the truck components and the frame of the locomotive to permit a visual inspection of the inward facing bearing journal box and axle.

If the locomotive had been inspected in a shop setting, it is still unlikely that such a crack would have been discovered, utilizing common inspection methods. Most shop inspections of locomotive “bottom side” components are conducted simply with a flashlight. Usually, truck components are not frequently cleaned, not even when a locomotive receives a periodic inspection, as the presence of dirt does not inhibit such inspections in most cases. To locate a crack like the one that caused the R3 axle to break, some sort of non-destructive testing such as magnetic particle inspection (MPI)³ or X-ray would likely have to be utilized.

FRA’s investigation determined that the root cause of the axle failure was metal fatigue of the No. 3 axle installed on the HZRX 187 locomotive. The axle failed due to fatigue initiating in the outside areas of the axle. The crack propagated by fatigue across 85 percent of the axle cross-section before the final “fast fracture” that occurred while Train 1 was moving. The axle crack was located near the inboard facing side of the R3 wheel bearing journal box.

In response to this accident, FRA issued Safety Advisory 2023-01 and Supplemental Safety Advisory 2023-01, recommending that railroads: (1) evaluate the thresholds for inspections based on hot bearing detector (HBD) data; (2) consider the use of real-time trend analyses of HBD data as a criterion for inspection; (3) ensure the proper training and qualification of personnel responsible for the calibration, inspection, and maintenance of HBDs; (4) insure proper inspection of rolling stock with HBD alerts; (5) improve the safety culture of their organization, particularly as it pertains to operational decisions based on HBD data; and (6) take action to evaluate the resiliency and accuracy of the overall process used to monitor and measure bearing health.
