Federal Railroad Administration, Office of Railroad Safety

Accident Investigation Summary Report HQ-2023-1824

Norfolk Southern Railway Company (NS) Derailment

Anniston, Alabama

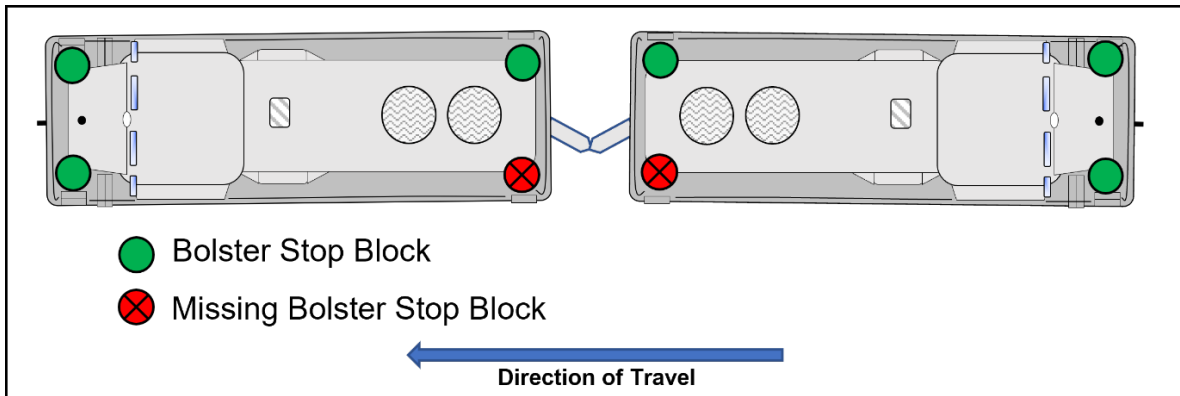
Figure 3: Position of Missing Stop Blocks

Coupler stop blocks, either metal or rubber, are used to reduce the amount of side-to-side movement of the coupler shaft on non-alignment control couplers, but do not reduce lateral forces. The rear draft pocket, of the RMEX 6, showed evidence that the right rear coupler stop block had recently been dislodged. The rear draft pocket of RMEX 8 showed evidence that the left rear coupler stop block had been recently dislodged. The metal mounting brackets displayed signs of a fresh break, evidenced by shiny metal.

FRA conducted a simulation using Train Energy and Dynamics Simulator (TEDS) which identified the train had experienced excessive buff forces around MP 707 (14 miles prior to the POD) exceeding 300 KIPS.⁶ These forces likely caused the coupler stop blocks to break away. The missing stop blocks were not recovered.

The alignment control draft system on the leading four locomotives of train 245A109 limited the coupler angle to about 8-degrees, where the non-alignment control draft system on the revenue freight locomotives had a coupler angle up to 15-degrees. As a result of the high buff forces, exceeding 225 KIPS, the large coupler angle of the revenue freight locomotives magnified the lateral drawbar force, distributed from the drawbar through the wheel, and produced a high L/V ratio⁷ resulting in the rail gauge spreading, and the derailment.
