CSX Transportation

Safety Culture Assessment Report

January 13, 2025

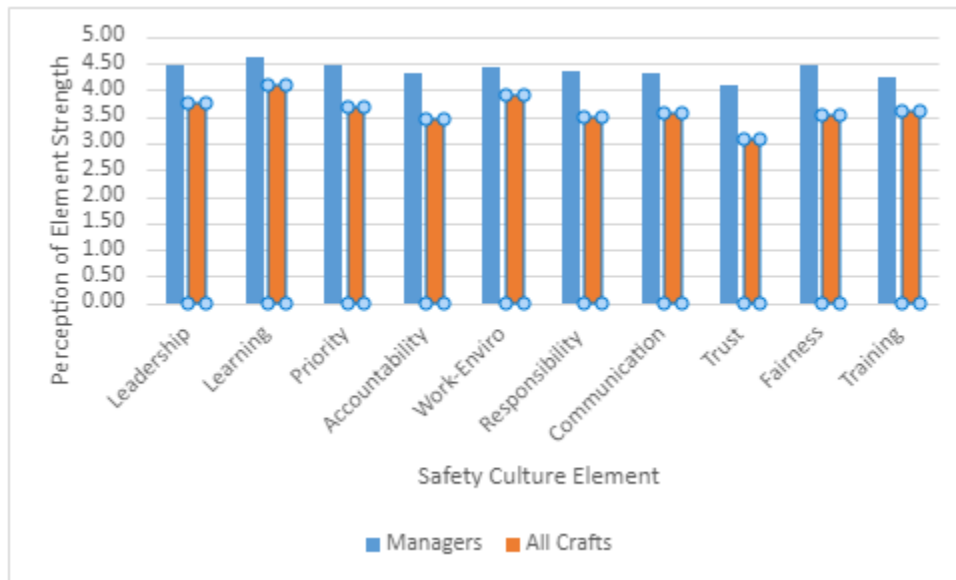
Figure 3. Differences in CSX Safety Culture Perceptions between Managers and Craft Employees

The biggest disparities in ratings between managers and craft employees involve safety culture elements related to trust, fairness, and prioritizing safety over other demands. Free-form comments provided by craft employees during the survey interviews revealed some employees believed safety was prioritized only to the point where it interfered with meeting production demands. Others reported that the safety culture of their work environment was supervisor dependent. Some reported a strong safety culture that permeated all aspects of operations while others reported a disconnect between the safety prioritization at the highest levels of CSX leadership and the production focus at the local level.

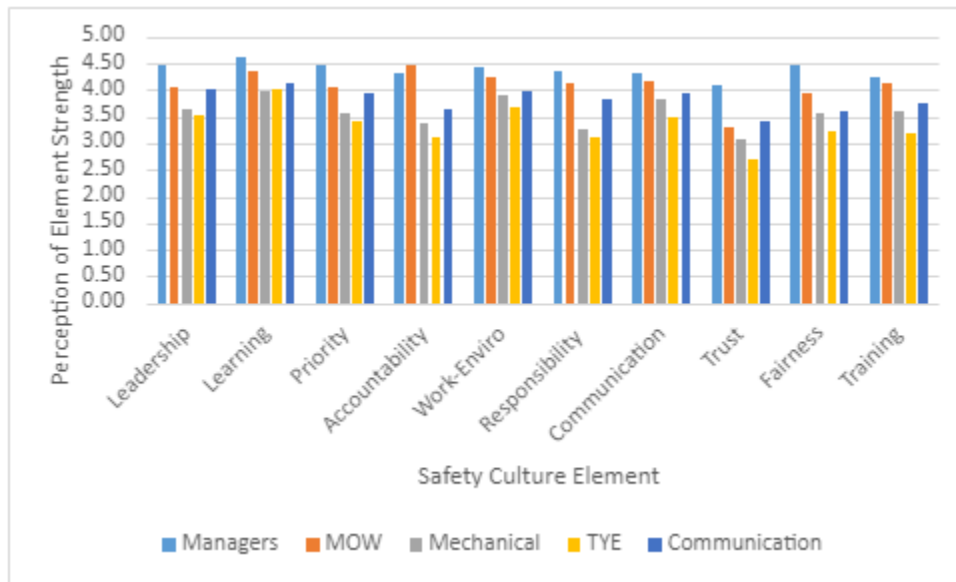
Figure 4. CSX Safety Culture Perceptions by Employee Craft

Figure 4 shows the summary results for each safety culture element by employee craft. The majority of the safety culture elements were rated lowest by operating craft employees (TY&E). The one exception is element 2 (railroad practices continuous learning) which was rated lowest by mechanical craft employees. Maintenance-of-Way (MOW) craft employees had the highest non-manager rating for 9 of the 10 safety culture elements. Communications

craft employees (signal and dispatch) had the highest non-manger rating for trust. Consistently, craft employees with more than 31 years of railroad experience rated most safety culture elements lower than any other experience group. Again, because the sample was one of convenience it is not known what might be driving this trend. However, the trends are consistent with what has been observed in assessments at other Class I railroads.

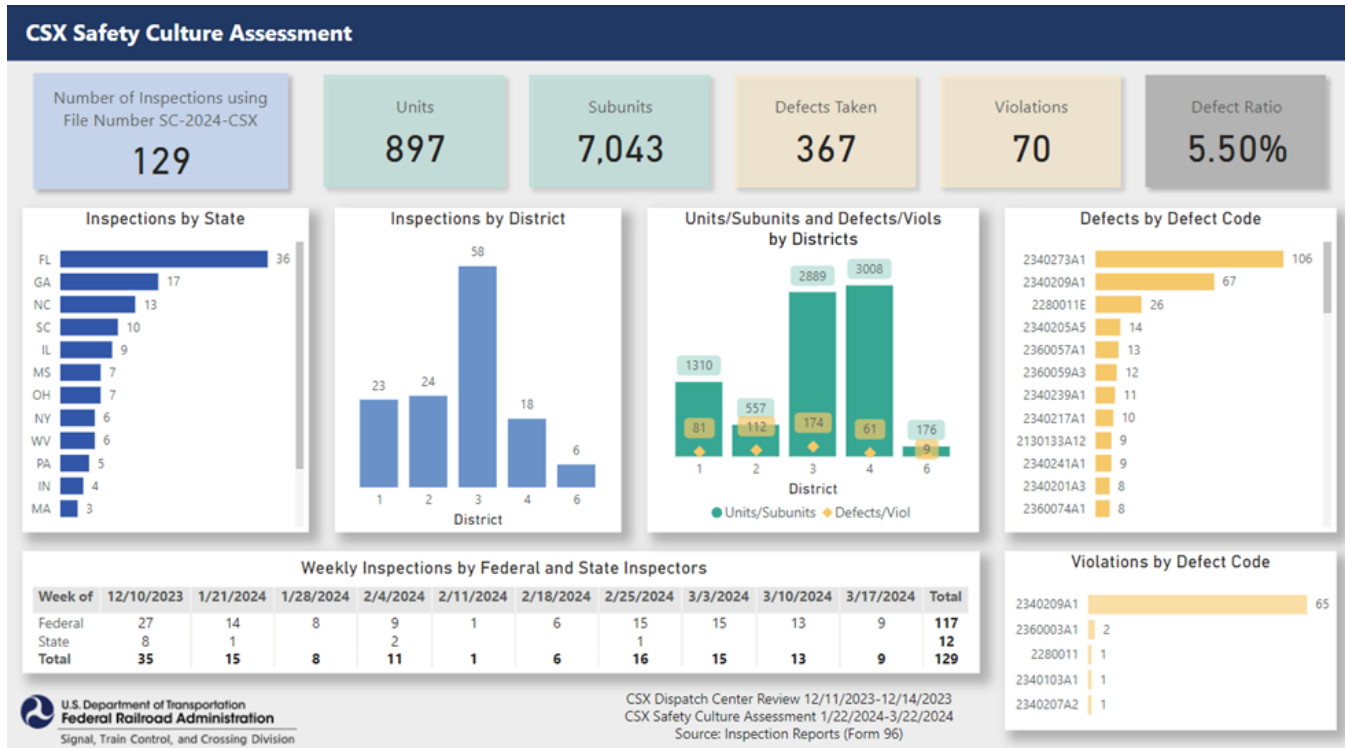
Figure 15. Summary findings of FRA’s Signal, Train Control, and Crossings inspectors

Finding 1: Maintenance-of-Way employees interfered with the normal operations of highway-rail grade warning systems.

During these inspections, FRA inspectors found numerous instances of interference with the normal operations of highway-rail grade crossing warning systems by MOW employees during review of credible report records. These actions cause false activations of the grade crossing warning systems (lights flashing with no trains). This reduces the general public's trust in the warning system and may influence driving behaviors, including the tendency for driving through a highway-rail grade crossing (HRGC) while the warning systems is activated. Reviewing the data from previous SCC inspections, MOW interference with HRGC warning systems remains a safety and regulatory compliance issue that has not been successfully addressed by CSX.
