**Federal Railroad  
Administration**

## **Fiberglass Wrapped Tie Performance Evaluation Report**

Office of Research and  
Development  
Washington, D.C. 20590

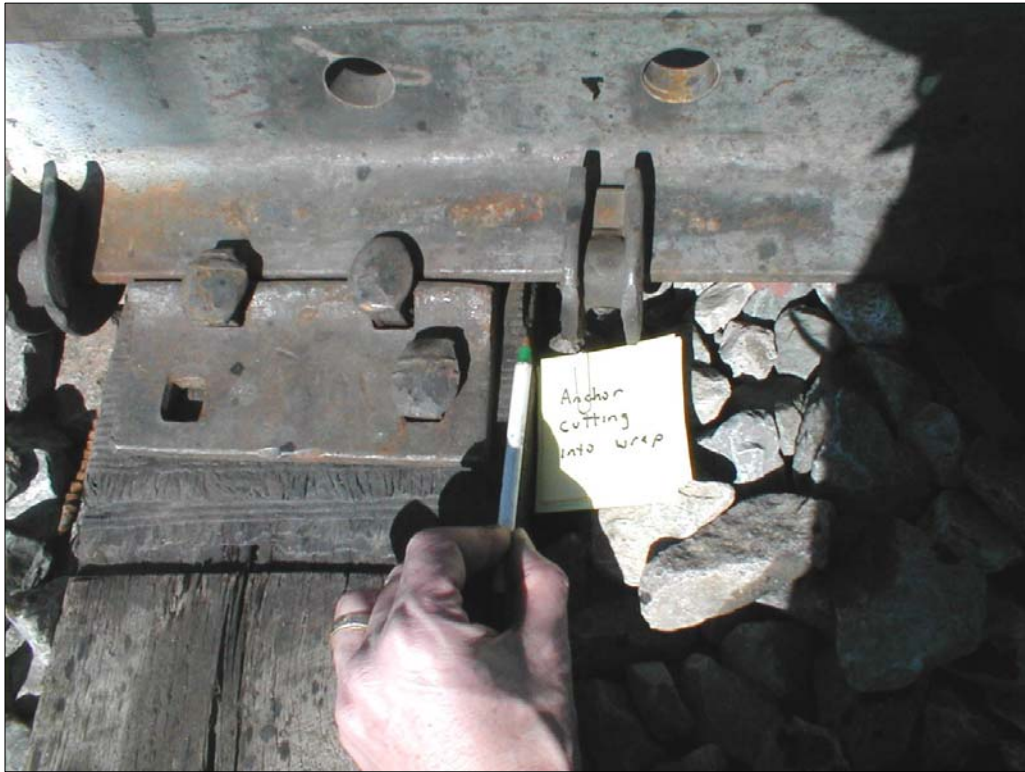
- The test zone held gage, surface, and alignment without maintenance.
- Rail anchors had damaged 77 of the 84 wraps (Figure 2).
- Tie plates had damaged 36 of the 84 wraps (Figure 3), but it did not appear that the wrap had been cut completely through on most of those ties. Removal of the tie plates would be necessary to further determine the condition of the wraps.

- Rail anchors damaged nearly all of the wraps. The only wraps that were not damaged were those that were protected from contact with the anchors by the shape of the ties.

**Figure 2. Damage to Wrap Caused by Rail Anchor**

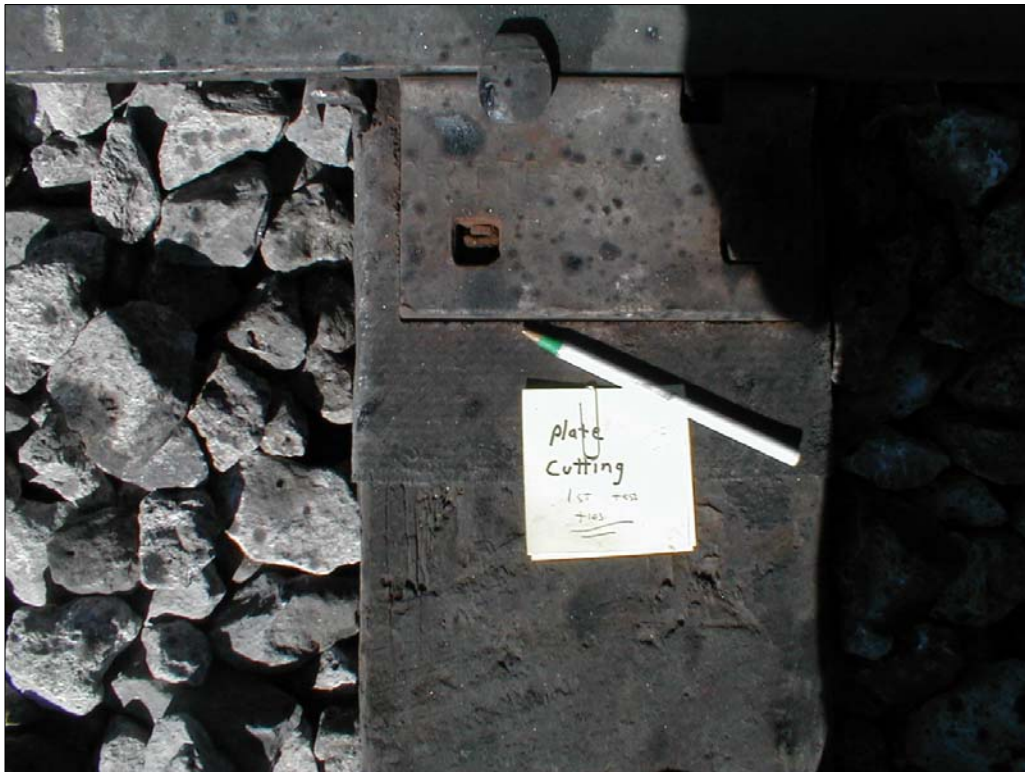
- Forty-three percent of the wraps showed some damage caused by tie plates. It did not appear that the wrap had been cut through on most of those ties.

**Figure 3. Tie Plate Cutting into Wrap**

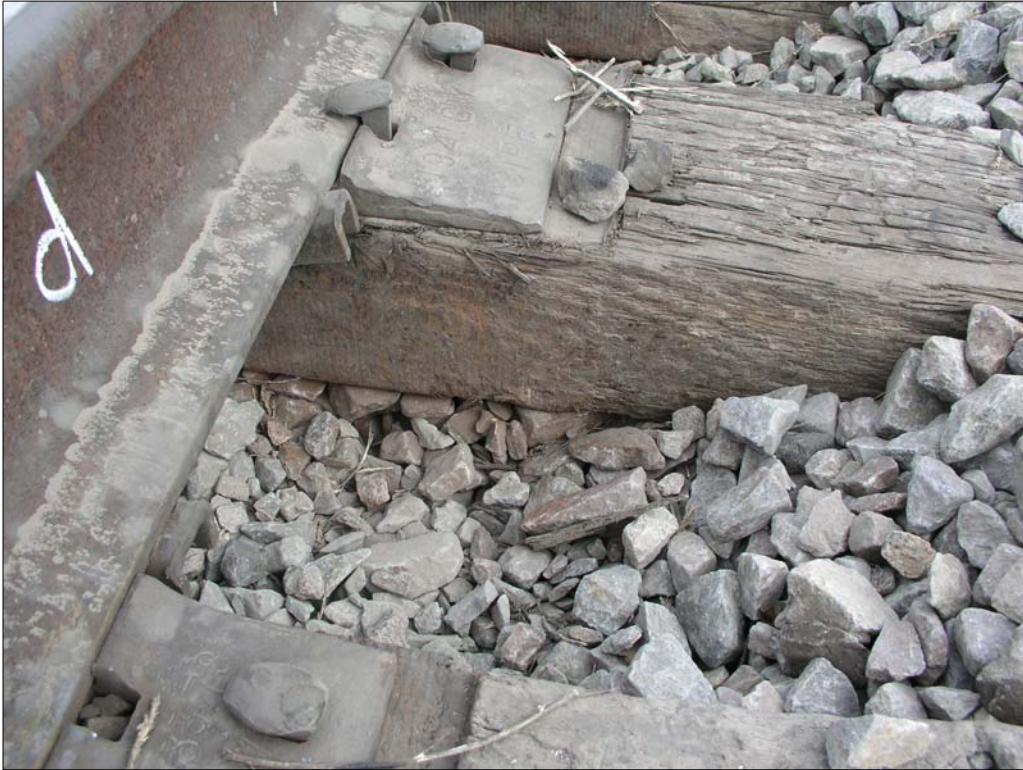
- On the two ties that had ballast moved away so the sides were exposed:
  - The sides on the low rail side of one tie were in poor condition (Figure 4). The sides of the other three wraps were in good condition (Figure 5).

**Figure 4. Side of Tie with Ballast Moved to Expose Wrap (poor condition)**

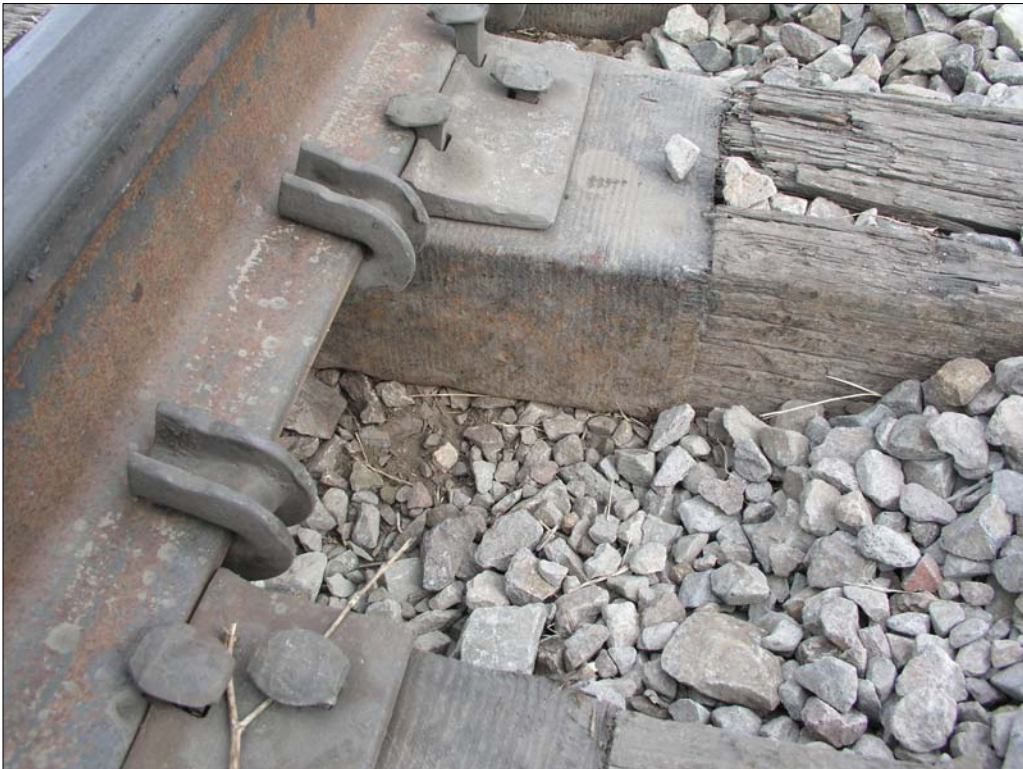
**Figure 5. Side of Tie with Ballast Moved to Expose Wrap (good condition)**

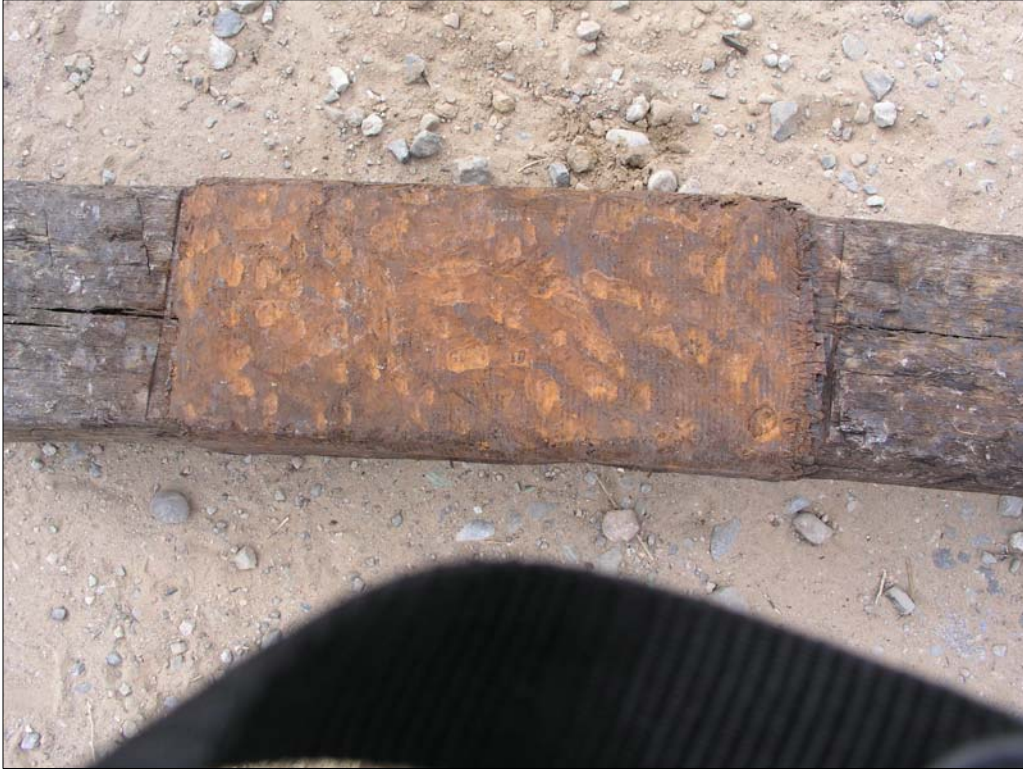
- There was no indication that pulling the ties through the ballast had damaged the wraps.
  - The sides of all four wraps were in good condition.
  - The bottoms of both wraps on one tie were in good condition (Figure 6).

**Figure 6. Bottom of Tie Removed from Track Showing Wrap in Good Condition**

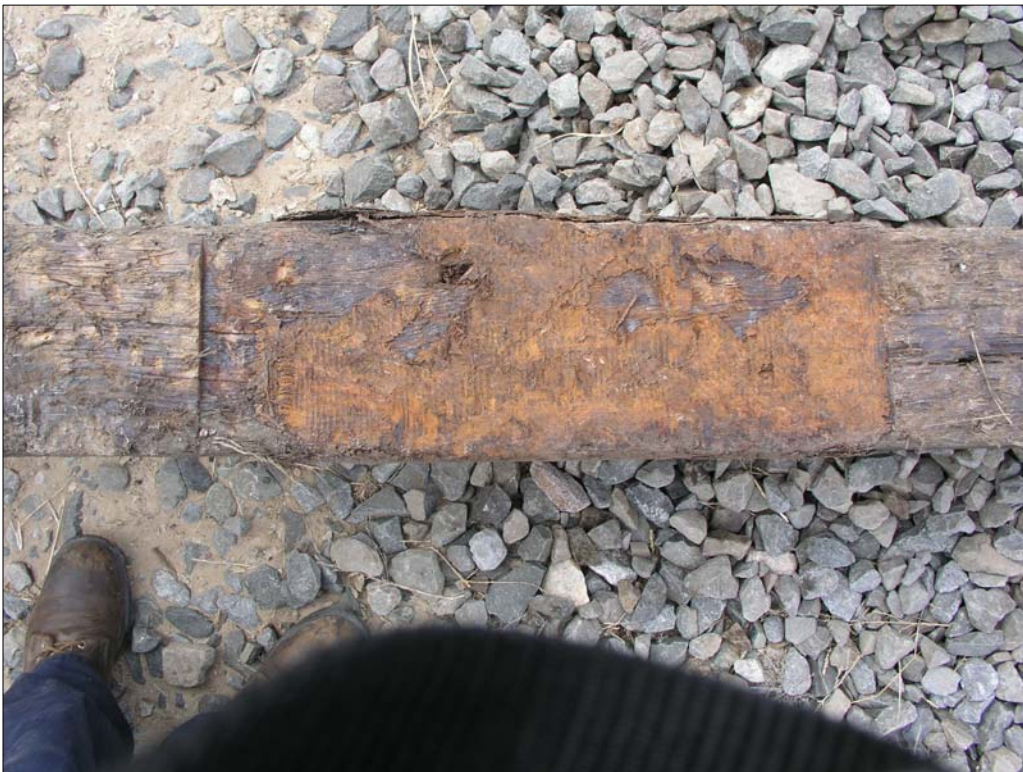
- The bottoms of both wraps on the other tie were in poor condition (Figure 7).
  - The wraps of both ties were in better condition than wraps on the original 200 ties were after 356 MGT (Figure 8).

**Figure 7. Bottom of Tie Removed From Track Showing Wrap in Poor Condition**

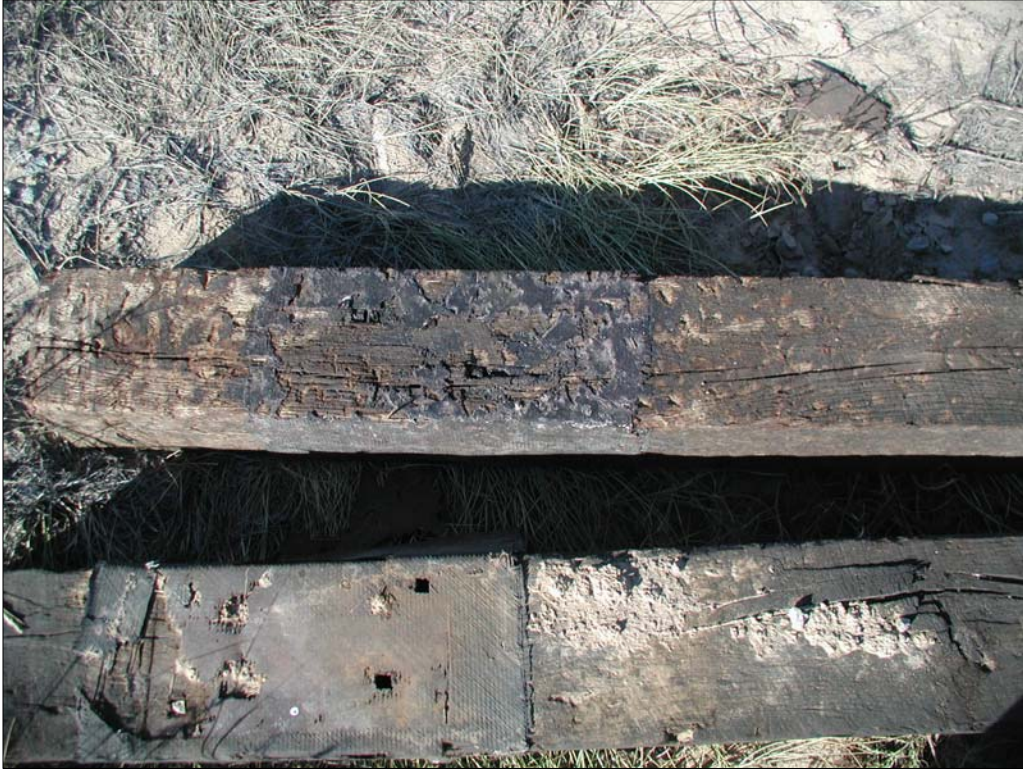
**Figure 8. Bottom of Tie with First Generation Wrap after 356 MGT**

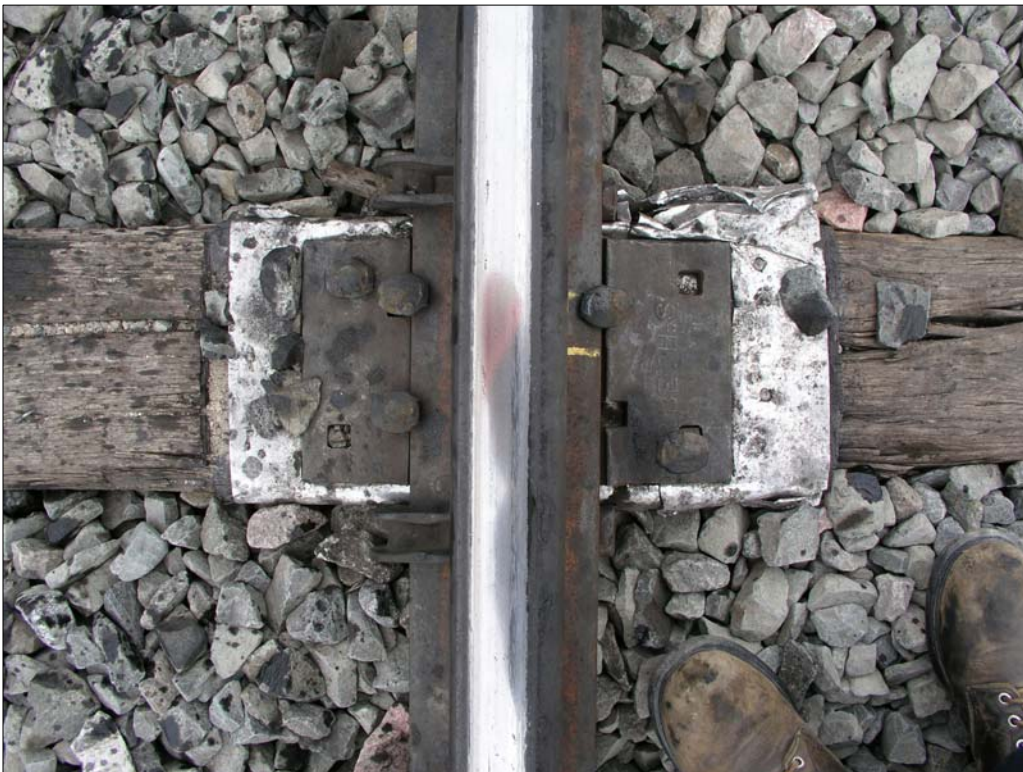
- The two ties with light-weight solid cover plates:
  - Were not able to withstand normal tie handling and train traffic. One of the plates was damaged during transit to TTC, and one was damaged during tie installation.
  - The two that were in good condition at 0 MGT were sufficiently damaged after 25 MGT, in that they no longer provided protection to the fiberglass wraps (Figure 9).
- The two ties with heavier solid cover plates:
  - One cover was damaged during installation.
  - Rail anchors had damaged four of the four cover plates (Figure 10).
  - Tie plates had damaged two of the four cover plates.
- The four ties with perforated cover plates:
  - Rail anchors had damaged five of the eight cover plates.
  - Tie plates had damaged three of the eight cover plates (Figure 11).

**Figure 9. Light-Weight Cover Plate after 25 MGT**

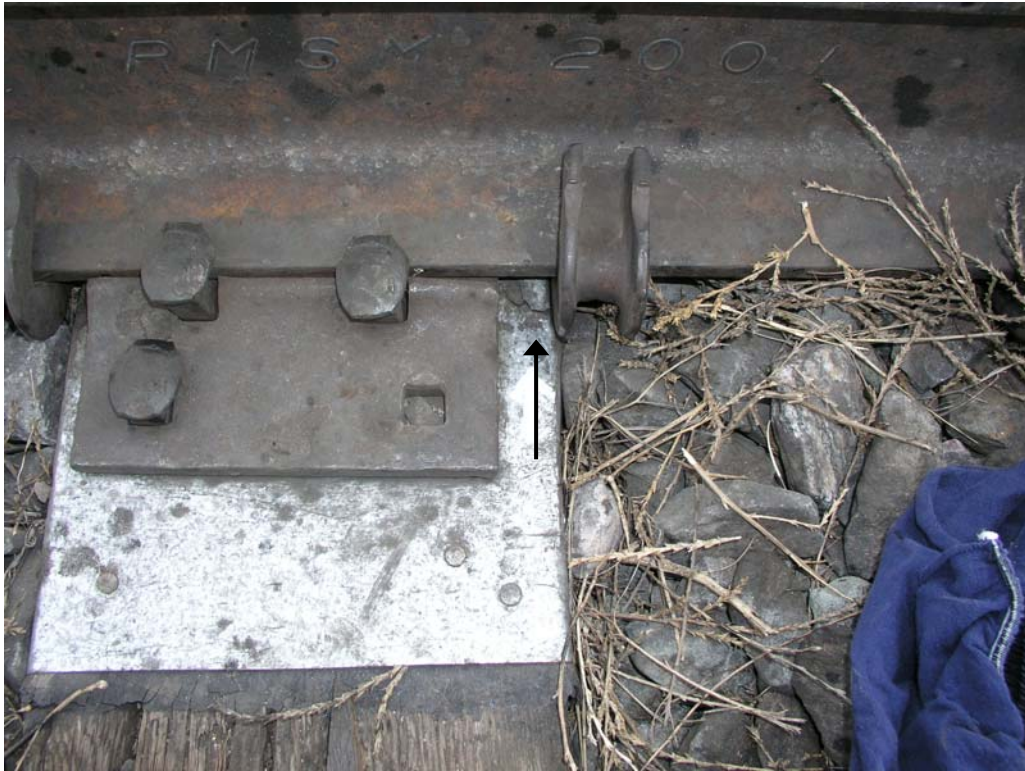
- The heavier metal plates and perforated metal plates provided the fiberglass wraps some protection from plate and anchor damage. The perforated plates were more durable.

**Figure 10. Heavier Cover Plate Damaged by Rail Anchor**

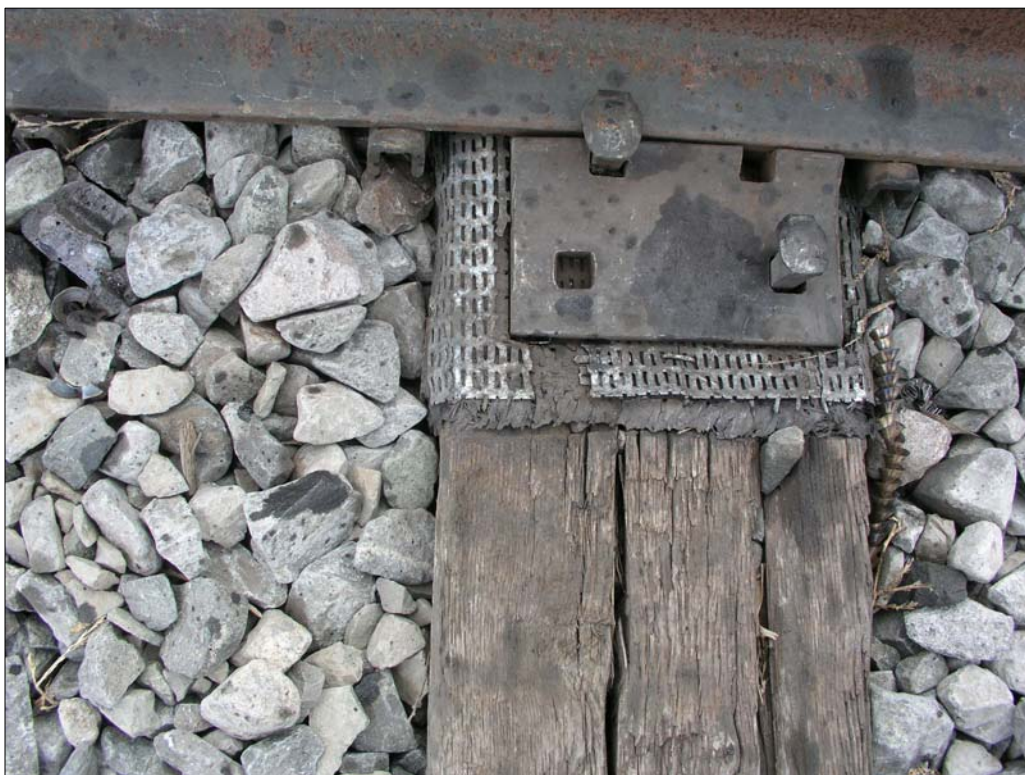
**Figure 11. Perforated Cover Plate Damaged by Tie Plate**
