RR 11-18 | September 2011

EFFECT OF MISSING OR BROKEN FASTENERS ON GAGE RESTRAINT OF CONCRETE TIES

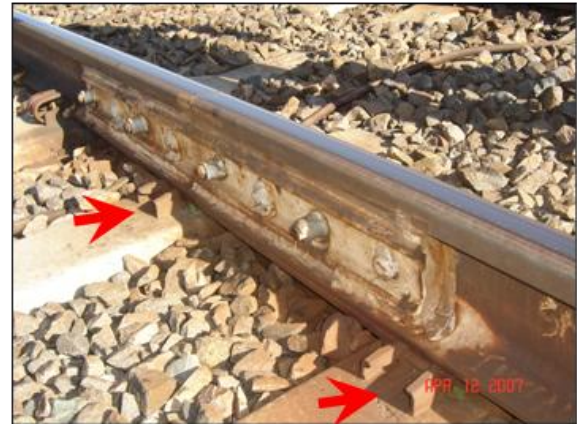
During HAL train operations, it is inevitable that some rail fastener components, such as clips and insulators, will break or become loose over time (Figure 2 shows an example). As such, there are questions concerning how track integrity or gage restraining capability by rail fasteners may be compromised as a result of failed or missing fasteners and how different parts of a fastener system can affect gage restraint (gage strength). Answers to these questions provided by actual field testing and

Figure 2. Example of Missing Fasteners in Revenue Service

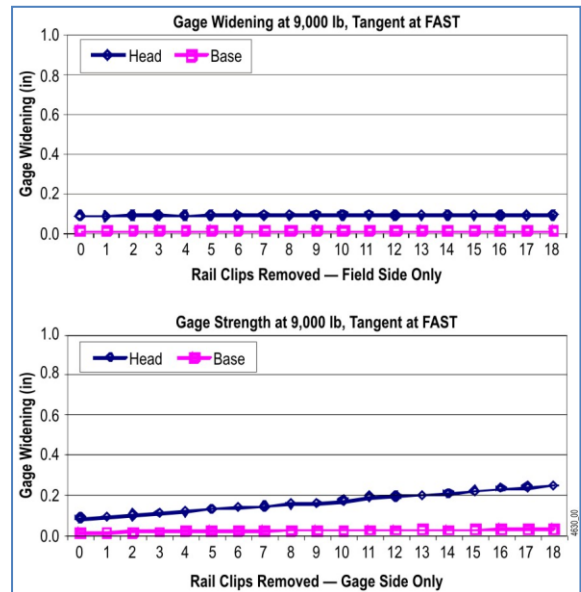
Figure 3 shows the test results at FAST. The top graph shows the test results when the field side clips were removed, and the bottom graph shows the test results when the gage side clips were removed. Removal of the field side clips (up to nine ties) had little effect on gage strength, but removal of the gage side clips had a more significant effect. As each additional individual gage side clip was removed, gage widening increased under the 9,000-pound gage widening force.

The results indicate that clips provide gage restraint by preventing rail roll. As such, toe load provided by clips on the gage side of the rail plays a much bigger role in preventing gage widening than clips on the field side of the rail.

Figure 3. Gage Widening as a Result of Missing Rail Clips at FAST

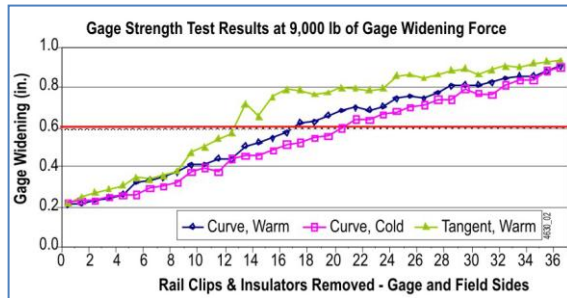
Figure 4 shows the test results for a tangent and a 2-degree curve track in warm weather conditions and for the same track in cold weather conditions. The results were obtained when the clips and insulators were removed one by one on both the gage and field sides for up to nine consecutive ties (a total of 36 clips and insulators). As illustrated, when all nine ties had their clips and insulators removed, the maximum gage spreading measured 0.97 inch (in). Changes in temperature did not cause significant variations in the results. Between the tangent and 2-degree curve, however, it appeared that the effect of missing fasteners was slightly greater for the tangent track.

Figure 4. Gage Widening Test Results in Revenue Service

To determine how many fasteners can be allowed to fail before compromising track strength and integrity, a magnitude of 0.6 in was estimated to be the gage widening limit at the 9,000-pound gage widening force produced by the PTLF. When this estimated gage widening limit is compared with the test results obtained, the following conclusions can be drawn: (1) In the case where only clips or insulators were missing, it took eight consecutive ties to reduce gage restraint below the allowable limit; (2) When both clips and insulators were missing, as shown in Figure 4, it took only three consecutive ties to reduce gage restraint below the allowable limit.
