U.S. Department
of Transportation
**Federal Railroad
Administration**

RR 11-11 | May 2011

PERFORMANCE OF PLASTIC COMPOSITE TIES IN REVENUE SERVICE

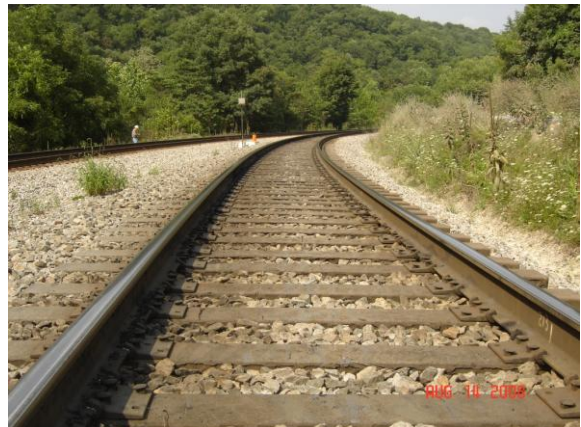
Figure 1. Plastic Composite Tie Test Zone at the NS Revenue Service Mega Site

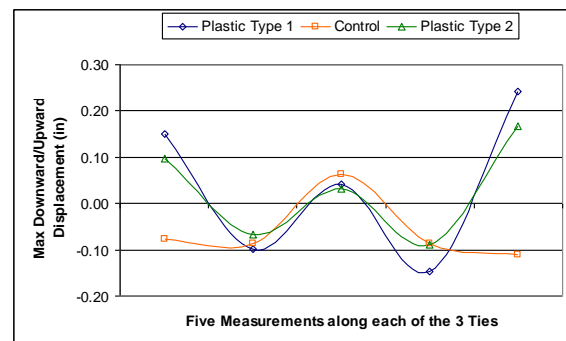
Figure 2. Vertical Deformation Behavior of Plastic Ties Composite and Wood Ties

As shown in Figure 2, the ends of the plastic composite ties bent upward much more than the wood ties, which is characteristic of the lower bending stiffness of plastic composite ties as compared with wood ties. Test results may indicate potential long-term problems associated with ballast pumping around the ends of the ties and large bending stress in the tie plates, which have been observed for some plastic composite ties evaluated under the program at FAST.

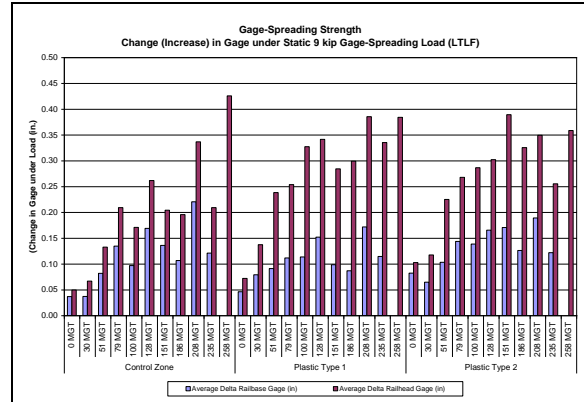
Gage strength degradation is gage widening as a function of applied load and accumulated traffic/tonnage. For the duration of the test (282 MGT), the plastic composite ties performed in the respect of gage strength. Figure 3 shows gage strength degradation test results using light track loading fixture. The plastic composite ties exhibited slightly higher gage spreading than the wood ties, but they exhibited gage strength degradation trends similar to wood ties.

Figure 3. Gage Strength Degradation Test Results

Figure 3 also shows the increased gage strength (reduced gage widening) in the three subzones resulting from regaging (done after 208 MGT but before 235 MGT measurements).

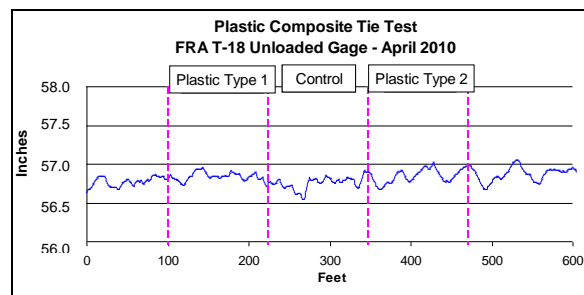
In April 2010, the final track gage measurements were taken in the plastic composite tie and wood tie control test zones using FRA’s T-18 GRMS test vehicle. Figure 4 shows the unloaded gage results, which indicate slightly higher but similar gage in the plastic composite tie zones as compared with the wood tie control zone.

Figure 4. Unloaded Track Gage Test Results of Test Zone

The effect of ambient temperature on the unloaded track gage over a 54°F range (27–81°F) indicate the following maximum changes in gage: 0.24 inch for one type of plastic tie type to 0.5 inch for another plastic tie type, and wood ties 0.16 inch.
