U.S. Department  
of Transportation

Federal Railroad  
Administration

RR 14-43 | December 2014

## CRIPPLING TEST OF AN M1 PASSENGER RAILCAR

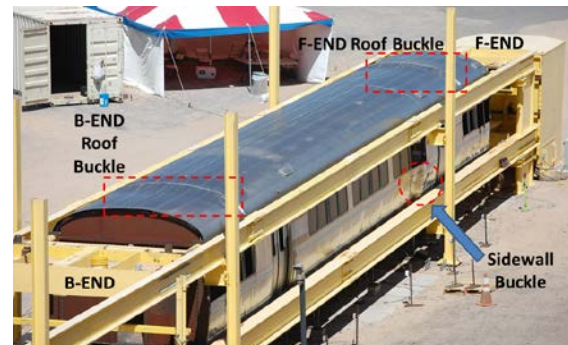
Figure 2. Post-test Photograph of M1

The post-test car is shown within the test frame in Figure 2. Damage to the roof can be seen on both ends of the car near the doors. Sidewall damage can also be observed on the F-end inboard of the door. The roof on the F-end of the car was the first area of the car observed to buckle. Buckling of the F-end roof initiated at a total applied load of approximately 700 kips.

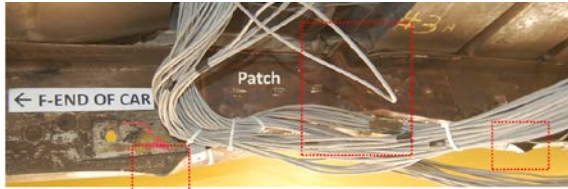
Figure 3. Right Side Sill Damage

The underframe of the car, consisting of the center sill and two side sills, buckled in several areas during the test. The right side sill had several buckles in one region. This region was adjacent to the sidewall damage observable in Figure 2, as well as to a previously repaired buckle. This previous damage is believed to have occurred when this car was used in a dynamic impact test. A patch had been installed on the side sill and sidewall of the car in this area prior to the 800-kip test. The post-test damage to the right side sill is shown in Figure 3, with three different areas of side sill buckling indicated. The arrow on the left-most buckle was drawn on the side sill prior to the crippling test. This mark indicates that a small buckle already existed at this location prior to the crippling test. This existing buckle served as an initiation site for the larger buckle that occurred in this area during the test.

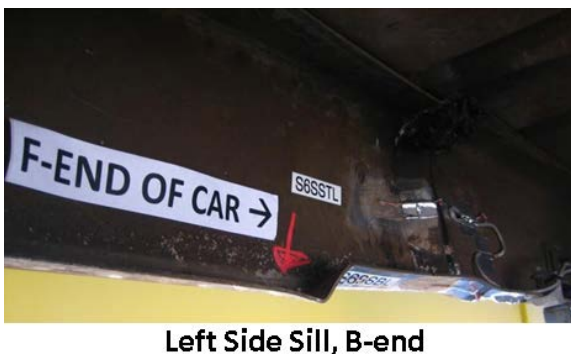
Figure 4. Buckle on B-end of Left Side Sill

The left side sill was found to have buckled in two different locations. Figure 4 shows the damage closer to the B-end of the car. The arrow in the B-end photograph was drawn on the side sill before the crippling test to indicate that a small buckle already existed at this location. From the figure below, it is apparent that this pre-existing buckle served as an initiation site for the side sill's buckle in this location. A second buckle, on the upper part of the side sill, is visible closer to the F-end of the car in this figure.

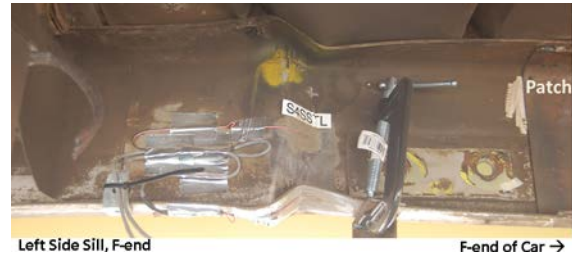
Figure 5. Buckle on F-end of Left Side Sill

The second buckled area on the left side sill occurred closer to the F-end of the car. This area of buckling is shown in Figure 5. From the strain gage data, it appears that the buckle on the B-end of the left side sill occurred earlier in the load sequence than the buckle on the F-end. The buckle on the F-end of the left side sill is located in the vicinity of the patch that was added to the left side sill to maintain symmetry with the right side sill's patch.

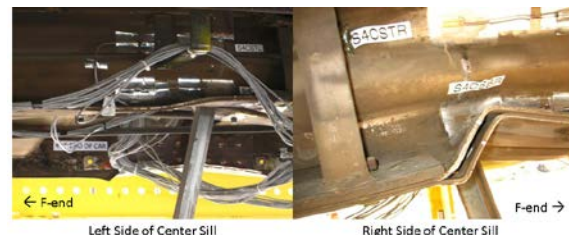
Figure 6. Buckle on the Center Sill

The center sill of the car had several minor buckles and one large buckle. This large buckle is located at a cross-section of the car adjacent to the two side sill patches. Based on the strain gage results, the center sill buckles at approximately the same time as the buckle that occurs on the F-end of the left side sill. This buckling event occurs at the highest load recorded during the test, indicating that crippling of the car occurs because of buckling of the center sill and left side sill. The buckle on the center sill is shown in Figure 6. This figure shows the damaged center sill from the left and right sides.

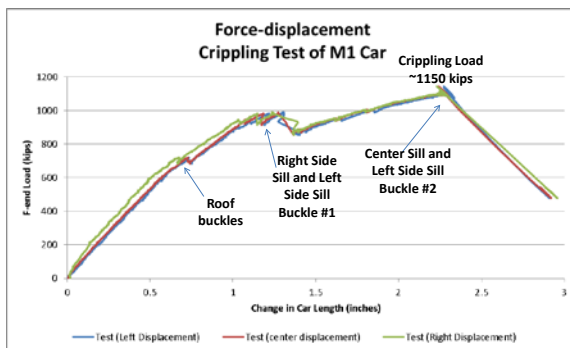
Figure 7. Force-displacement Characteristics

The resulting force-displacement characteristics are plotted in Figure 7. These characteristics indicate that the right side of the car has a slightly higher relative stiffness than the center or the left side. The global maximum load, or crippling load, is approximately 1.15 million pounds for this car. At that point, the center sill and the left side sill at the F-end of the car buckle. The car's overall structure has been compromised completely and the load for further displacement starts to drop.
