# EVALUATION OF IMPROVED TRACK STRUCTURAL COMPONENTS UNDER SUB-ARTIC CONDITIONS

JANUARY 1979

FINAL REPORT

1. Report No. FRA/ORD-79/01		2. Government Accession No.		3. Recipient's Catalog No.	
4. Title and Subtitle Evaluation of Improved Track Structural Components Under Sub-Arctic Conditions				5. Report Date January 1979

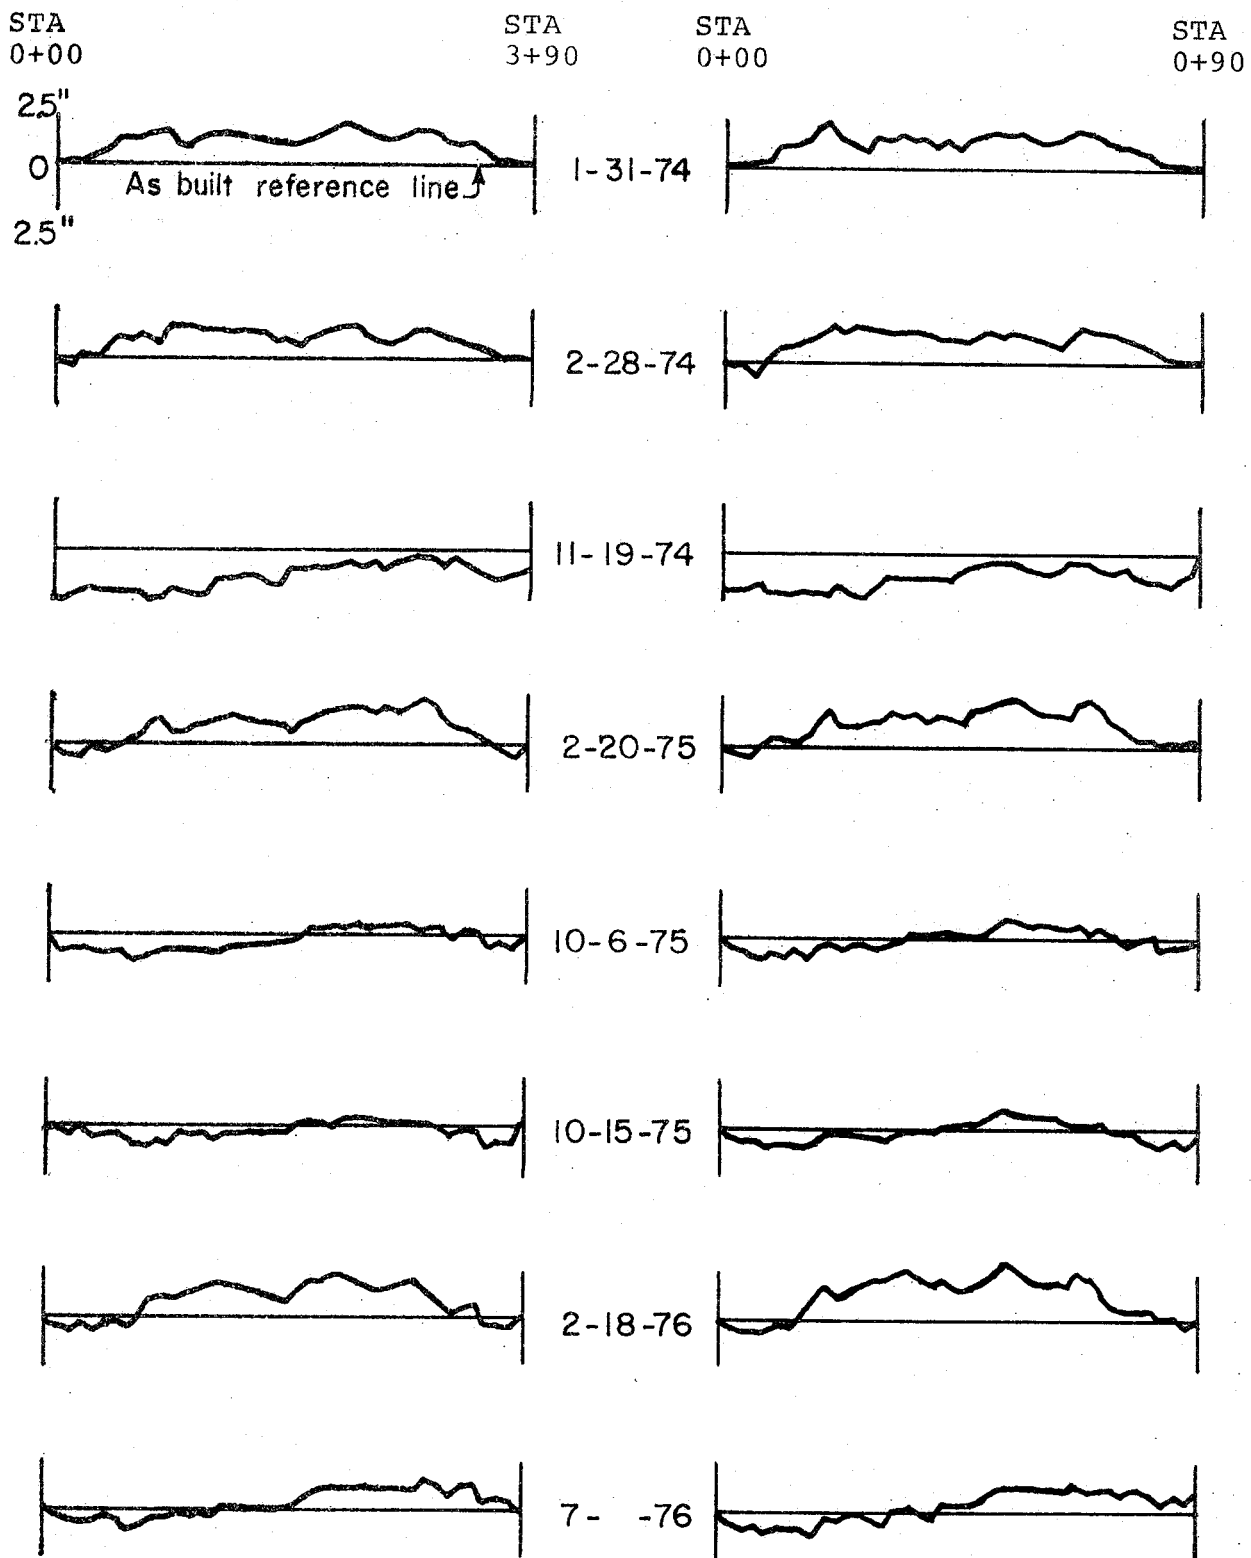
2. Examination of Figures 1 and 2 shows that both the test and control sections moved upward (heaved) during the winters and moved downward during frost free periods. However, November 19, 1974 profiles show that the test and control sections were considerably lower than the as-built elevation prior to the 1974 winter heaving. This is evident also in the November 6, 1975 profiles, although to a lesser degree than during the frost free period prior to the 1975 winter heaving. The July 1976 profiles show that the south end of the test section and the north end of the control section were lower than "as built" while the north end of the test section and the south end of the control section were higher than "as built". An examination of the data did not indicate any particular reason for these trends.

FIG. 1 - RAIL PROFILE CHANGE  
MONTANA CONCRETE TIE SECTION

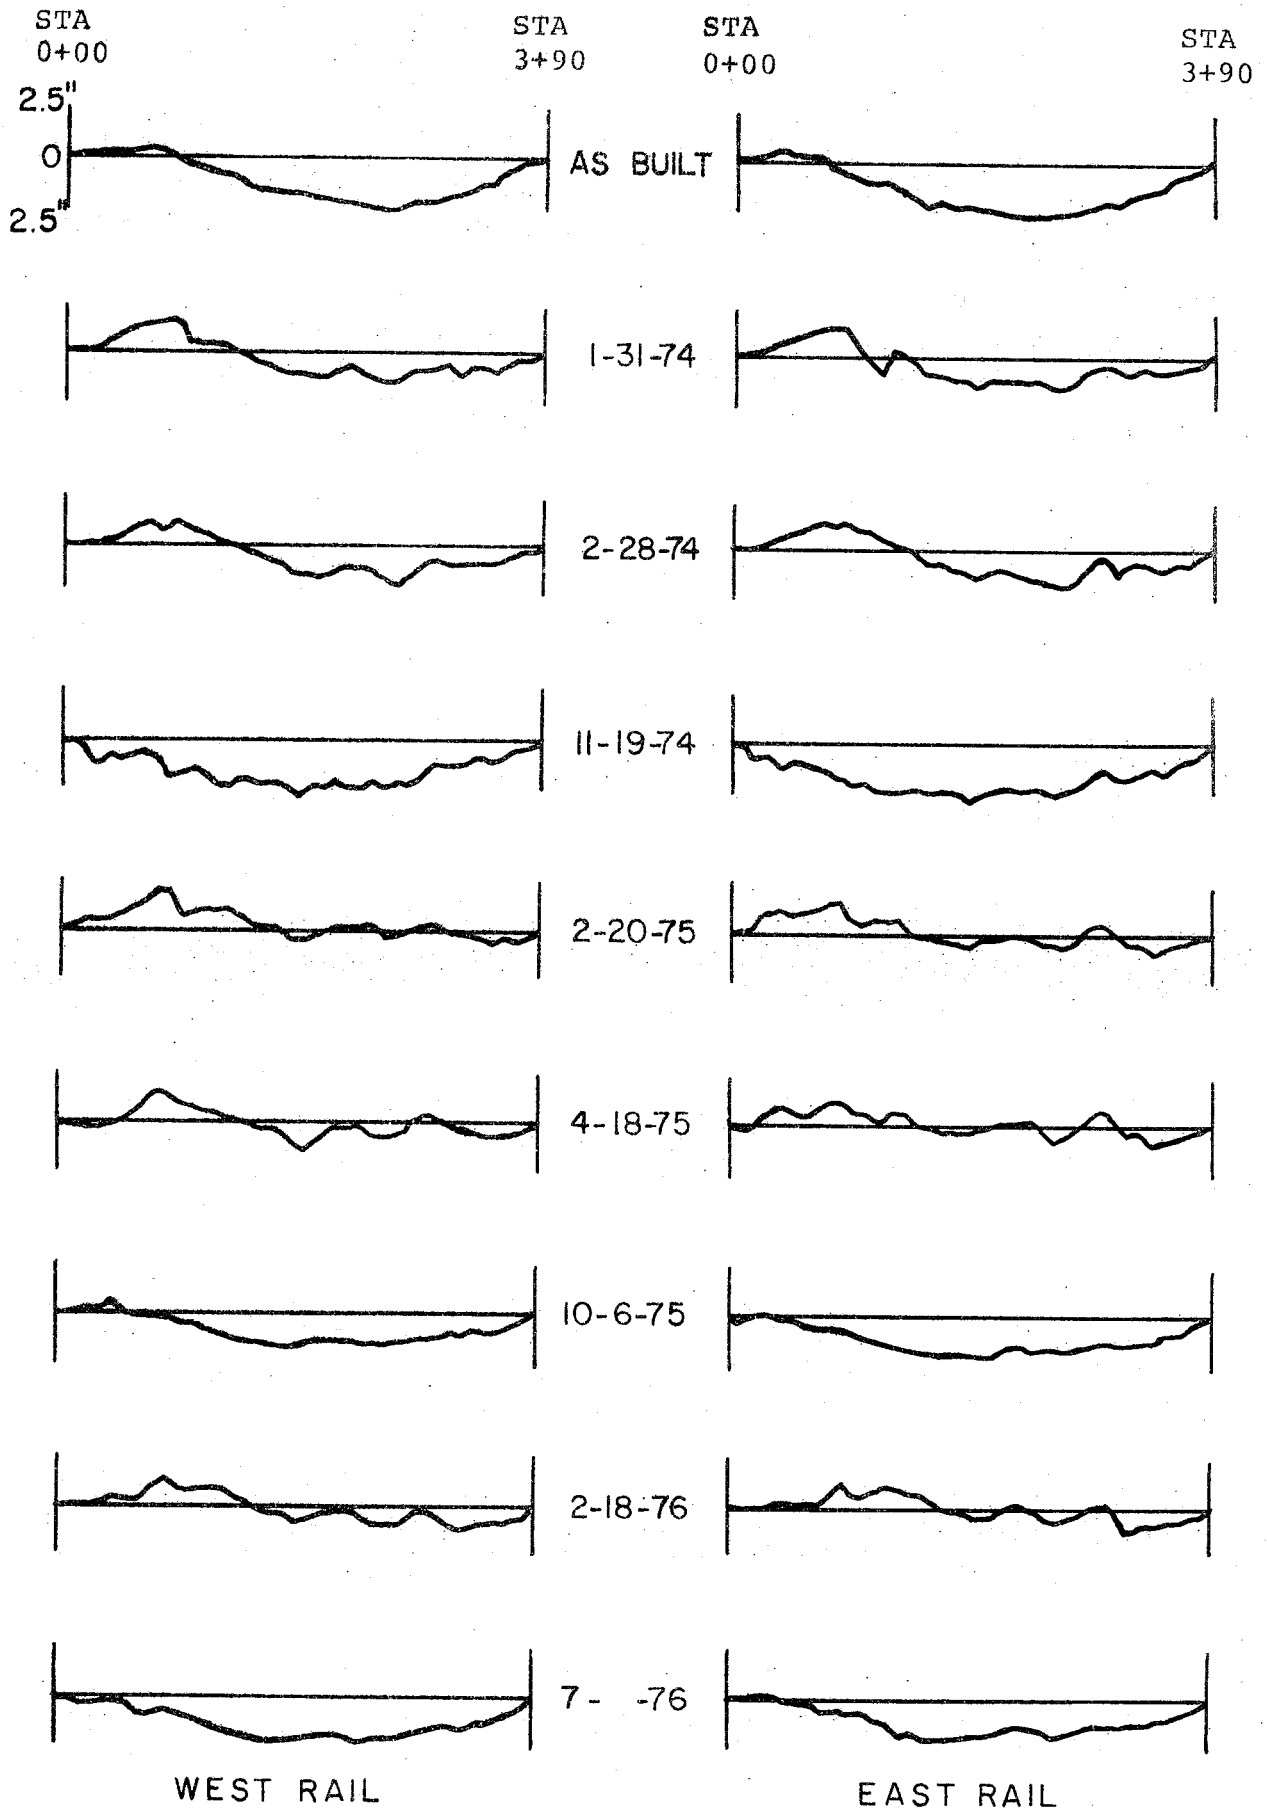
The November 19, 1974 profiles of the test and control section were taken when there was no frost. Although somewhat rougher, the "as built" sags could still be seen.

February 20, 1975 and April 18, 1975 profiles for the test and control sections show heaving similar to the first winter. Although numerous shims were placed in the test and control sections, it would appear that additional shims should have been placed to smooth out observed rough spots, particularly in the test section.

October 6, 1975 profiles were taken immediately prior to field welding the 21 rail joints in the test section. The original sags were evident though somewhat modified in both the test and control sections.

Test and control section profiles taken February 18, 1976 show that heaving, similar to that observed on February 20, 1975 and April 18, 1975, was evident, though not quite as severe as observed during the first winter.

FIG. 3 - RAIL PROFILES  
MONTANA CONCRETE TIE SECTION

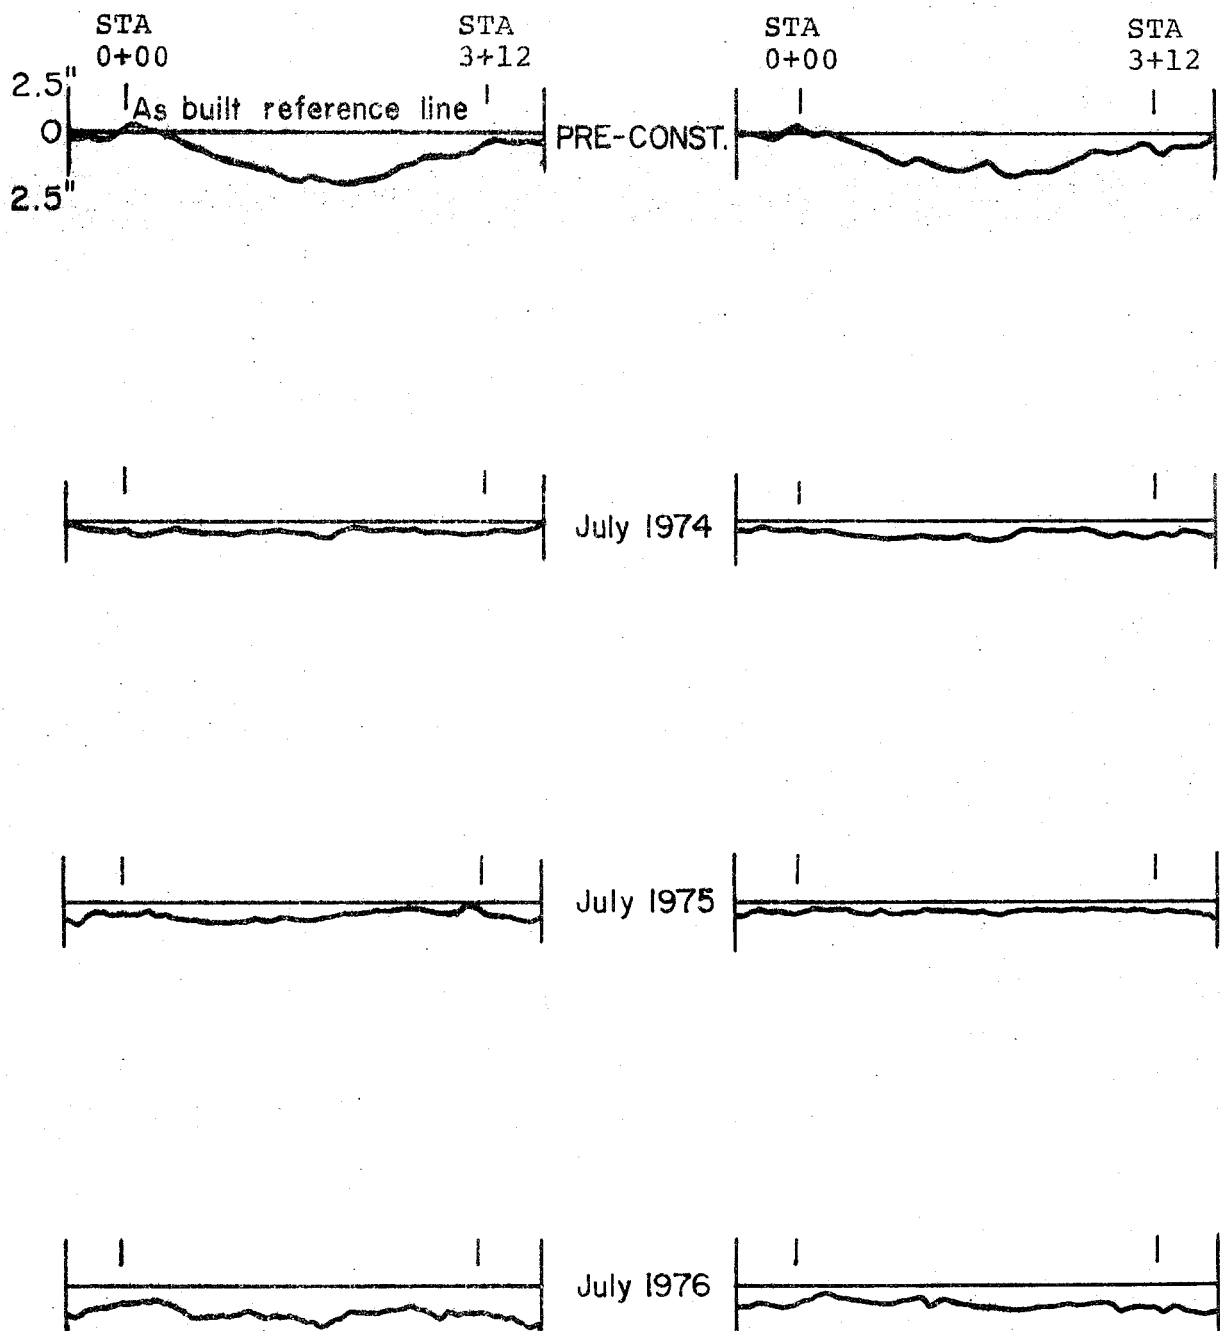
The July 1974 profile plotted against the "as built" profile show that settlement up to 0.84 in. (21 mm) occurred

FIG. 5 - RAIL PROFILES  
HOUSTON STABILIZED BALLAST SECTION

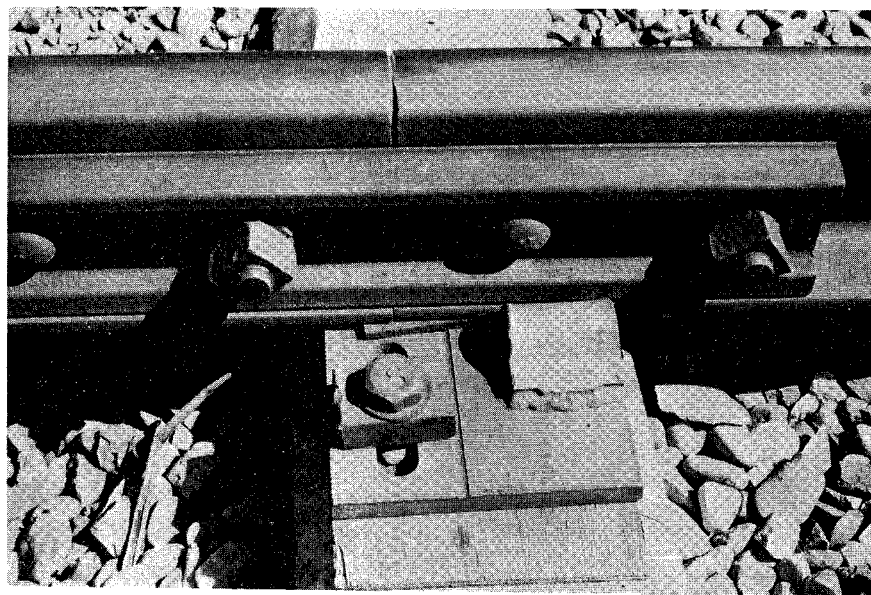
Inspection in July 1974 showed the ties to be crack-free and the fastening to be undamaged, except for a slight migration of some rail seat pads. This was particularly evident at rail joints where spring clips were not installed due to insufficient space around the joint bars. Tie ends directly under the joints had begun to settle leaving a small gap between the rail-seat pad and the base of the rail. Several hold down bolts were removed and found to be bright and unbent. Wood shims that had been removed were found to be undamaged and reusable.

Pad Displacement Beneath Rail Joint  
Fig. E-6

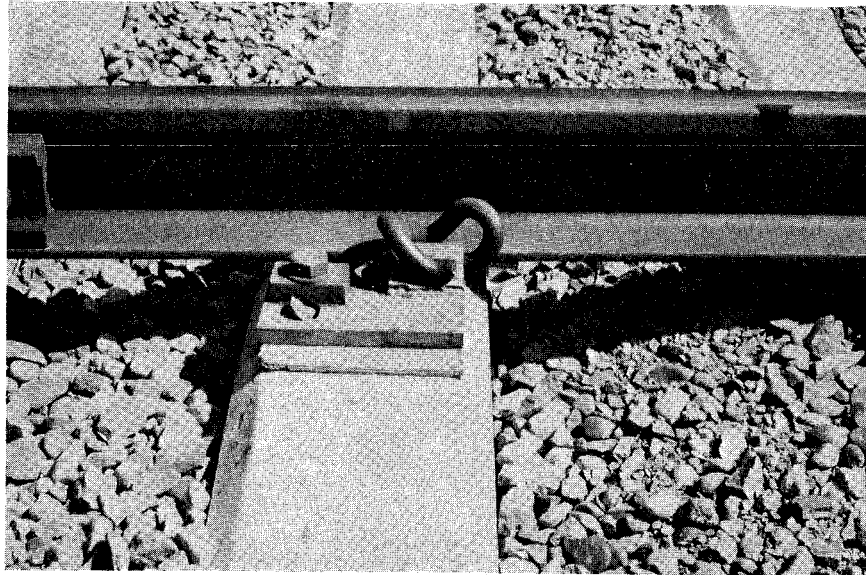
Pad Displacement on Tie Adjacent  
to Rail Joint  
Fig. E-7

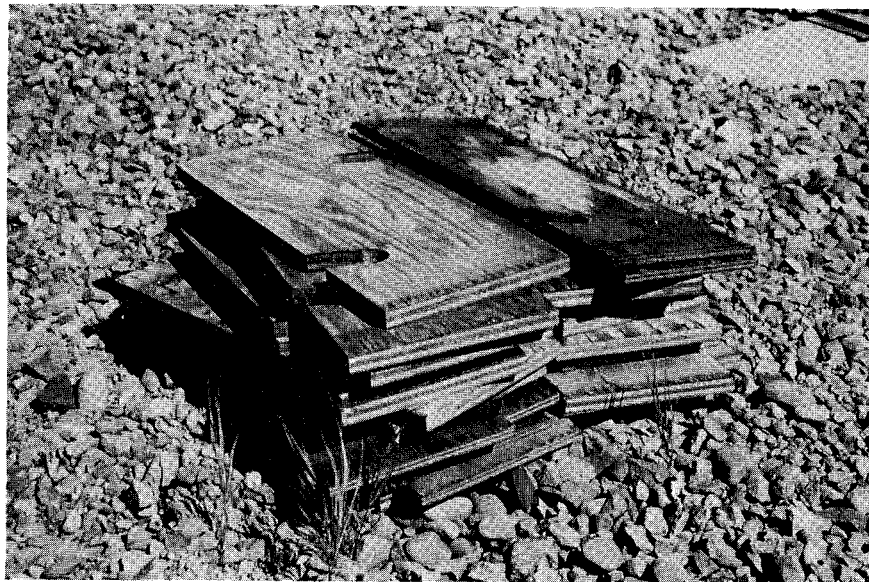
Wood Shims Removed After First Winter  
Fig. E-8

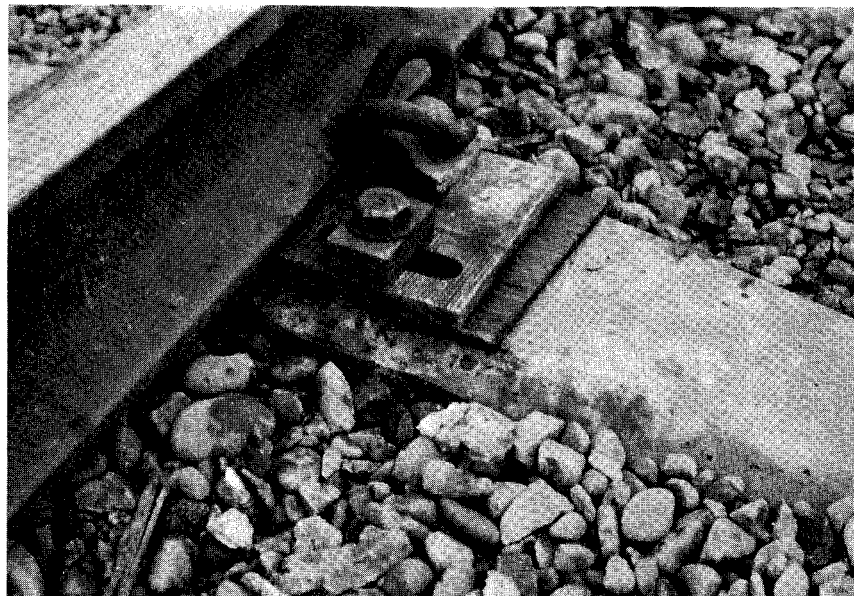
Spalled Concrete Caused by Over  
Torqueing Anchor Bolts  
Fig. E-12

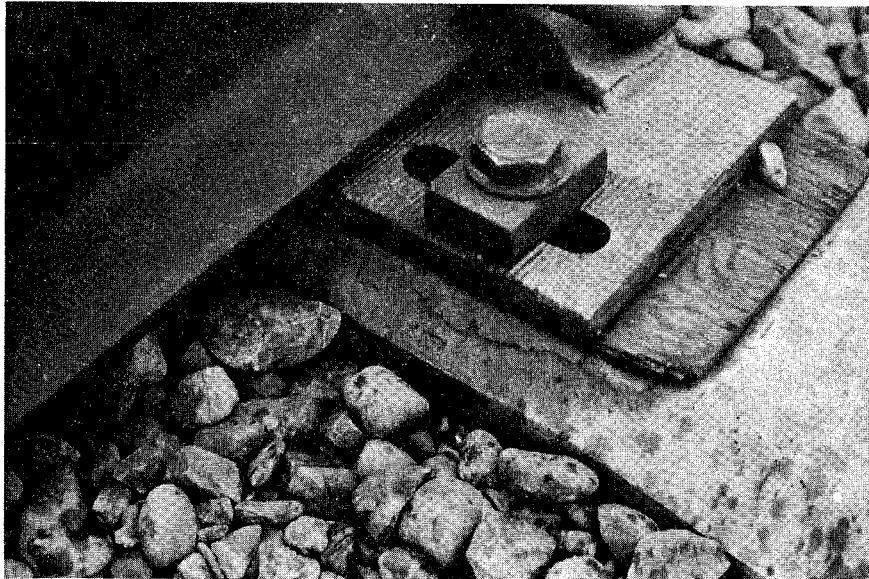
Damage Caused by Excessive Anchor Bolt Torque  
Fig. E-13

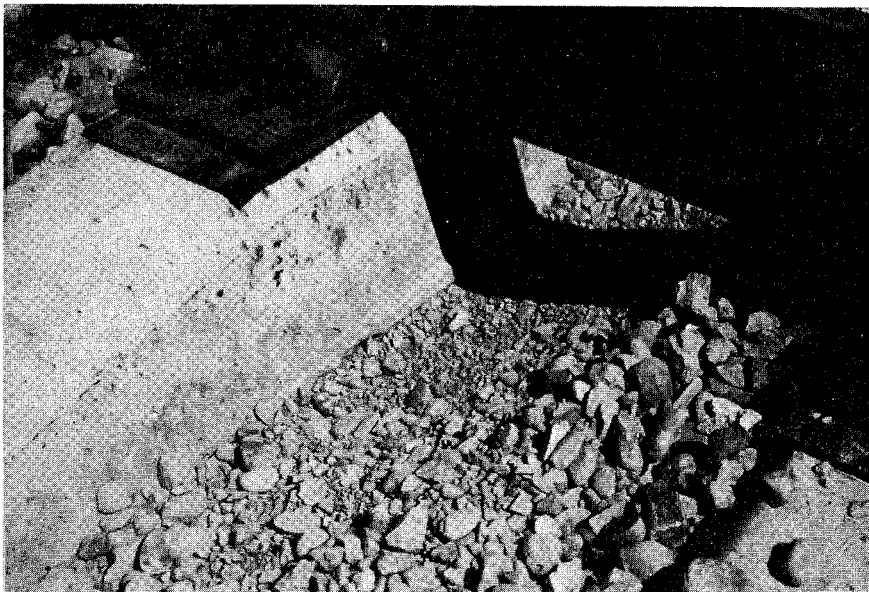
When inspected in July 1976, the concrete ties were still crack-free with the fastenings in excellent condition. All the pads that had been repositioned during October 1975, including the ones placed beneath the welded joints, had remained in place. Any remaining displaced pads were repositioned.

Tie Condition - 1976  
Fig. E-14

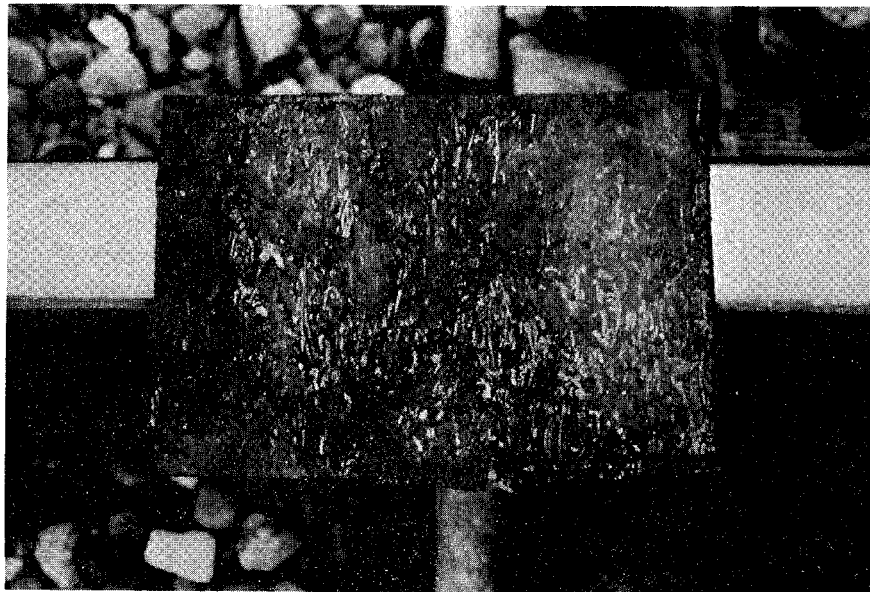
Crushed Rail Seat Pad  
Fig. E-16

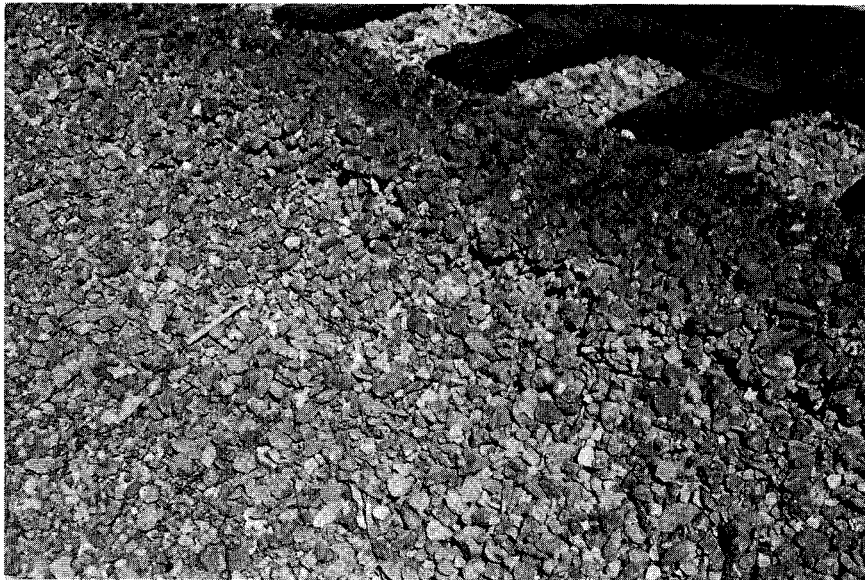
1. Ballast outside the stabilized shoulders showed evidence of slumping downward and out away from the top of the shoulders. A maximum slump of about 1 in. (25 mm) occurred on the outside of the left shoulder referenced to increasing mile posts, at several locations along the test section. The same condition, though to a lesser degree, existed outside the right shoulder.

Beginning of Ballast Settlement Outside  
Stabilized Shoulder - July 1974  
Fig. F-4

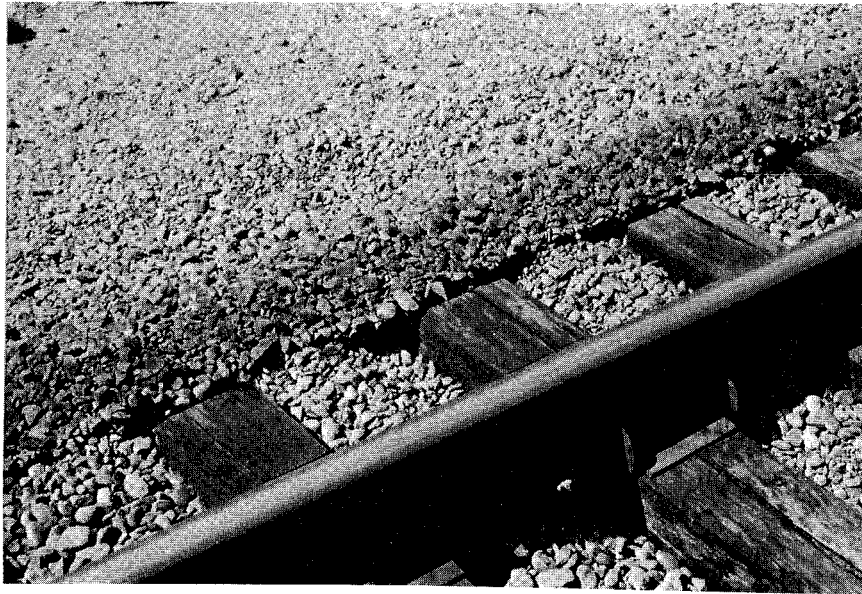
Ballast Migration Along Inside Edge of  
Stabilized Shoulder - July 1974  
Fig. F-5

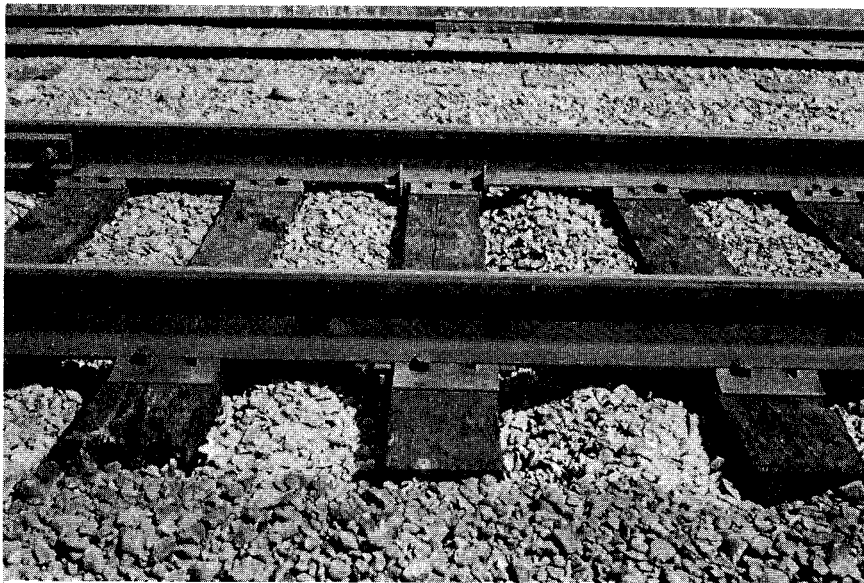
First Sign of Back and Forth Tie Movement  
- July 1974  
Fig. F-6

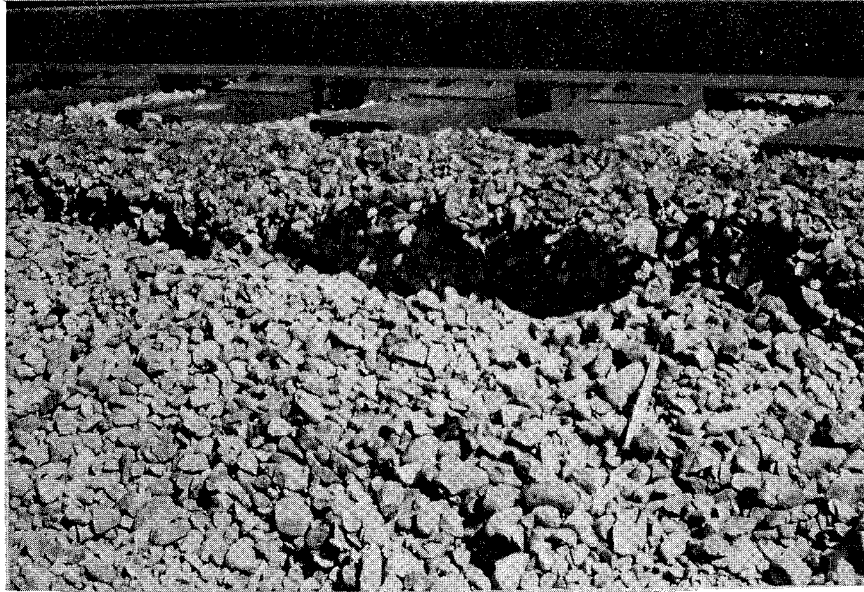
The July 1975 inspection revealed that the conditions observed during the 1974 inspection had become worse. The maximum amount of ballast slump at one location outside the left shoulder was 7 in. (178-mm). Numerous locations outside both shoulders showed slumping of from 2 to 5 in. (51 to 127 mm). At the location of the 7-in. (178-mm) slump, some ballast was removed from under the stabilized portion of the shoulder. This ballast was loose and easily removable. Ballast particles in the stabilized portion of the shoulder were firmly bound together and the exposed binding material at the top of the shoulder had hardened due to weather. At this location the stabilizing material had cured to a depth of 7 to 8 in. (178 to 203 mm).

Settlement of Ballast Outside of Stabilized  
Shoulder - July 1975  
Fig. F-7

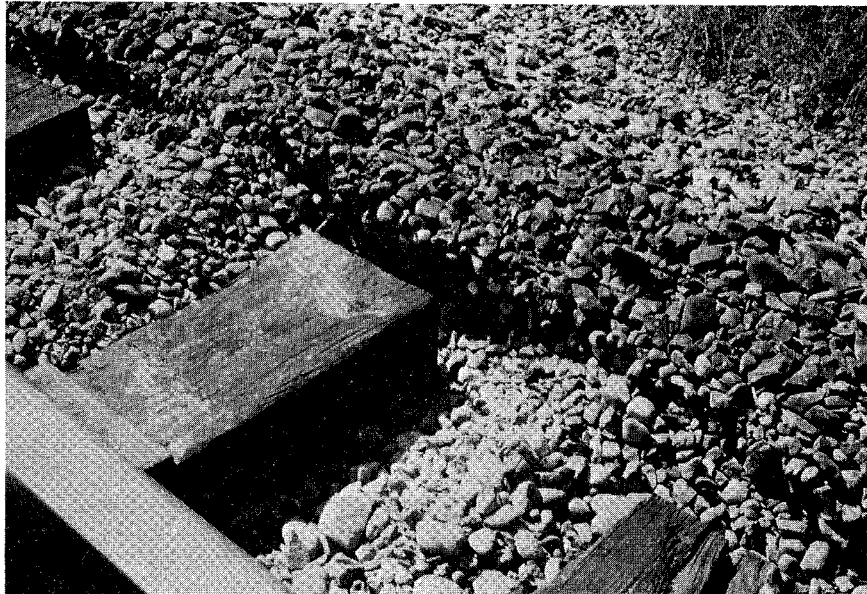
Migration of Ballast Inside of Stabilized  
Shoulder - July 1975  
Fig. F-8

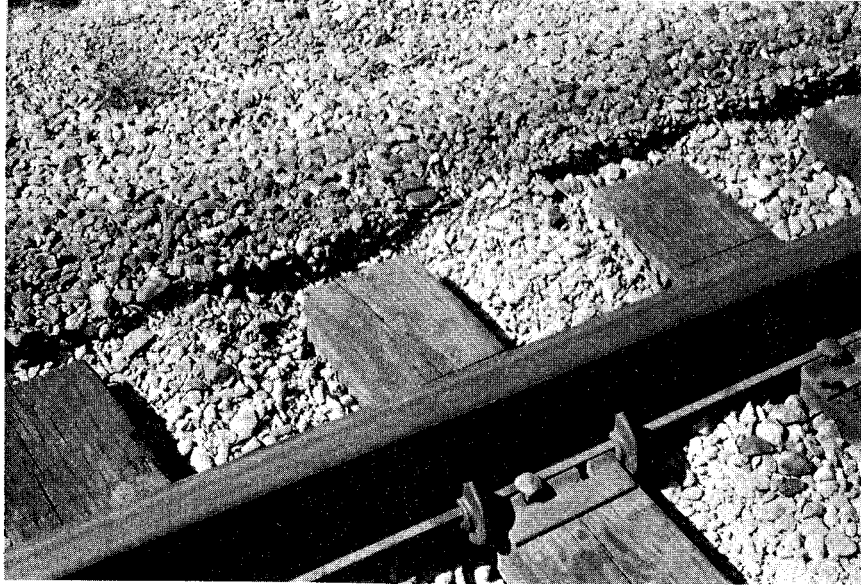
Ballast Movement Inside of Stabilized  
Shoulder - July 1975  
Fig. F-9

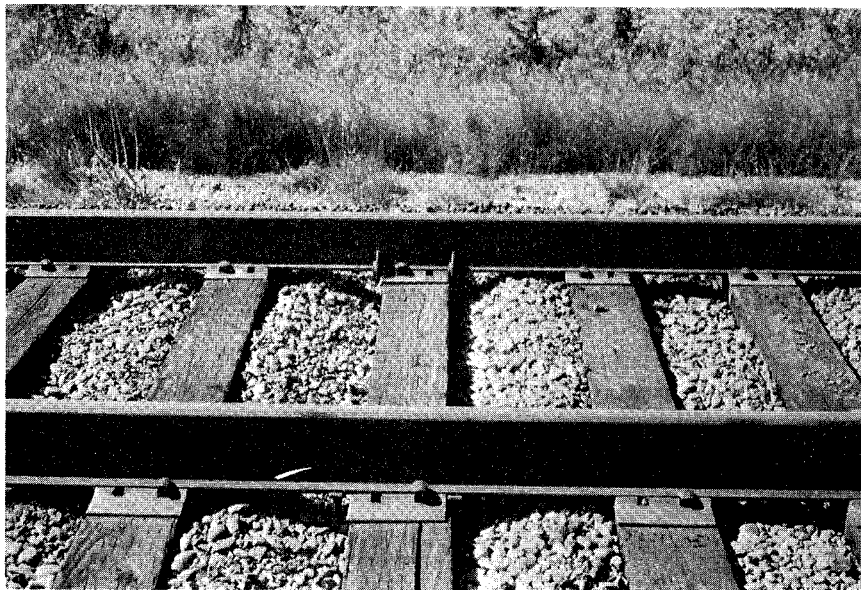
Signs of Back and Forth Tie Movement  
- July 1975  
Fig. F-10

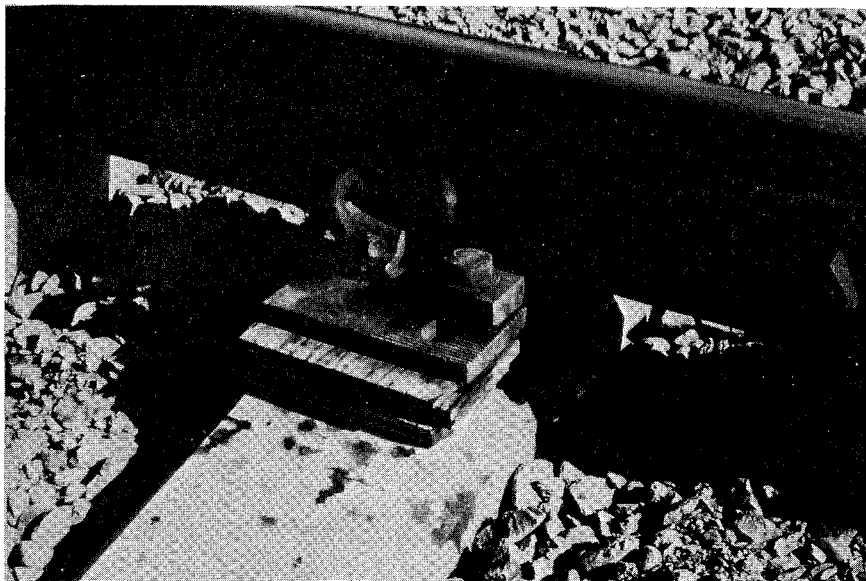
2¼ in. Shimming Used During 1975-76 Winter  
Fig. G-2
