Report No. FRA-OR&D 75-30

# FRAGMENTATION AND METALLURGICAL ANALYSIS OF TANK CAR RAX 201

APRIL 1974  
FINAL REPORT

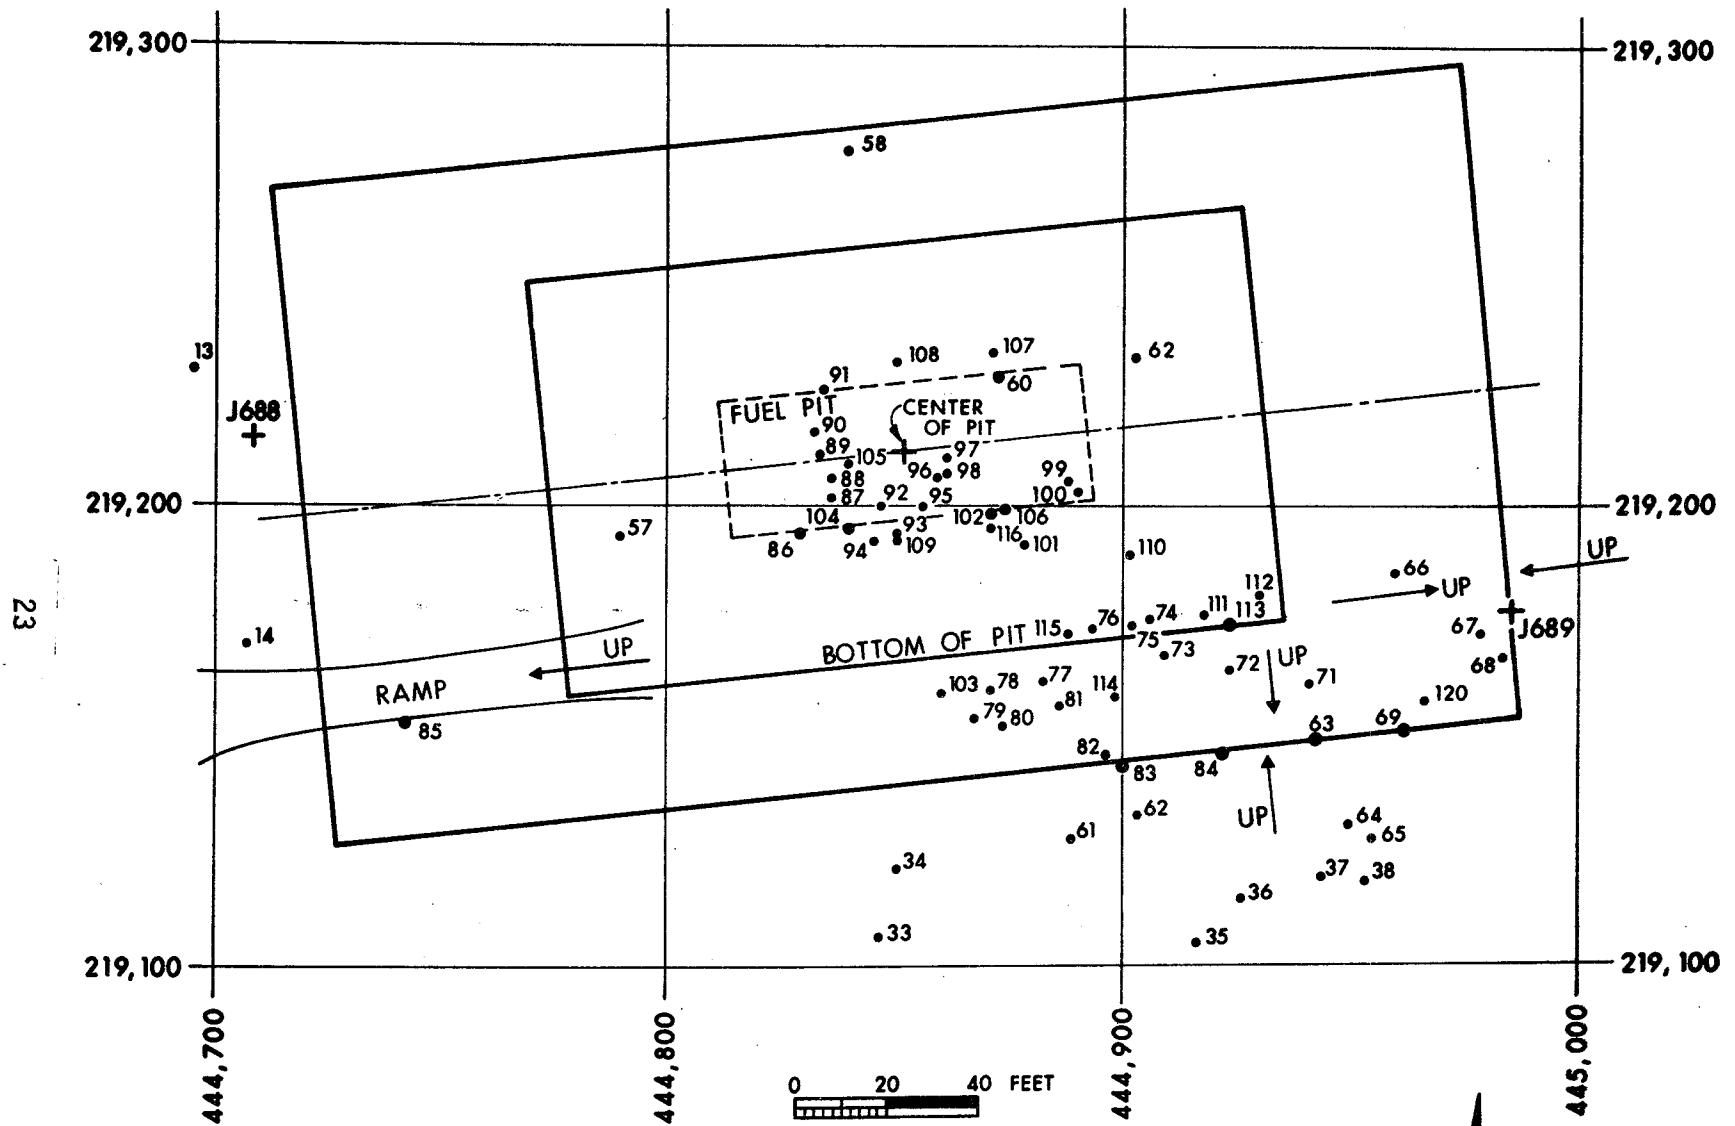
Figure 4 - Fragment Locations for Rupture of RAX 201 within Test Pit Area

occupy a finite area, so the distance measured between two points naturally depends upon where the survey stakes were placed relative to the fragments. The most distant fragment (Item 47), a large piece of the catwalk, was hurled 407m (0.25 miles) from the center of the pit.

SwRI began their examination in the test pit, the major fragments of interest being Item 76 (a portion of the tank car shell), Item 58 (a portion of one ellipsoidal head plus a piece of the shell), and Item 114 (the added manway which contained the back-up Louisiana Tech relief valve plus some of the surrounding shell).

Item 15 (a portion of an ellipsoidal head), and Item 16 (a portion of the shell), were found out of the pit to the west. These fragments were 104.2m (342.0 ft.) and 112.9m (370.3 ft.) respectively from the center of the pit. Item 4 (essentially the remainder of the shell) was out of the pit 133.4m (437.7 ft.) to the southeast. The standard manway, Item 1, containing the Midland relief valve, was located between the test pit and Item 4, 94.5m (310.0 ft.) from the center of the pit. Items 7 and 9 were originally the other ellipsoidal head. These two fragments were out of the pit 145.7m (477.9 ft.) and 73.6m (241.5 ft.), generally to the south. Table III summarizes the major tank car fragments and their distances from the center of the excavation.

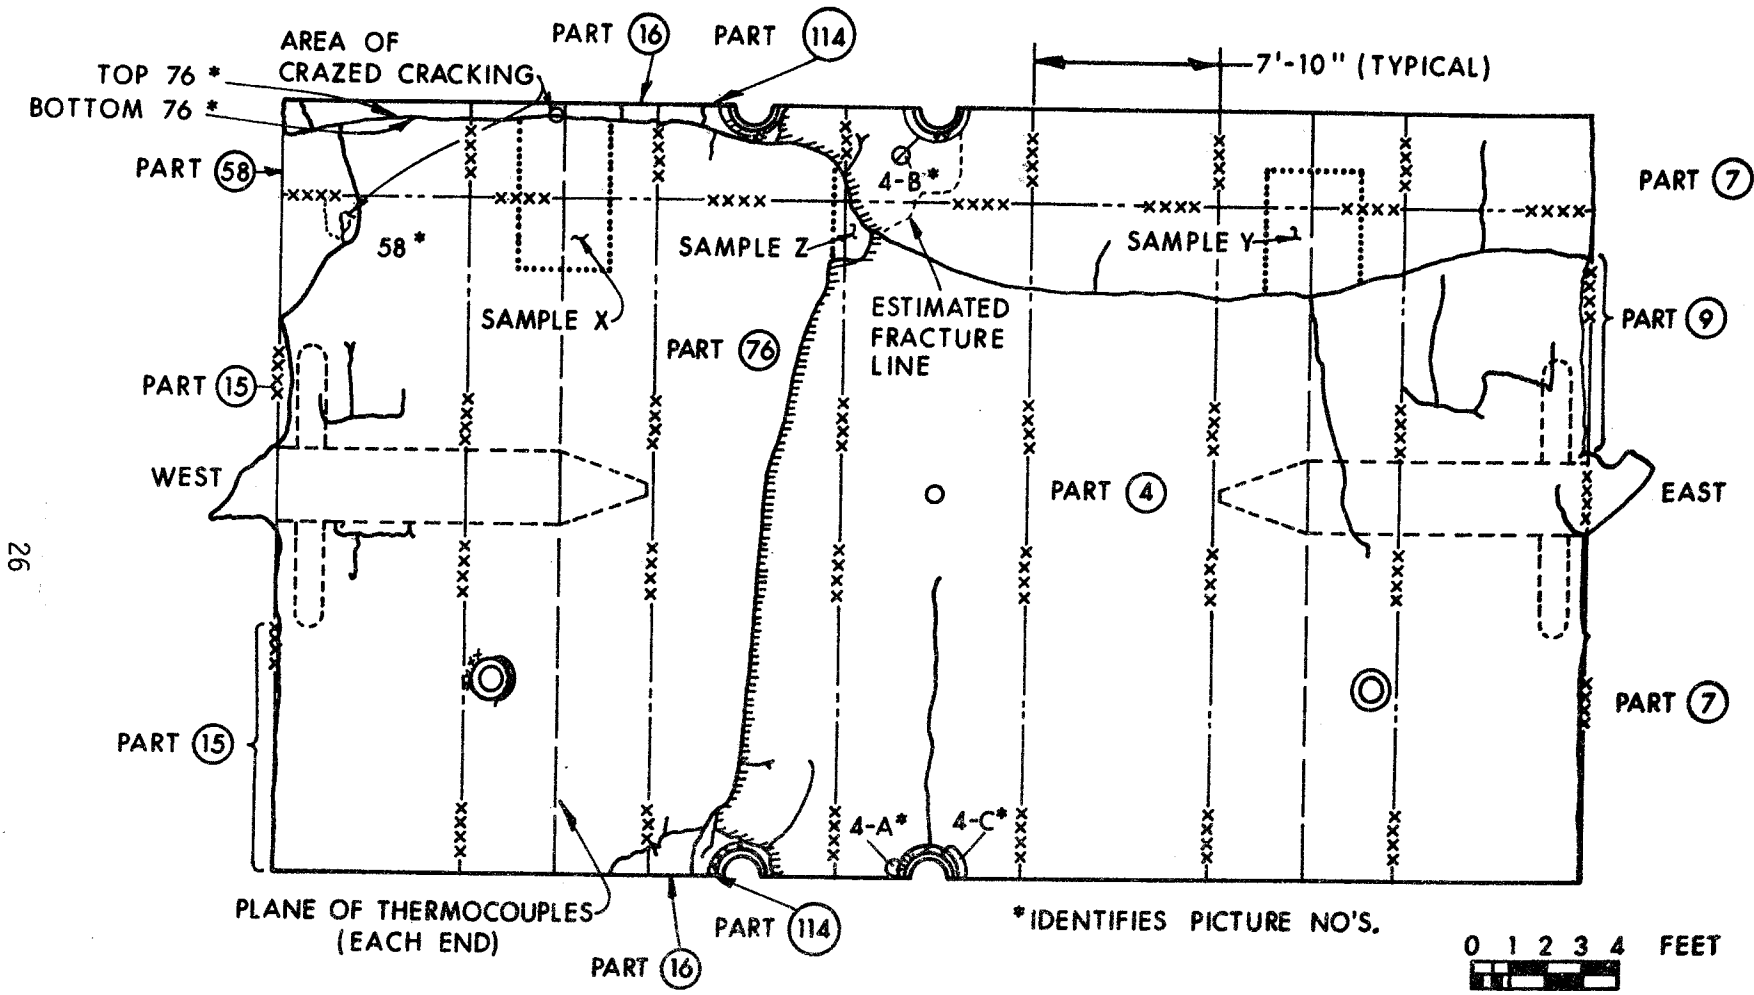
Figure 5 - Fragments of Ruptured Tank Car Assembled as They Existed Before Rupture

By mapping the fracture paths in detail, SwRI was able to reconstruct the tank car on paper. Hence, it was concluded that Items 58 and 15 came from the west end ellipsoidal head and had been attached to Item 76. Items 7 and 9 came from the east end ellipsoidal head and had been attached to Item 4. Figures 5, 6, and 7 map out the fragment parts as they existed before the rupture. A description of each of the major fragments of the tank car is given below.

Item 76: The fracture paths bore no relationship to the long seam weld or the girth welds except that Part 76 separated from the associated ellipsoidal head very close to the shell-to-head weld for about one-half of the circumference. With the exception of one 15.2 cm (6.0 in.) long zone, all fractures were of the 45° full-shear type accompanied by some thinning typical of fast ductile fracture in a thin steel plate. The 15.2 cm (6.0 in.) long zone referred to above was located along the longitudinal fracture about 3.5m (11.5 ft.) from the head-to-shell weld. This zone was photographed, and its

These conditions are characteristic of a stress-rupture failure under the conditions of loading which existed and therefore, this zone is a prime suspect as the fracture initiation point.

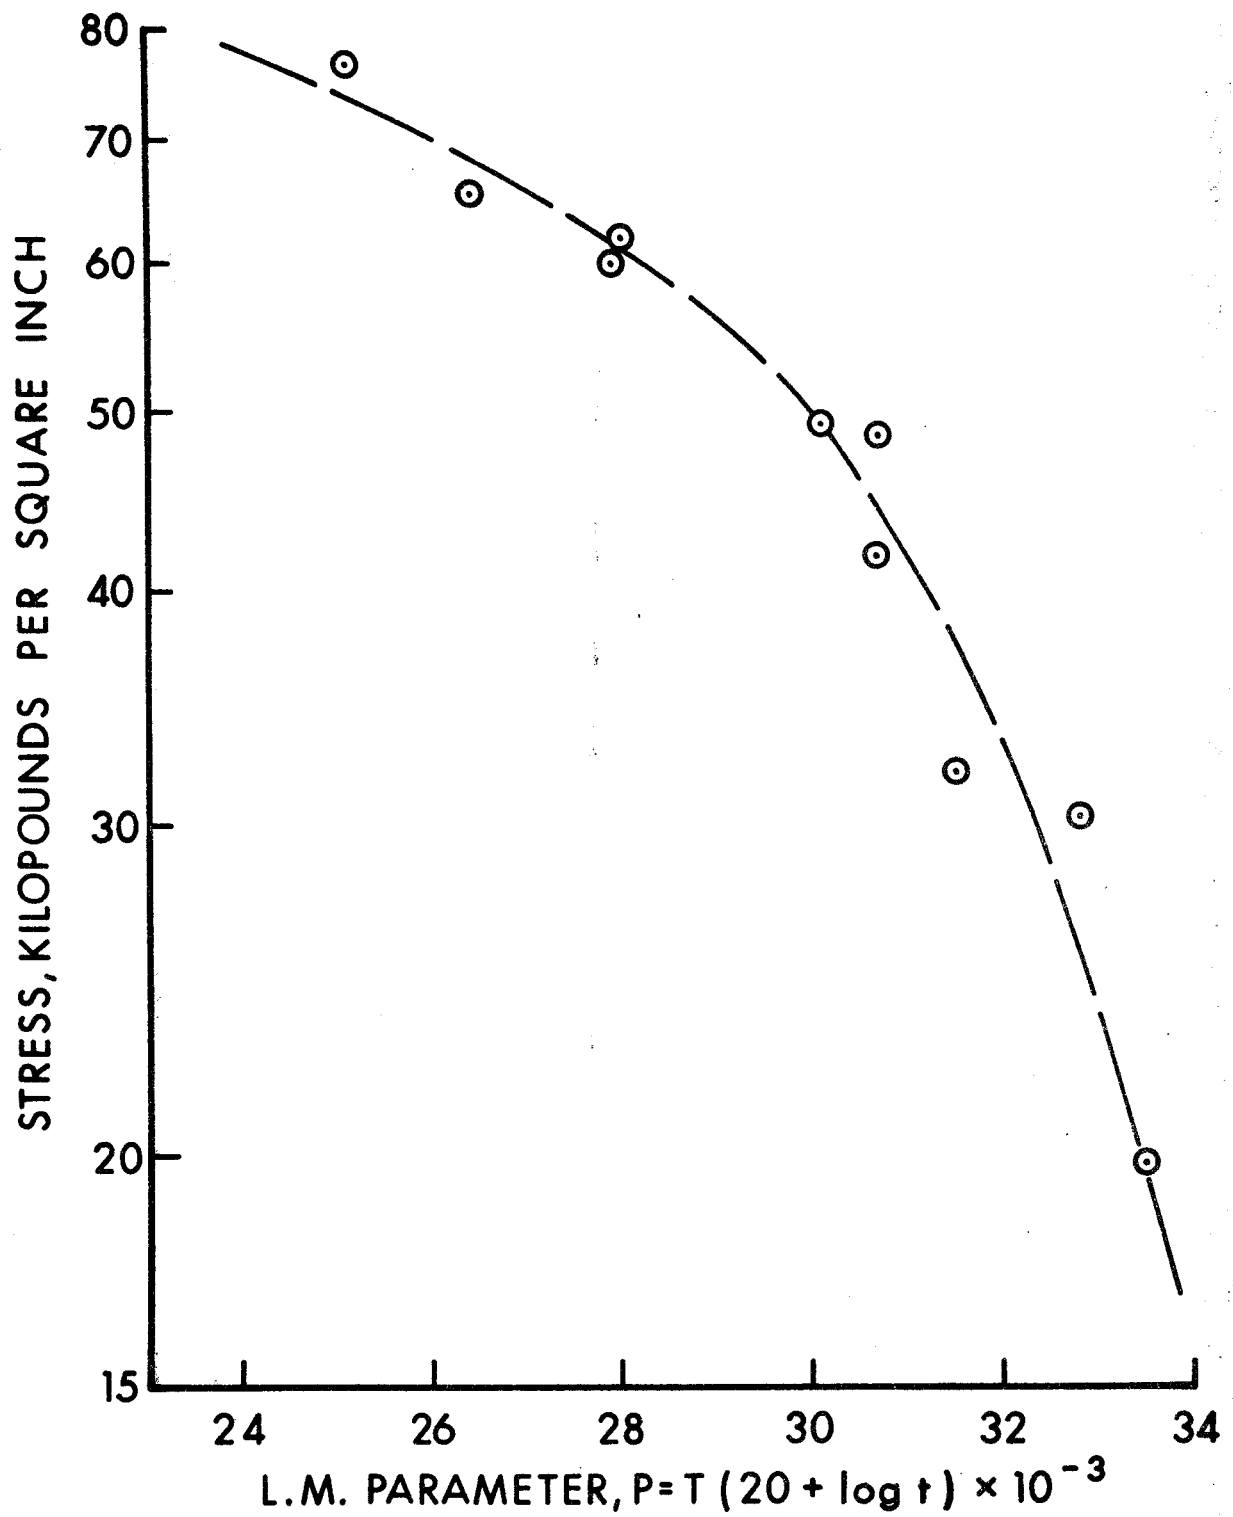
**Figure 8 - Parametric Analysis of Tensile and Stress Rupture Data**

The tensile data were plotted at an assumed life of 0.03 hours and the stress-rupture data were plotted at their actual rupture lives in Figure 8.

The Larson-Miller curve, Figure 8, was used to predict the stress-rupture strength of the tank car material at several combinations of temperature and rupture life as shown in Table V. These data are converted with the hoop stress formula,

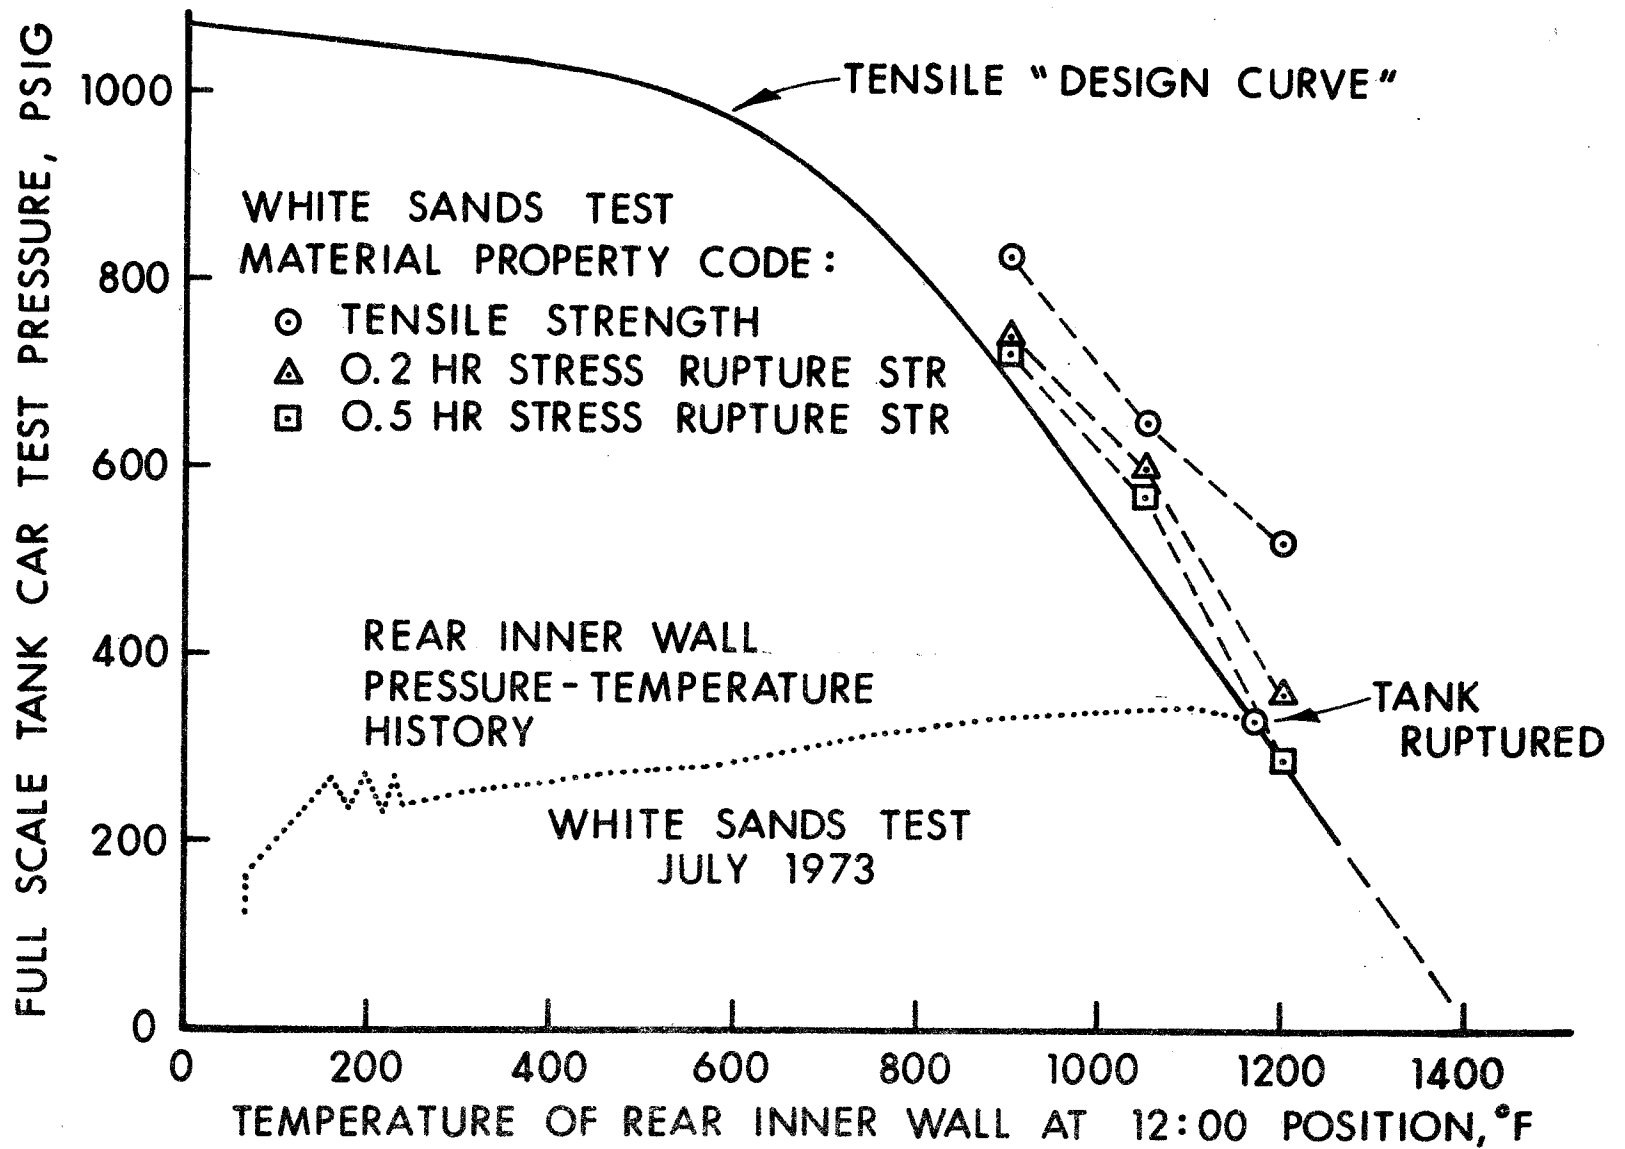
Figure 9 - Comparison of Test Conditions  
with Material Properties

Examination of Figure 9 indicates that the tensile strength of the tank car was higher than the "design" curve. In addition, the time dependence of high temperature strength properties reduces the pressure at which tank rupture would be predicted. Note that the tank car ruptured just below 650°C (1200°F) at a pressure stress equivalent to the predicted 0.5 hour stress-rupture strength of the tank car material. All evidence thus confirms the original conclusion that the material failed by stress rupture.

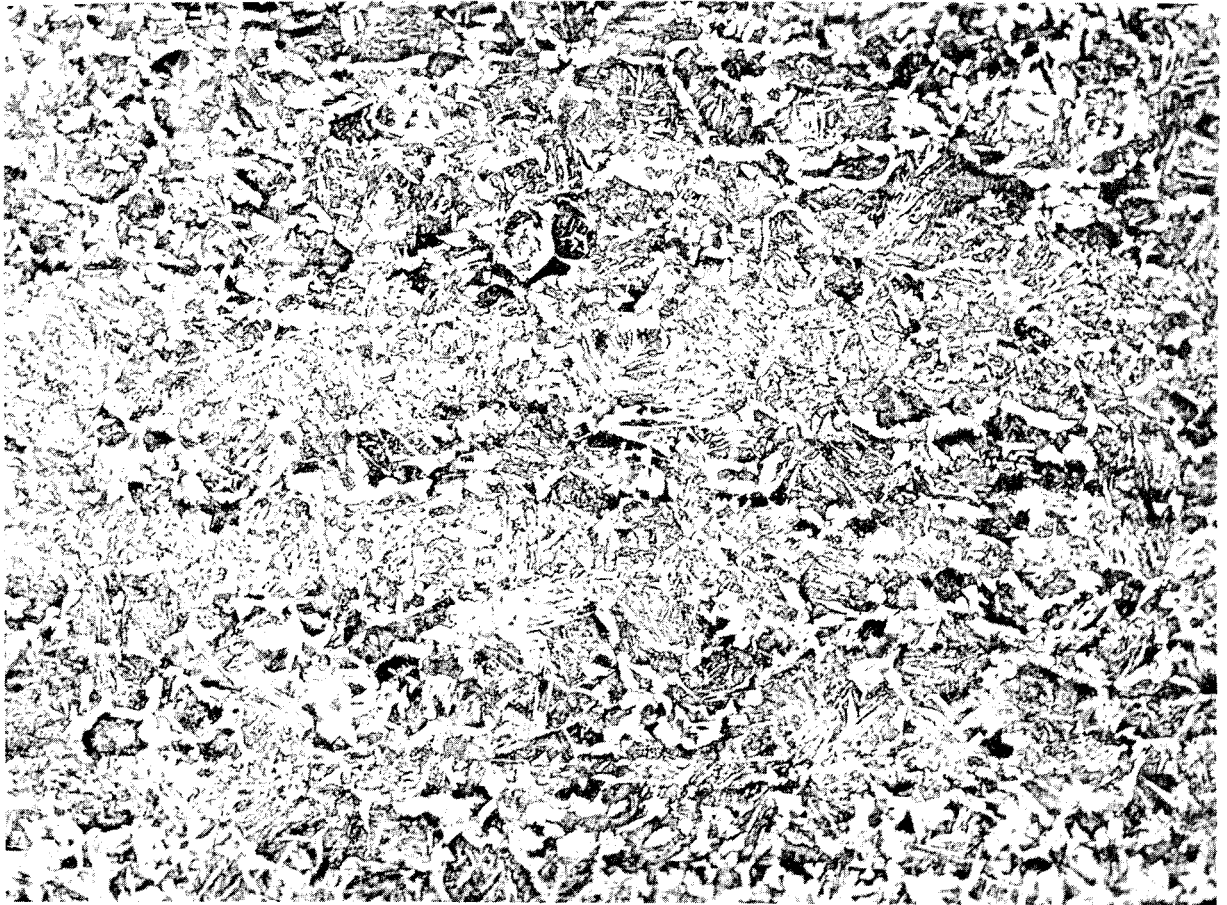
Figure 10. Typical Microstructure of Tank Car Material

The metallurgical examination of the suspected fracture initiation area revealed that the general microstructure was pearlitic plus blocky ferrite, Figure 10. An unexpected observation was the presence of a thin layer, 0.102 cm (0.040 in.) maximum, of an acicular microstructure (see Figure 11) on the inside diameter tank surface where the fracture was thought to have initiated. A hardness traverse across this layer into the normal microstructure (Table VII) indicated that the layer had been tempered at a high temperature after it was formed, indicating that it was formed before the fire test. No evidence of this condition was found at the other end of Sample X where the tensile/stress-rupture specimens were located.

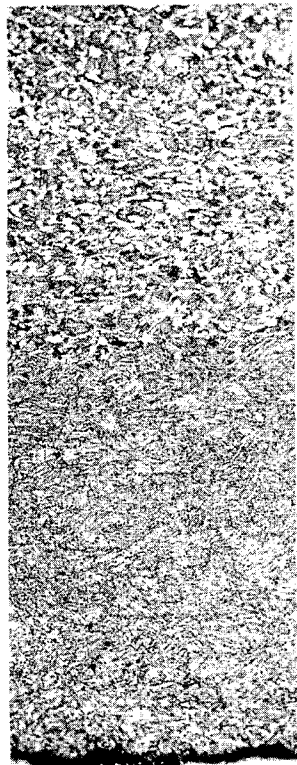
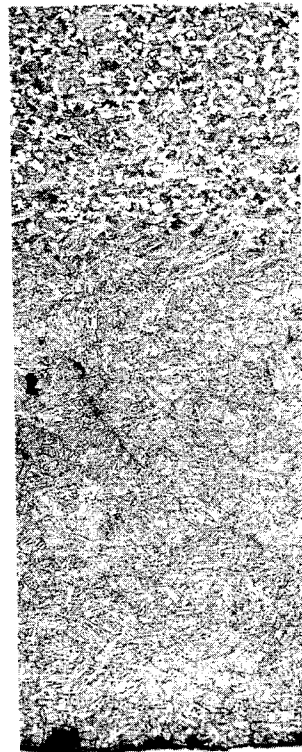
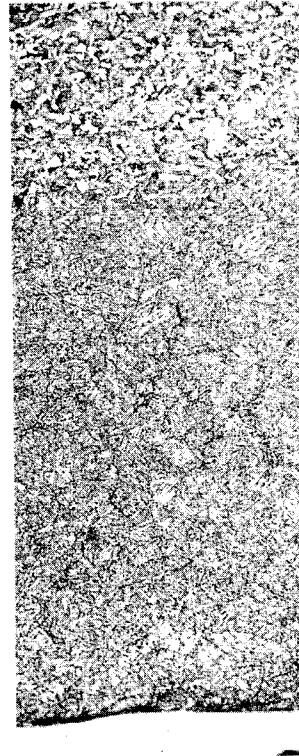
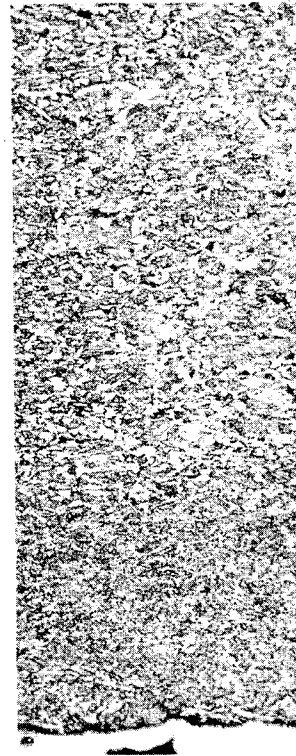
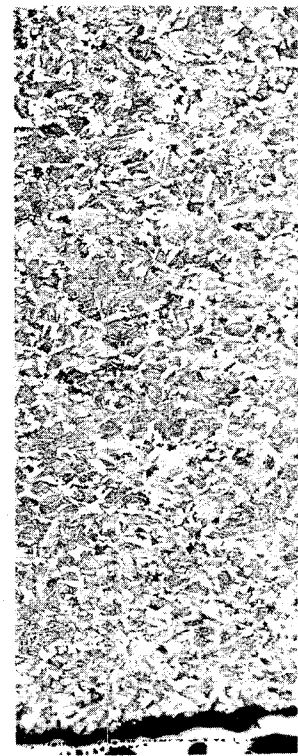
Figure 11. Variation in Depth of Acicular Microstructure  
Along Fracture at Suspected Initiation Site (I.D.Surface)

The acicular type of microstructure is produced by heating above 732°C (1350°F) followed by relatively fast cooling. Considering the conditions existing during the tank car test, it is difficult to imagine how a thin layer on the inside diameter surface would reach a higher temperature than the body of the steel. In consideration of this and the hardness traverse data, it appears unlikely that the layer was produced during the test. One can only assume, therefore, that the condition existed in the steel plate as received, or that it was produced during tank car fabrication or tank car instrumentation. Since the spot appears to be quite limited in extent, one possible explanation would be a rapid, localized heating from the inside diameter surface with a torch, such as might have been used in the application of the copper beads (which were installed on the inside walls to house the thermocouples) or bracket mounts (which were installed for the pressure gauges and grid network).

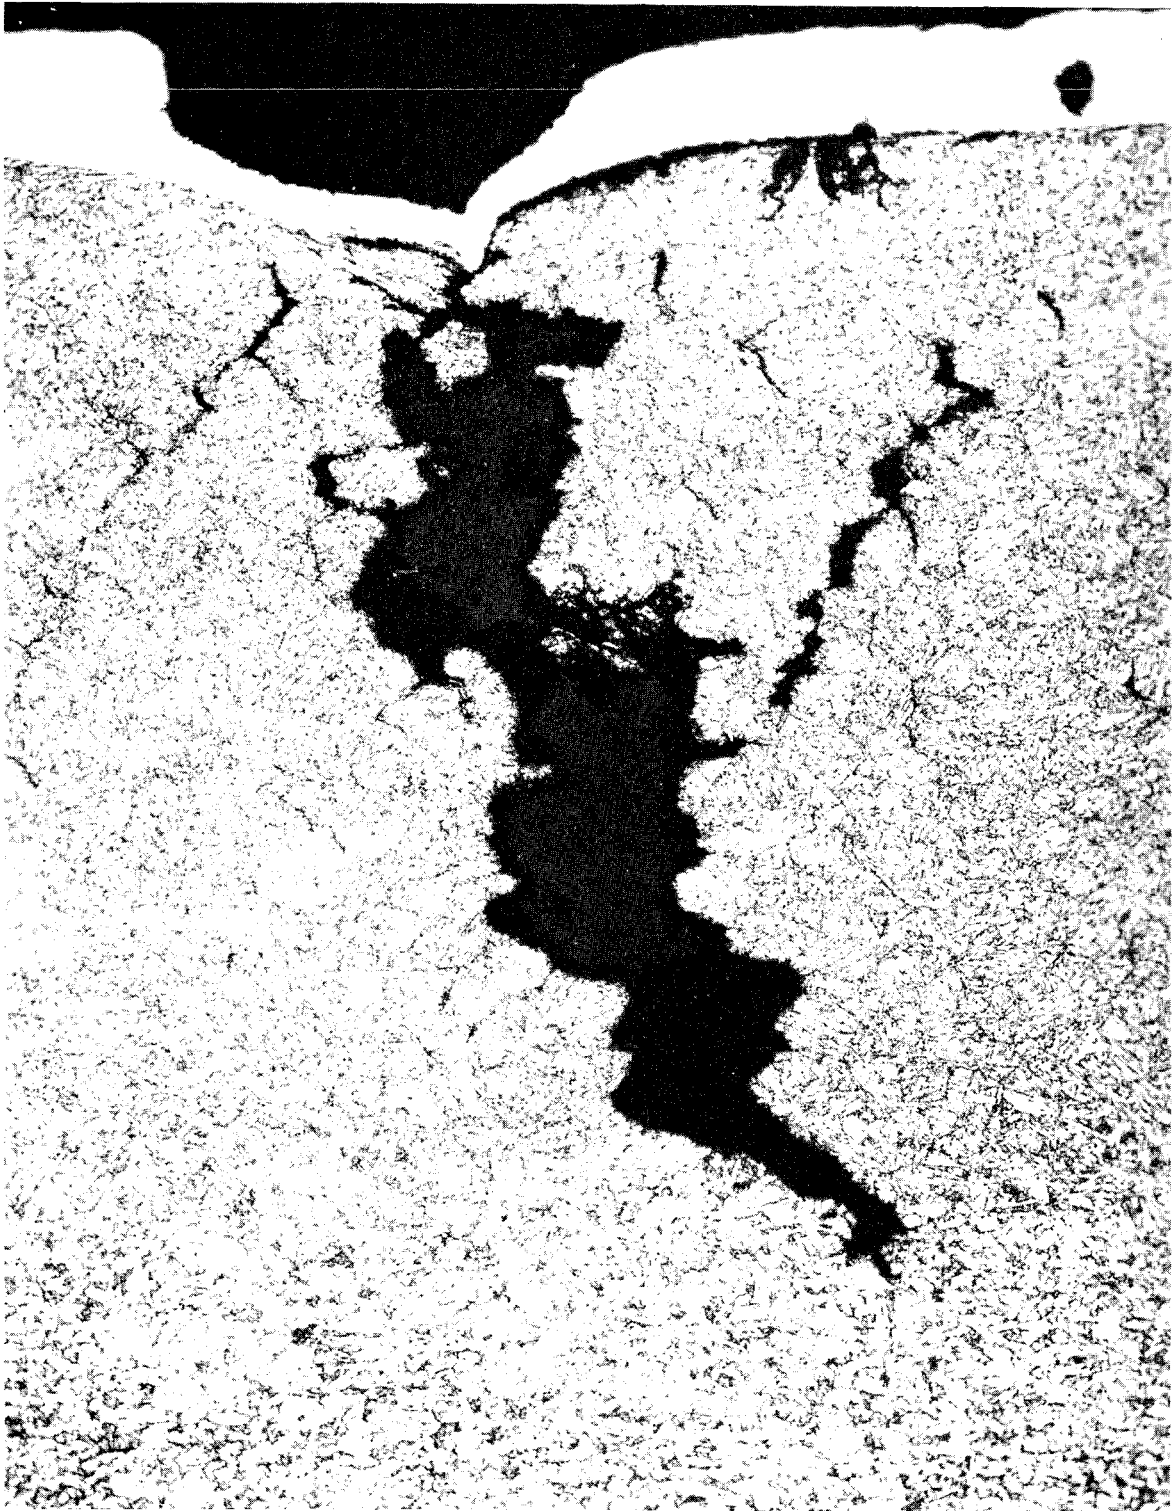
Figure 12. Secondary Crack on Tank Car I.D. Surface Arresting at Microstructure Interface

The tank car fracture appeared to initiate within the acicular microstructure; in fact, several secondary cracks were observed to arrest at the boundary between the acicular and normal microstructures, Figure 12. However, based on limited stress-rupture data, the normal material would have failed by stress rupture in a rather short additional time had the acicular layer not been present.
