U.S. Department  
of Transportation  
**Federal Railroad  
Administration**

## **Conrail Electronically Controlled Pneumatic Brake Revenue Service Test**

November 1997  
Letter Report

This letter report, prepared by the Association of American Railroads (AAR), Transportation Technology Center (TTC), Pueblo, Colorado, covers the final report on the Conrail Electronically Controlled Pneumatic (ECP) Brake Revenue Service Test. The test report written by Conrail is attached. The Conrail revenue service ECP brake test was intended to investigate the possible benefits of ECP brakes. Mechanical repairs and energy consumption were tracked on the ECP train and on a nearly identical train in the same service (this train is referred to as the "placebo" train in the Conrail report). This report will also include the latest information on the ongoing Burlington Northern Santa Fe (BNSF) revenue service testing.

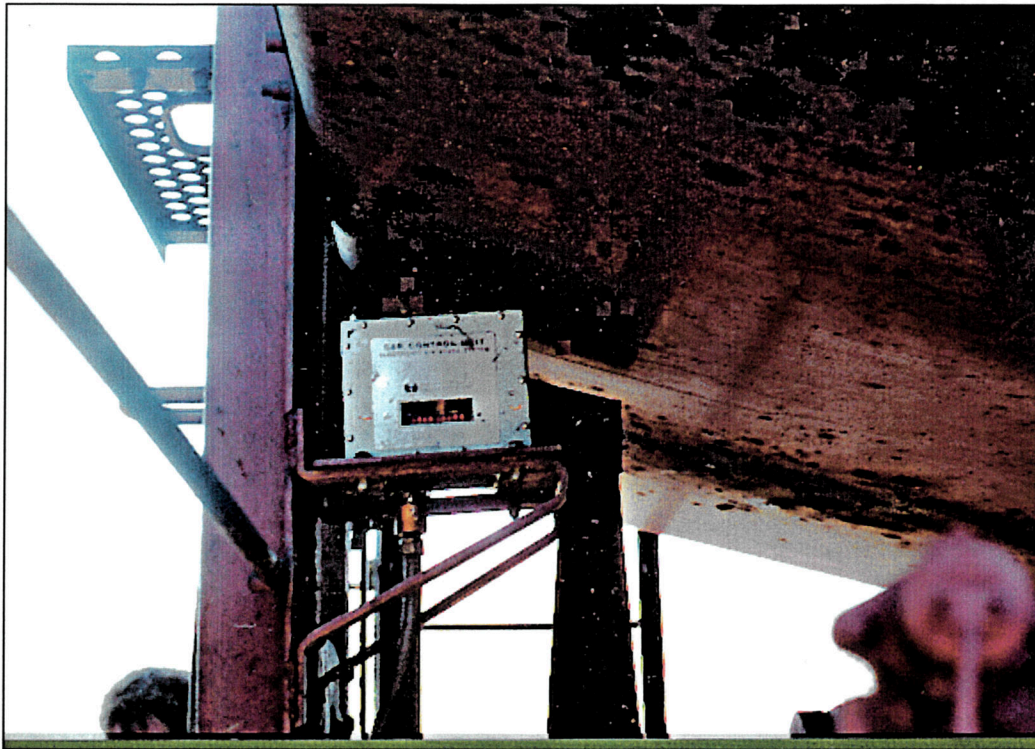
CCDs suffered a high failure rate during this test. This is again unlike testing on other railroads, where CCD reliability has been much higher than expected. The high-failure rate on Conrail could be attributed to two related factors: (1) CCDs produced over a certain time period had incorrectly assembled circuit boards. All of these CCDs were on the Conrail test train, and (2) these CCDs failed when they were subjected to high coupling forces when emptied cars rolled out of the car dumpers and impacted standing cuts of other empty cars. The mounting location of these CCDs was on a shelf bracket welded to a vertical structural post between the center sill and the slope sheet (Figure 1). This subjected the already defective CCDs to considerable shock and vibration, resulting in early CCD failure. As a result of this experience, the performance specification for ECP brakes, AAR Specification S-4200, has been modified.

**Figure 1. CCD Mounting on Conrail Coal Hopper**

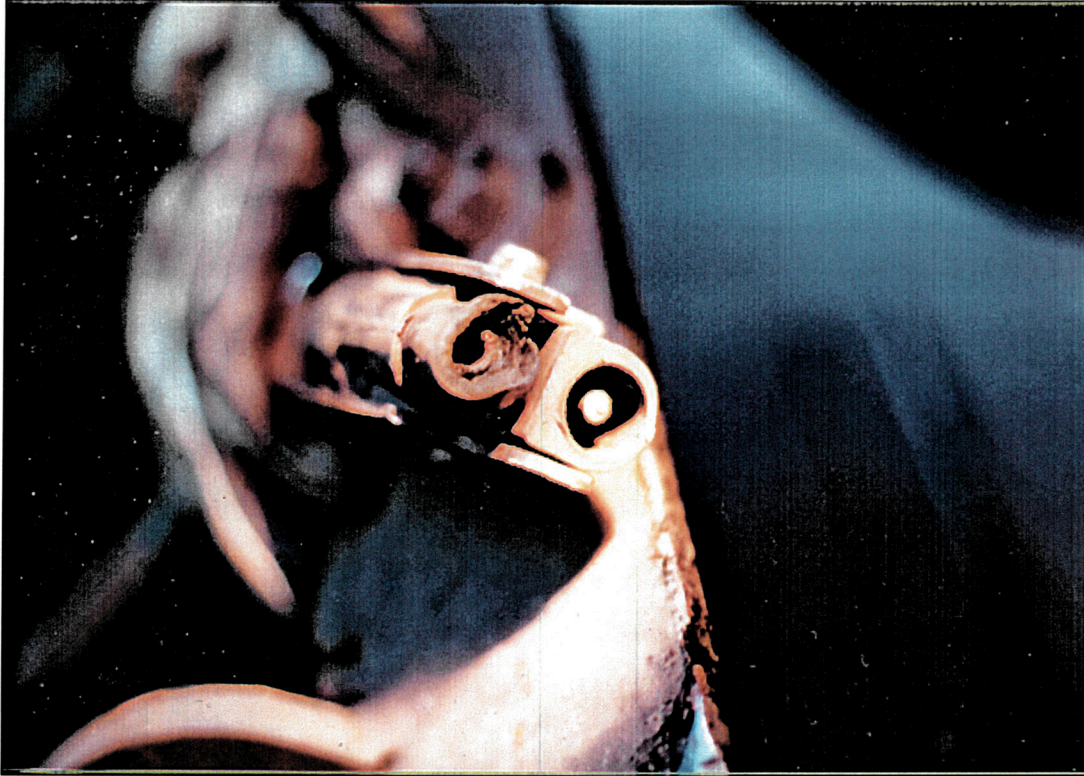
One of the primary problems with the Conrail test was the percentage of time that the ECP train was forced to operate as a conventionally braked train. It was hoped at the start of the test that the ECP train could be compared with the conventional train, but the ECP train ran in ECP mode only 73 percent of the time. Thus the wheel savings shown in the maintenance data was only an indication of what might have been experienced if the ECP train had operated at 100 percent in the ECP mode. Some causes for conventional operation were lack of ECP equipped locomotives, lack of trained crews, and the abnormally high CCD failure rate. Another problem was the reliability of the temporary train line connectors used in this test. These connectors had no positive latching mechanisms, and after numerous uncouplings, they began to cause problems. Figure 2 shows one of these connectors. The connector designs adopted by the AAR are expected to solve these connector problems (Figure 3).

**Figure 2. Failed Connector on Conrail**

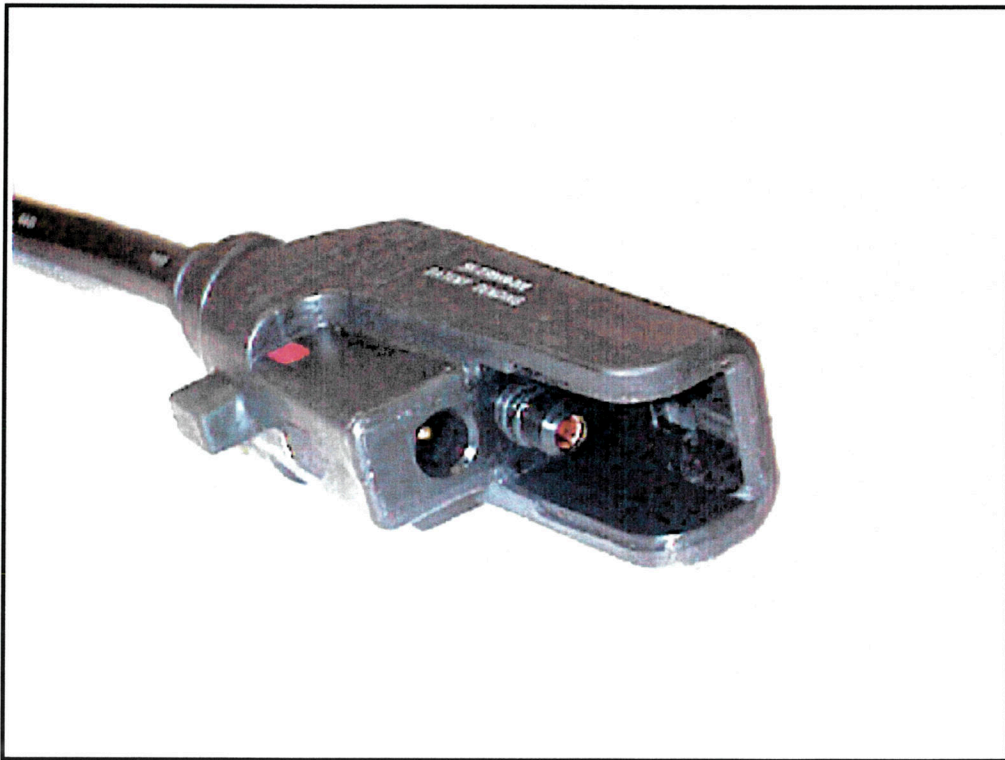
**Figure 3. Connector Design adopted by the AAR**

The Conrail test was constructive, but not as effective as initially envisioned. Due to the high percentage of time that the ECP train operated in the conventional mode, and due to the unexpected manufacturing problems which contributed to a high CCD failure rate, some of the maintenance data is tainted and unreliable. There is a positive trend in wheel replacements due to brake related faults. And as a result of this test, the vibration and shock requirements in AAR Specification S-4200 were improved. This test also reinforced the need to select, as an AAR standard, a train line connector with a positive latching mechanism and a quick and reliable means of making field replacements of damaged connectors.

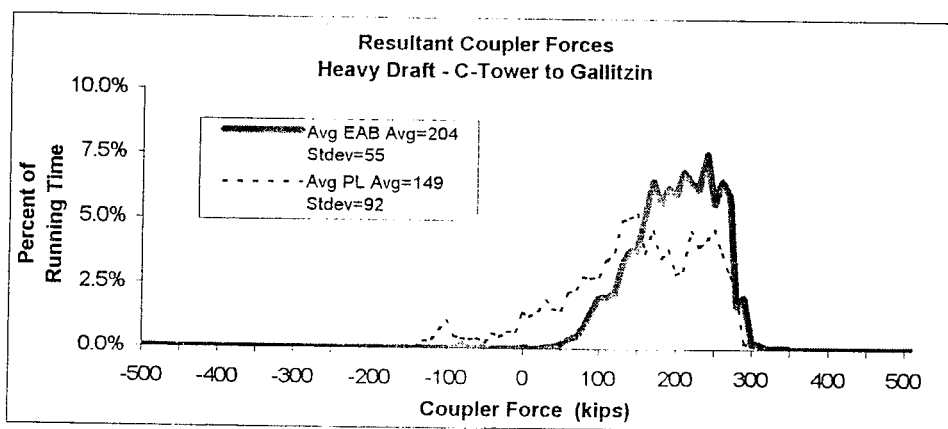
Figure 10 Head-end forces, heavy draft.

buff and draft operations were analyzed. Referring to the elevation information of Figure 3, two segments of the eastbound trips were used to provide this comparison, the uphill run from C-Tower to Gallitzin, and the downhill segment from Gallitzin to Rose. Coupler force data were compiled in a histogram format whenever the train speed was greater than two miles per hour. The coupler force data in the histogram could range from -500 kips (compressive, buff forces) to +500 kips (tensile, draft forces) in 10 kip increments. Used for the comparative analysis were six EABS test runs averaged to represent a typical ECP train, and five placebo test runs averaged with one EABS test run that operated in conventional braking mode to represent the typical placebo (PL) train. Each of these trains were aided up and over these segments by a pair of helper locomotives on the rear of the train. Additionally, the collected histogram data were converted from counts per cell, to a percentage of total counts recorded. This normalization process provided a direct comparison between the trains and illustrates the distribution of the head-end coupler forces while the train is in motion. The resultant, normalized histograms are illustrated in Figures 10 and 11 for the draft and buff operations, respectively.

Among the anticipated benefits of the ECP brake system is improved train handling resulting in reduced costs of equipment, track, roadbed, lading, and collateral damage.<sup>4</sup> The resultant coupler forces illustrated in Figures 10 and 11 indicate that the EABS trains did have less variation in dynamic coupler action than did the placebo trains. However, one must be cautious in the interpretation of these data. The data collected cannot be used to describe the influence that the helper locomotives had on the train dynamics, and the EABS trains regularly had more braking and tractive effort available to control the train. Three SD-60M locomotives always powered the EABS trains while two locomotives powered the placebo trains. The effect of the additional tractive and braking effort can be seen in these figures by the higher average draft and buff forces, respectively.

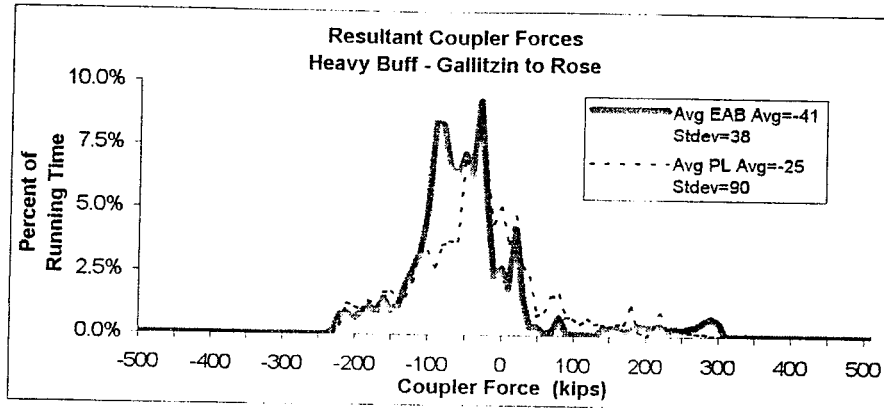
**Figure 11 Head-end forces, heavy buff.**

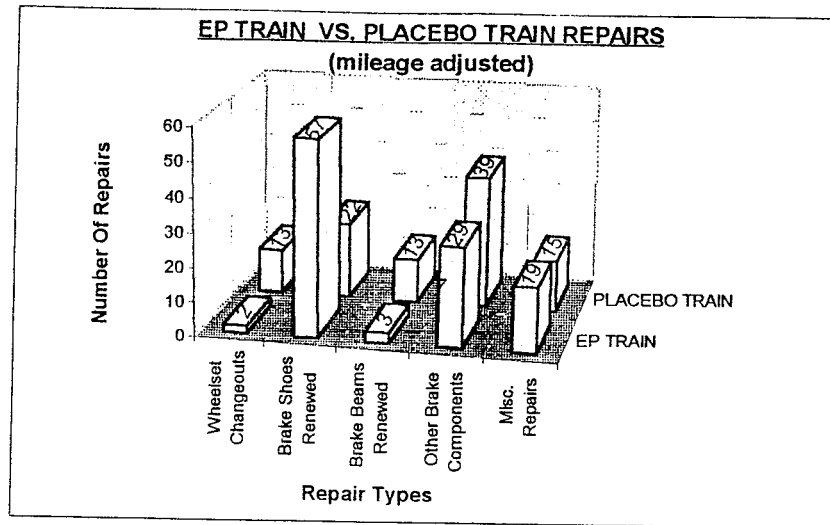
**Figure 12 Mileage adjusted repair requirements.**

As seen in Figure 12, the wheel change out rate on the EABS equipped cars was much lower than the cars of the placebo train. When adjusted for mileage, the EABS equipped train had two sets of wheels replaced versus thirteen wheel sets for cars of the placebo train. It is worth noting that the two wheel sets changed on the EABS train were from a single car reported to have slid flats caused by a dragging hand brake. Regardless of the braking technology, human error is still present.

The placebo train required four times as many brake beam replacements than did the EABS train during the test period. Most of the brake beams were replaced due to a burnt brake head. However, it is not clear why the conventional brake system would result in more burnt brake heads. This finding appears to be inconsistent with observations made during tests on other railroads.

The repair data suggest that brake shoes wear out much faster on cars in an ECP train than those in a train with conventional air brakes. Nearly a threefold number of brake shoes required replacement on the EABS cars when compared to the cars of the placebo train. It may be attributed to the fact that the train crews had a tendency to use the EABS brake more frequently as it provided better train control than a conventional brake system. This statement is supported by the additional braking witnessed during the in-train evaluation among the eastern segments of the route.

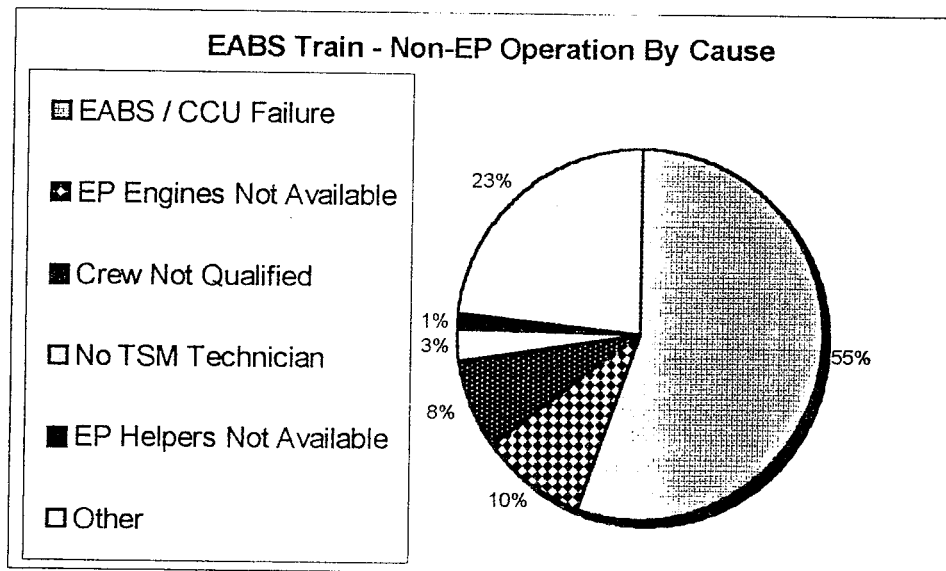
During the test period, two problems developed on the EABS train involving the brake system's CCUs. Some units would unexpectedly lose power and terminate their communications with the Head End Control Unit located inside the cab of the lead engine. This first problem started from the beginning of the test, and in association with failing CCUs, brake lock-up problems were reported on three cars with faulty CCUs.

**Figure 13 Reason for non-EP operation.**

vertical pillar (end post) which extended upward from the car's center sill to the top of the end slope sheet. Twenty-three CCUs had failed within the first two months of the test. This alarming failure rate was thought to be caused by improper potting of particular circuit components. The retrofitting of the existing CCUs with improved units for the test train was started on August 28. By September 19, all EABS test cars were retrofitted with the new units. Most of the fifty-two round trips were operated in full EP mode; however, the EABS equipment averaged an utilization rate of 73% after providing repairs to the CCUs. The graph of Figure 13 illustrates why the EABS train did not operate completely in electro-pneumatic mode. CCU failure continued to be a major reason for non-EP operation. Consequently, the AAR and TSM personnel conducted a series of
