U.S. Department
of Transportation
**Federal Railroad
Administration**

Evaluation of Damaged Tank Car Structural Integrity

1. Report No. DOT/FRA/ORD-88/02		2. Government Accession No.		3. Recipient's Catalog No.	
4. Title and Subtitle Evaluation of Damaged Tank Car Structural Integrity			5. Report Date January 1988

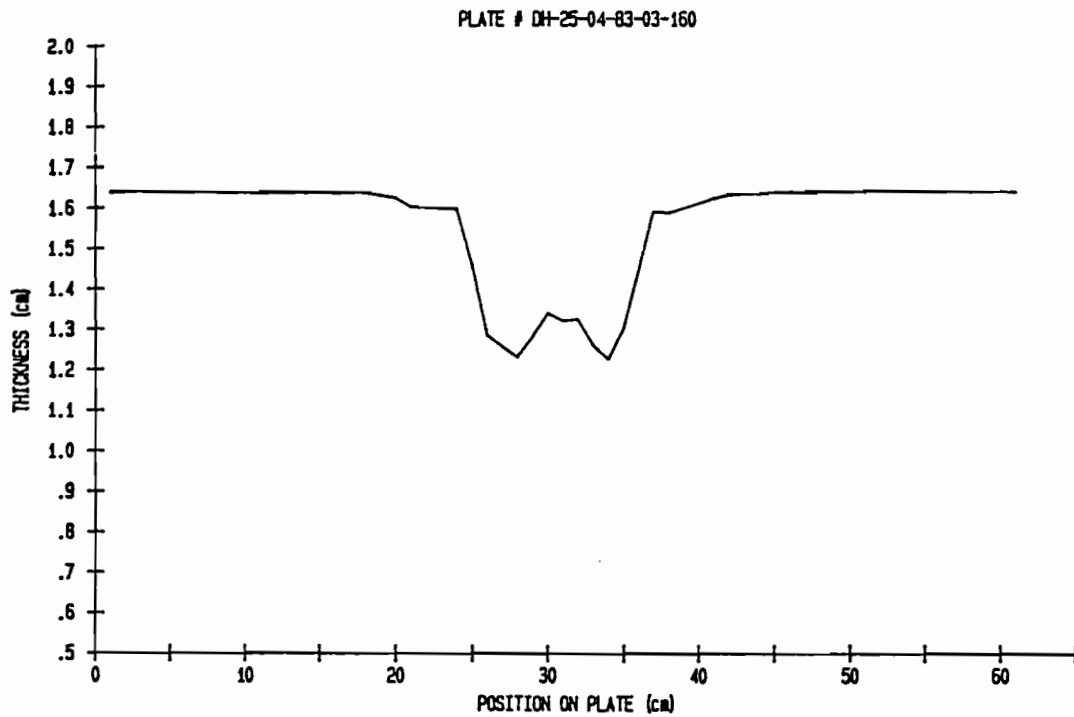
(a) Slightly damaged (dent depth of 2.78 cm).

(b) Dent depth of 4.28 cm.

Figure 1. Typical measurement of thickness vs. position, obtained by use of ultrasonic thickness gauge, for 3 BRL plates.

(c) Deeply dented (dent depth of 9.98 cm). The two lobes on this plot represent the areas of greatest thinning.
