**F R A
TASK ORDER #30A
WORK EFFORT 2
SHORT TERM TEST**

FINAL REPORT
Acquisition and Analysis
of
Wayside Acoustical Noise & Infrared Heat Signatures
associated with
Roller Bearing Defect Progression

SERVO CORPORATION OF AMERICA
111 New South Road
Hicksville, New York 11802

June 1989

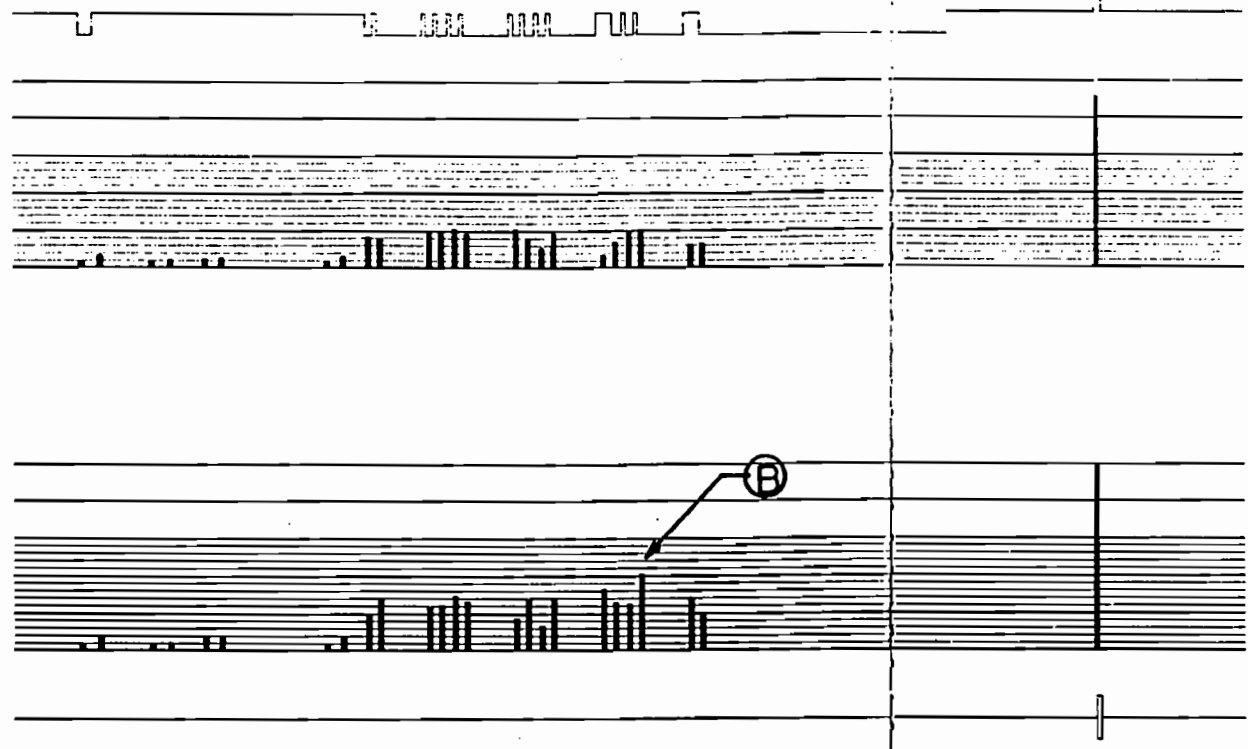
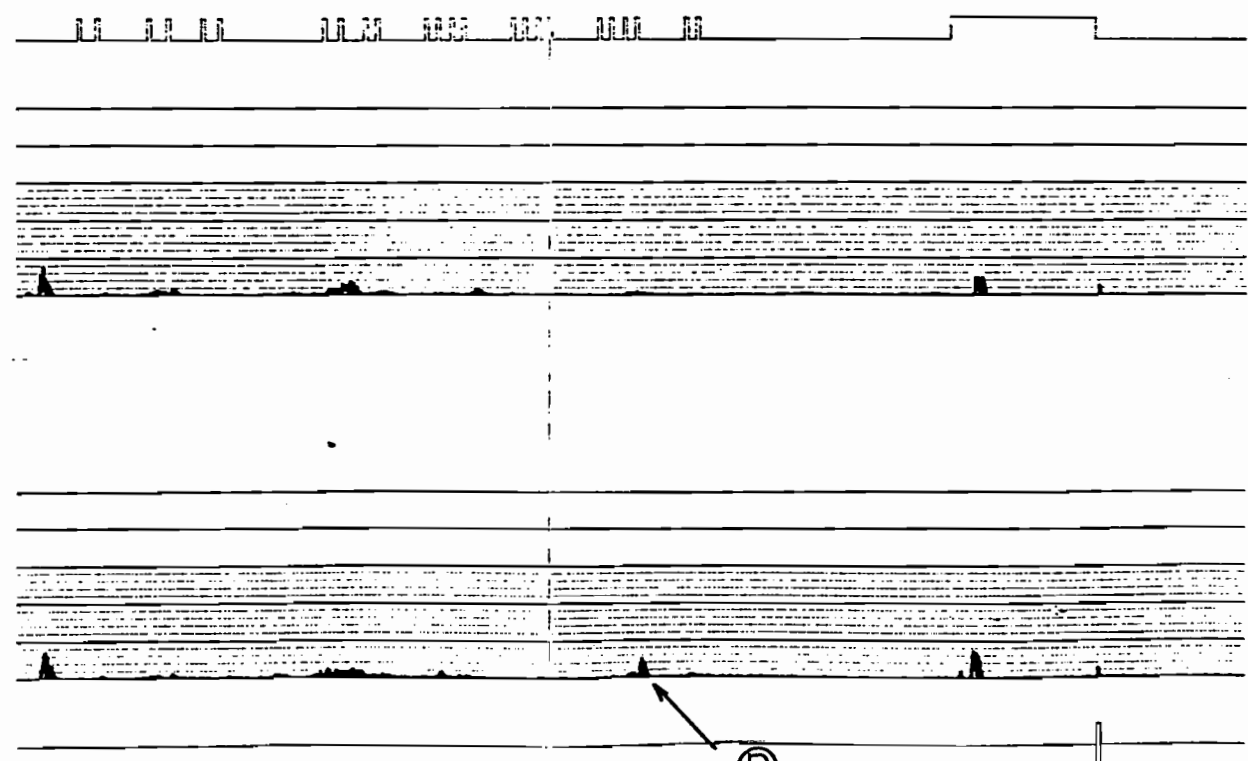
CHART 1

Normal direction around the RTT is counter-clockwise or Eastbound with severely defective bearings A and B outboard around curves and with signatures recorded on the lower group of the DATAGRAPHS. For the Westbound direction, locations are reversed.

BN ACOUSTIC DETECTOR
 MILEPOST 1310.8
 DATE 03/10/89 TIME 08:00
 TRAIN 2 DIRECT EAST SPEED 48MPH #AXLES 24
 NO ALARMS
 SELFTEST PASSED
 RAIL1 22.3MM RAIL2 25.1MM

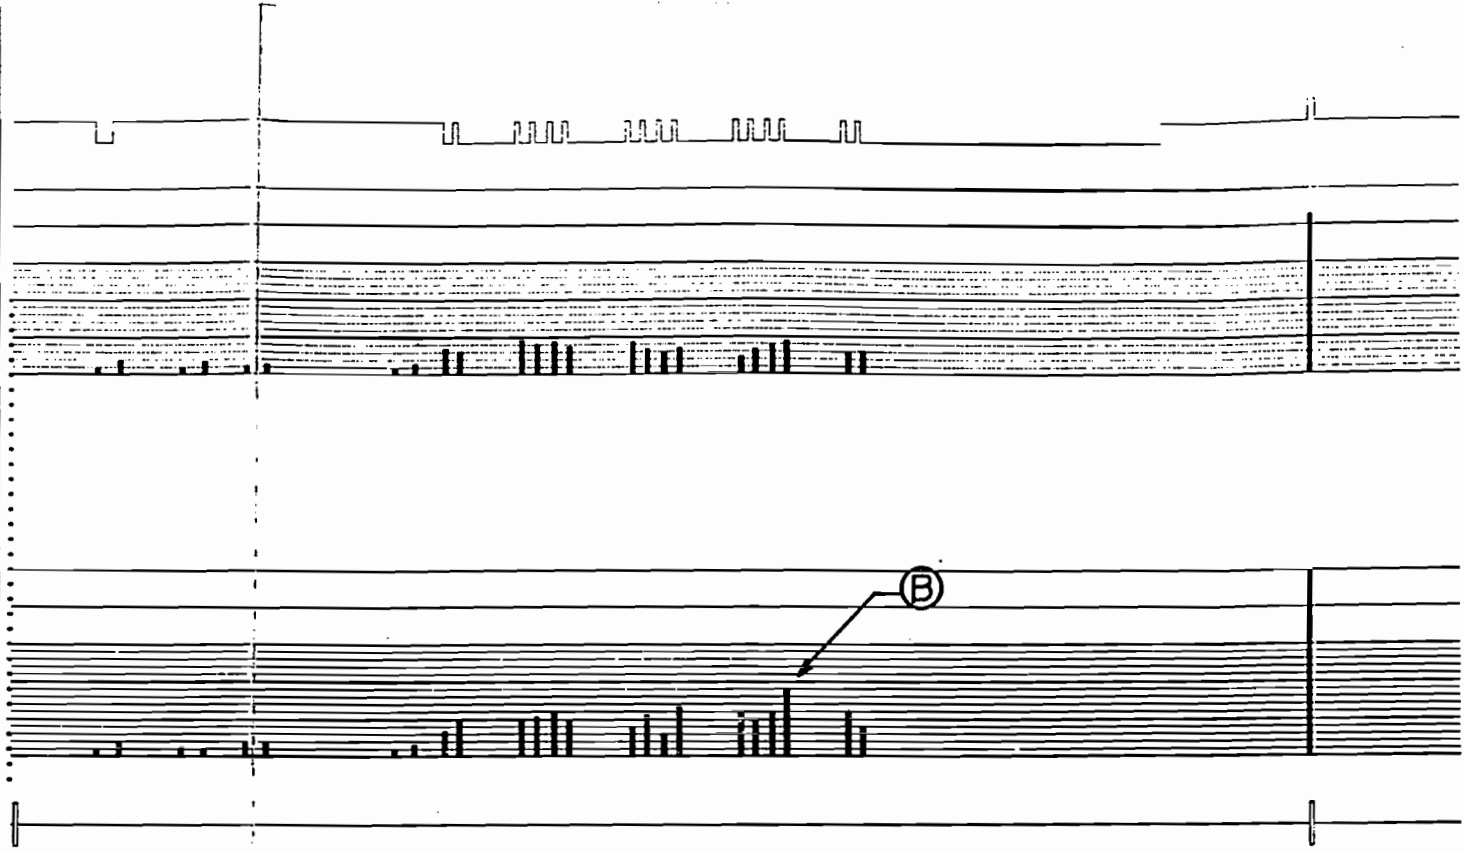
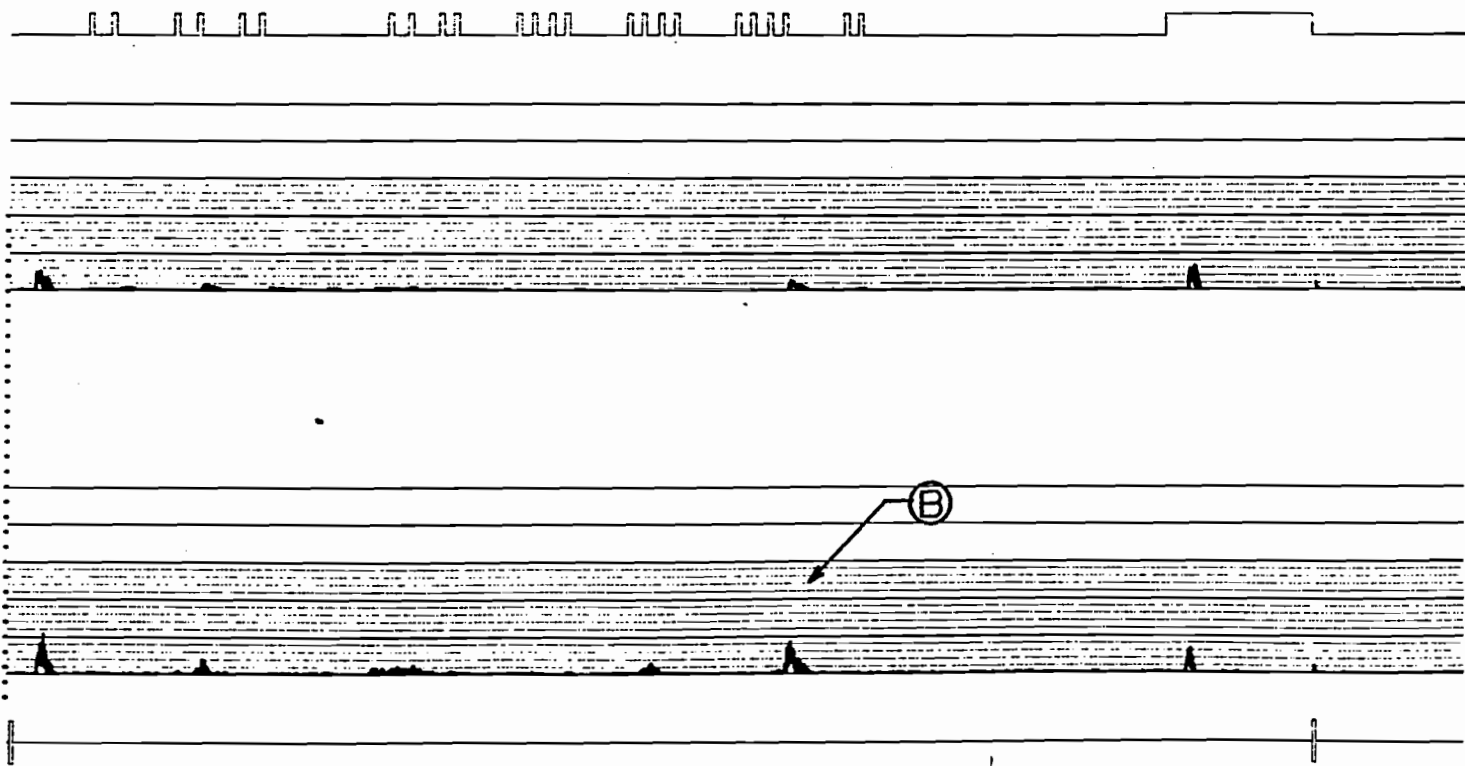
CHART 3

After a few passes around the RTT, bearing B tripped hot box alarms without emitting any significant acoustical noise. Bearing A, although hot as measured by on-board instrumentation, did not trip hot box alarms and was quiet. All of the other bearings behaved normally.

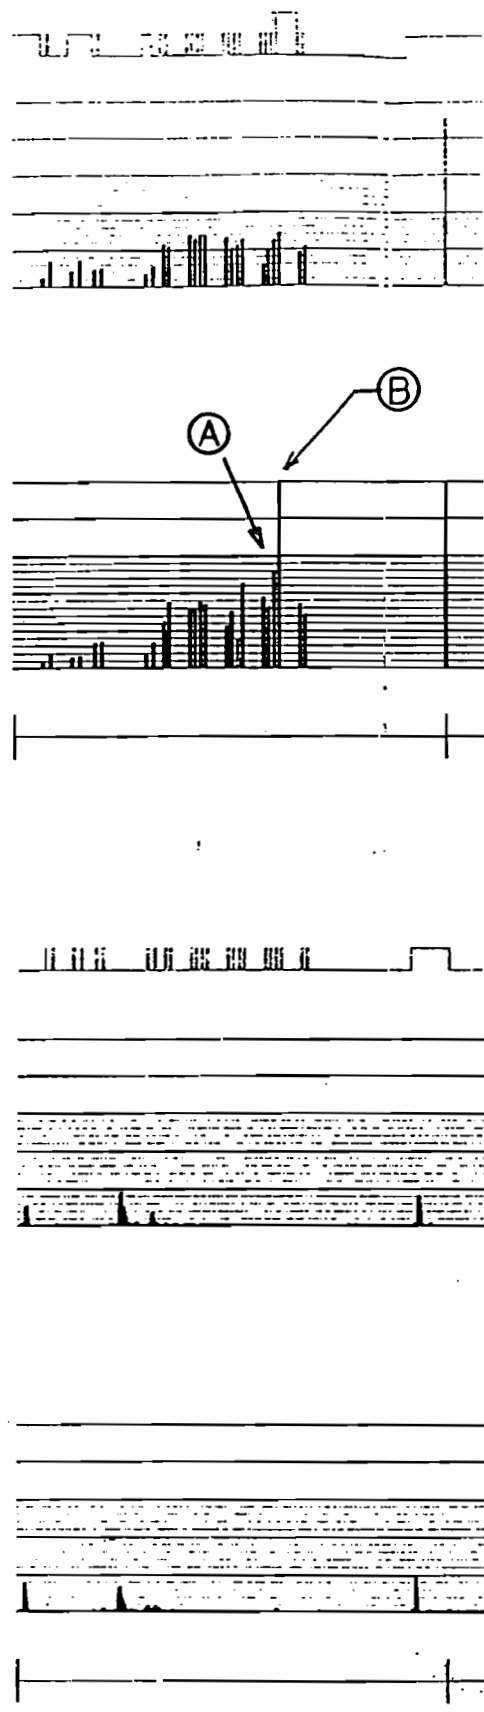
CHART 5

During the week of 13 March, the same behavior was repeated until finally both bearing A and B triggered hot box alarms without emitting significant acoustical noise (DATAGRAPH charts 5, 6, 7, and 8).

The wheelsets containing bearings A and B were replaced by normal wheelsets with no defects for the remaining weeks of the test. All survived to the 5,000 mile limit that was reached on Friday, 7 April. All bearings operated quietly without emitting significant acoustical signatures. Except for bearing U that triggered HBD alarms on 21, 23 and 28 March, all others operated with normal heat (DATAGRAPH charts 9, 10, 11, 12 and 13).

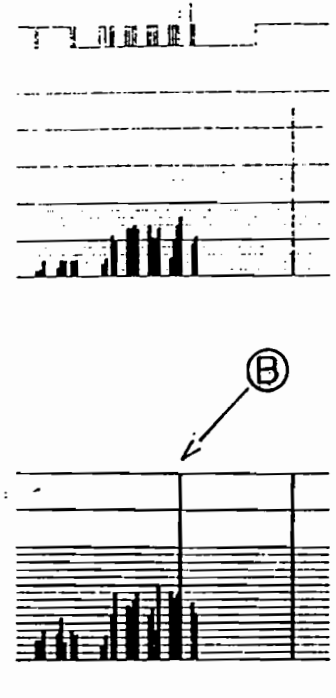
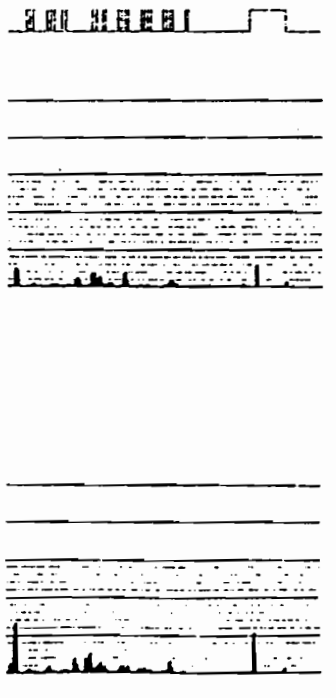
CHART 8

AXLE COUNT FROM HEAD
 ALARM TYPE HEAT RLM AXLE#
 HOT BEARING 25.2MM 2 24
 OTHER RAIL 8.0MM 1 24

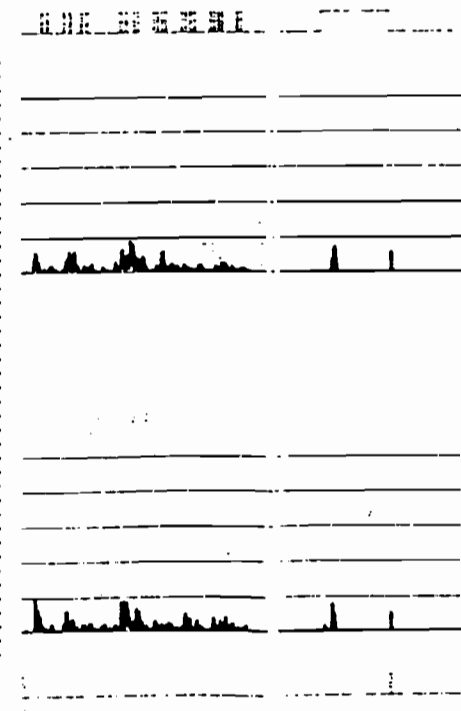
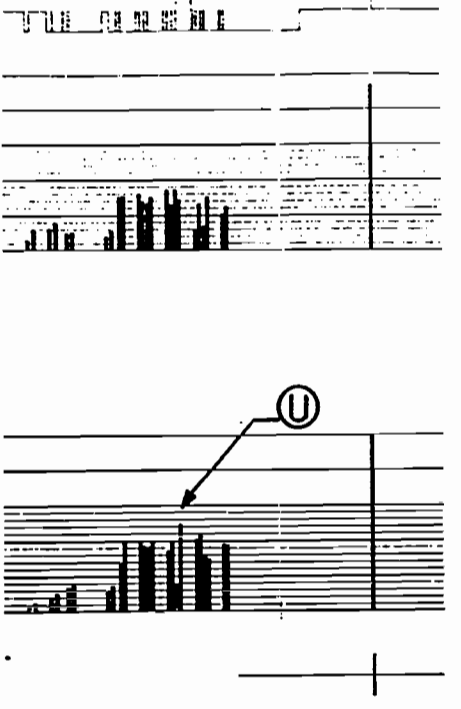
CHART 10

ALARM TYPE HEAT 2 18
HOT BEARING 12.0MM
