NBSIR 84-2858

REPORT NO. 11
OBSERVATIONS OF THE APRIL 8, 1979
RAILROAD ACCIDENT AT CRESTVIEW,
FLORIDA

April 1984

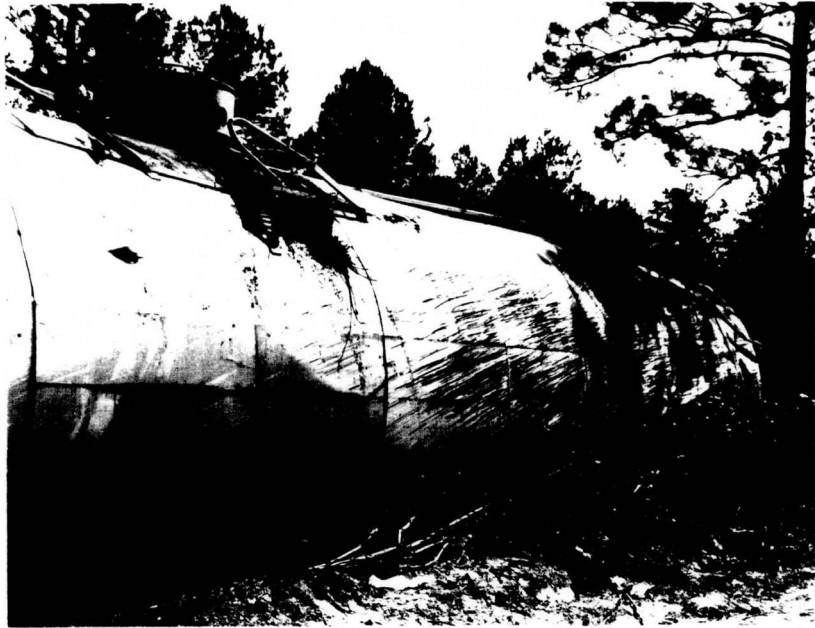
Jacket: No Jacket _____ or Describe: Photos show badly wrinkled jacket with a fracture of 2 3/4 inches by 12 inches in the 7th course from the A head. No significant damage to jacket on either A or B-heads.

Photo 1-1: Tank-car GATX 49258 showing rumpled jacket and fracture in the 7th jacket course from the A head.

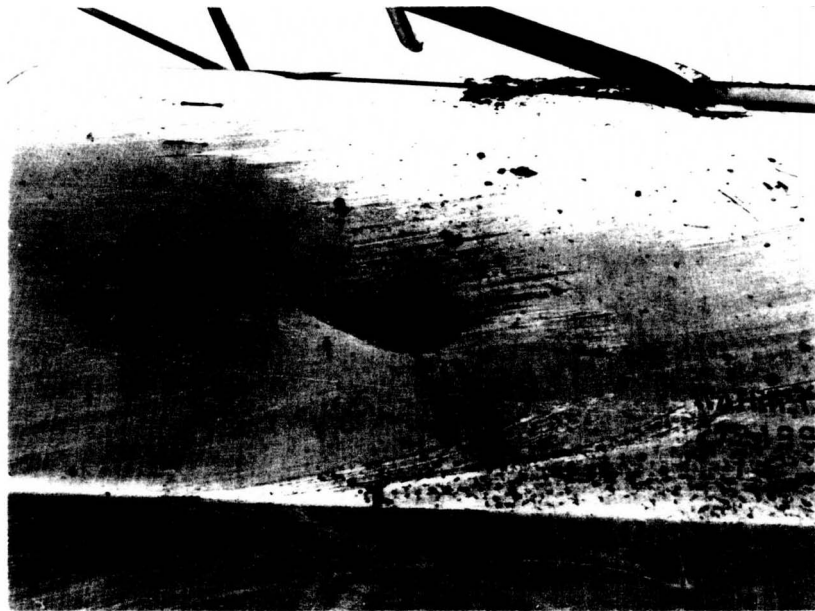
Photo 1-2: Close-up of 2 3/4 by 12 inches fracture in the 7th jacket course from the A head of tank-car GATX 49258.

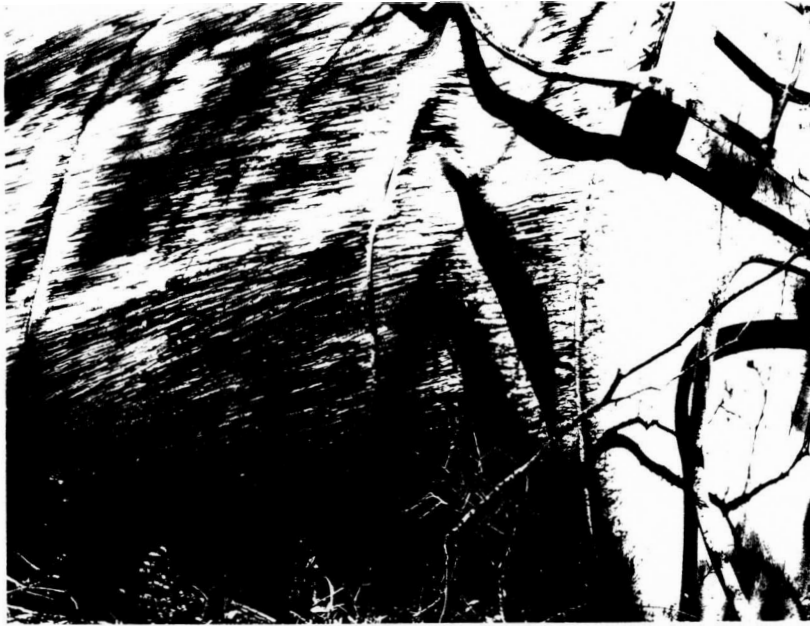
Photo C1-8: Close-up of rumped jacket at the A end of tank-car GATX 49258.

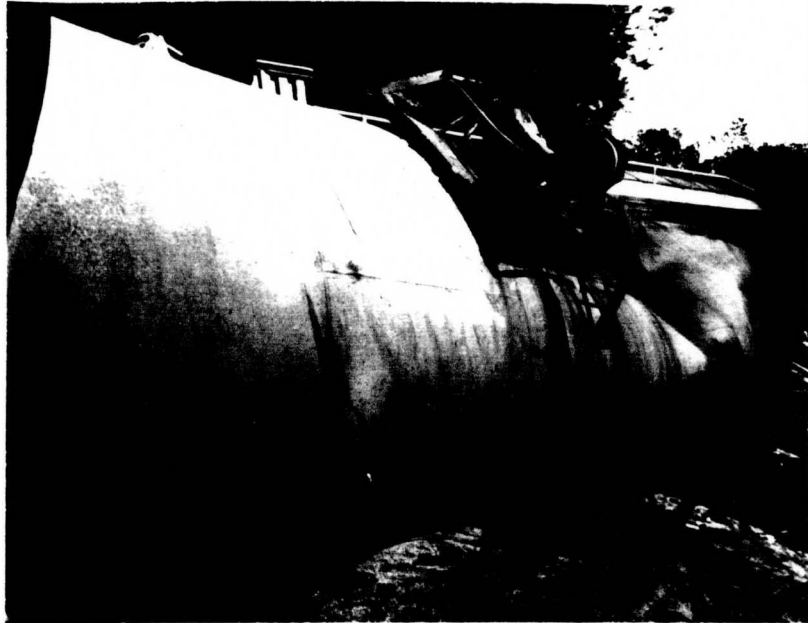
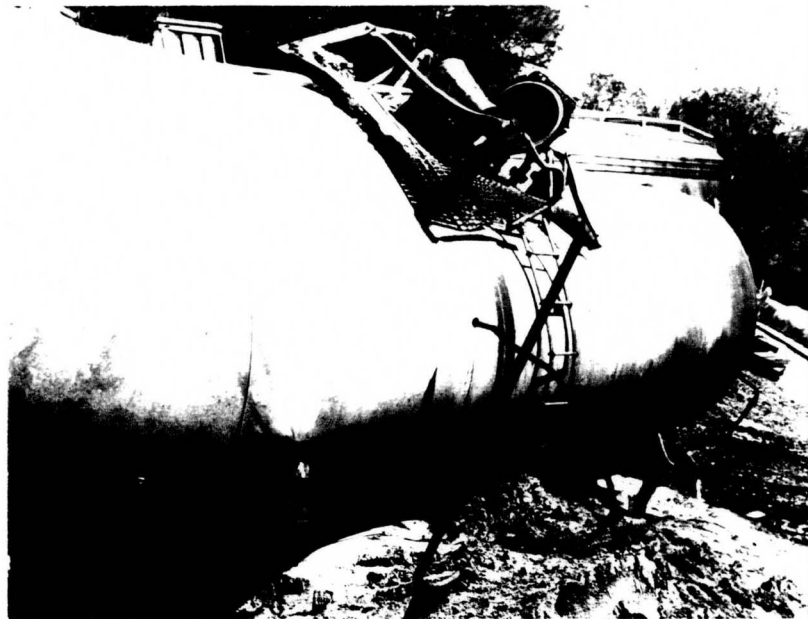
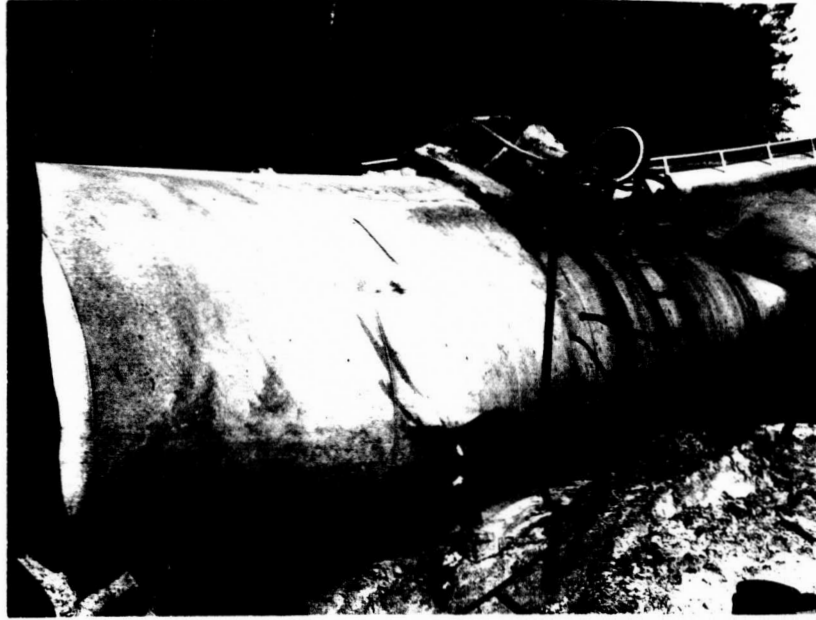
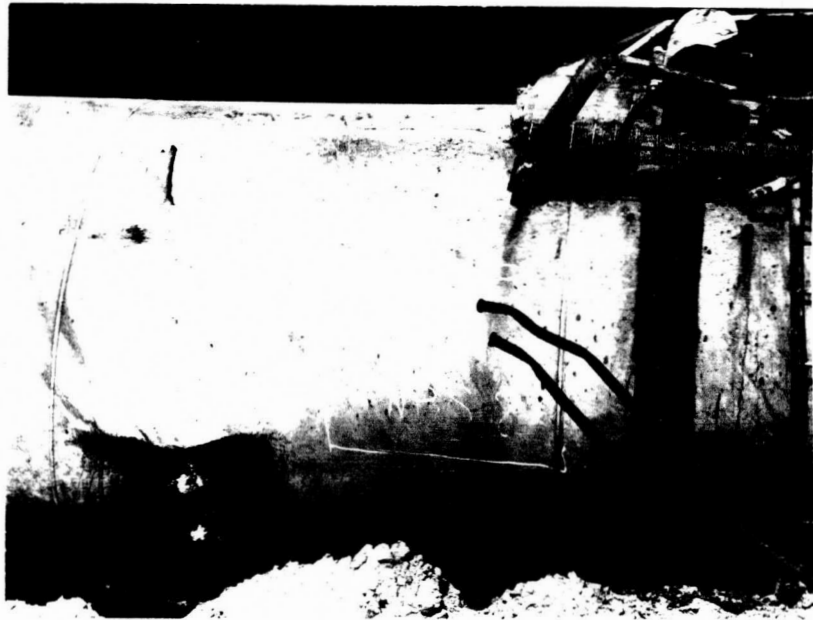
Shell and Head Plates: This very badly damaged car had only one fracture (in course 4). It was 17" long in a shell plate at a region of very high strain. NBS 8 contains course 4 and the weld to 3. The A-head contained a dent at the edge. (cont. on Attachment _____)

Photo 1-16: Tank-car GATX 44019 showing a 17 inch fracture.

Photo 1-17: Tank-car GATX 44019 showing a 17 inch fracture.

Photo 2-6: Tank-car GATX 44019 showing a 17 inch fracture.

Photo 2-5: Tank-car 44019 showing a closer view of a 17 inch fracture.

Photo 1-18: Close-up of a 17 inch fracture in tank-car GATX 44019.

Photo 1-19: Close-up of a 17 inch fracture in tank-car GATX 44019.

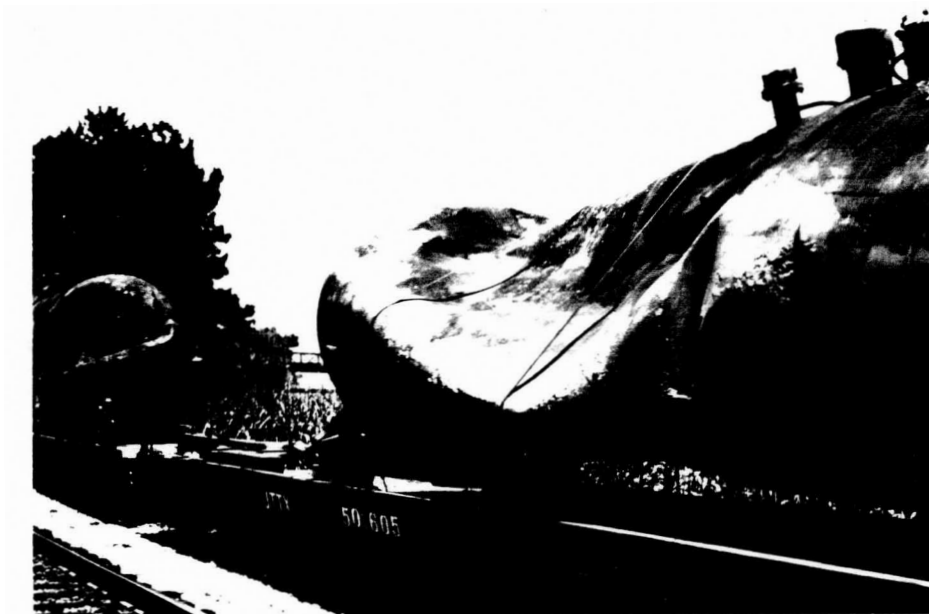
Photo C5-11: Crushed area of tank-car NATX 23367.

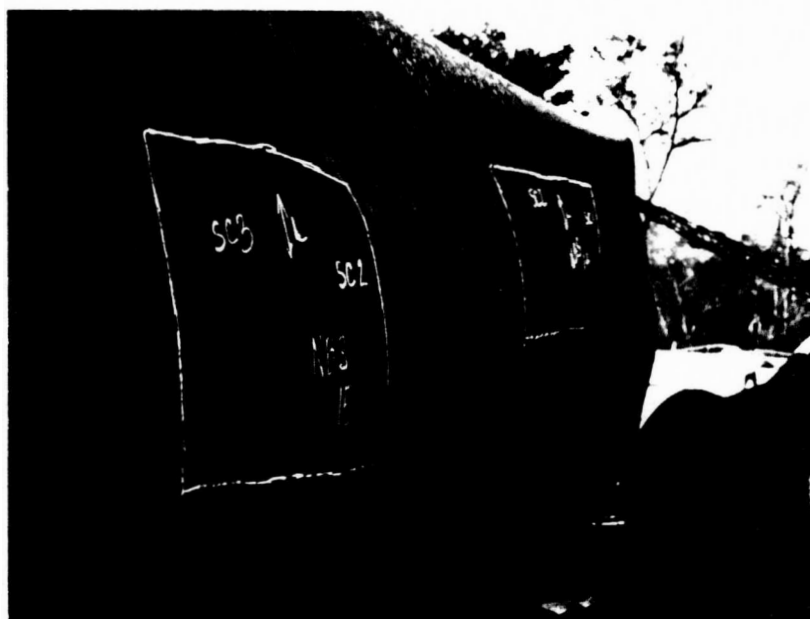
Shell and Head Plates: NBS 14 and 15 which contained badly damaged shell courses that took much abuse, had to be deleted (for economic reasons) from the list of sample plates taken for use at NBS. The samples were in relatively undeformed parts of these shell courses. B-head contains no significant damage. (cont. on Attachment _____)

Photo 2-22: Close-up of a relatively undeformed area of badly damaged shell courses of tank-car NATX 23367.

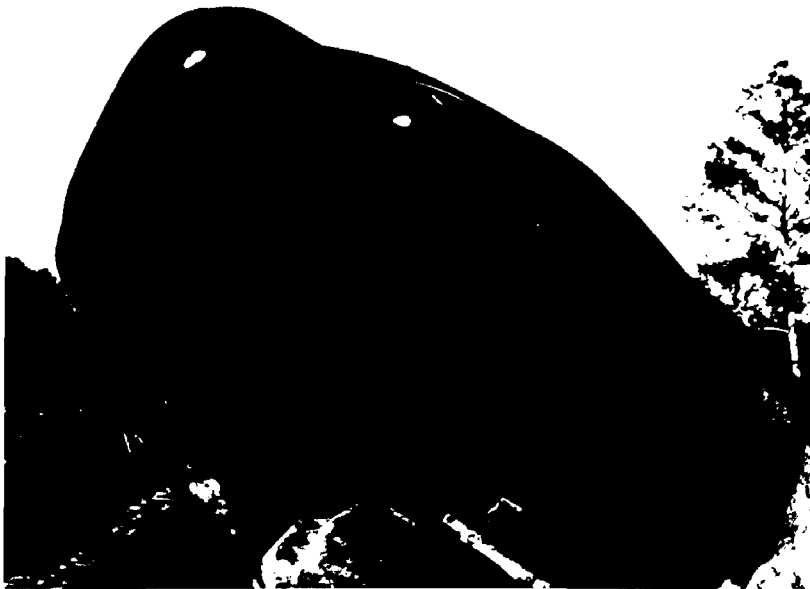
Shell and Head Plates: Failed circumferentially into two parts: one was badly flattened and contained NBS 6. The other contained NBS 4 on a badly damaged, but not fractured head, as (cont. on Attachment A)
Sill, Coupler, Wheel, other parts (in that order) _____

Photo C4-13: Circumferential fracture of the B-end tub of tank-car ACFX 89990.

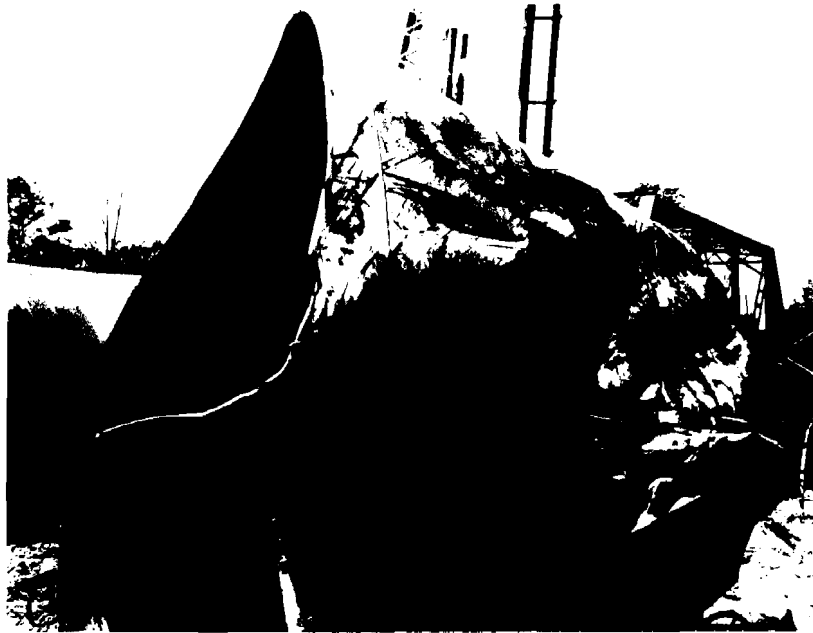
North side tub, with 1-1/2 shell courses, is shown to be less affected by fire. See the photo 1-37 of this tub. The fracture face of this tub is shear everywhere except the part marked NBS 3.

Photo 1-37: North side tub (B-end) of tank-car
IMCX 2513.

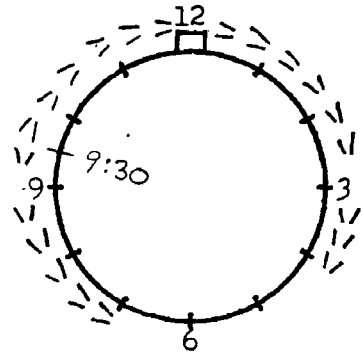
Location Fracture on B-end.
Shell course 2.

Brittle
Fracture on B-end 9:30 - 4:00

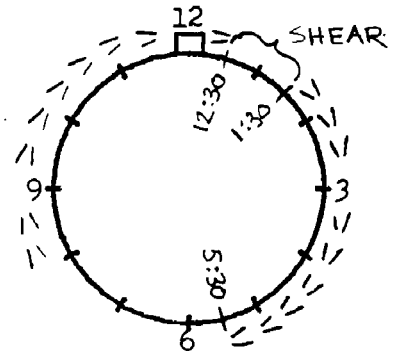
Location Fracture on A-end.
Shell course 2.

Ductile
Fracture on A-end 8:00 - 12:30 1:30 - 5:30

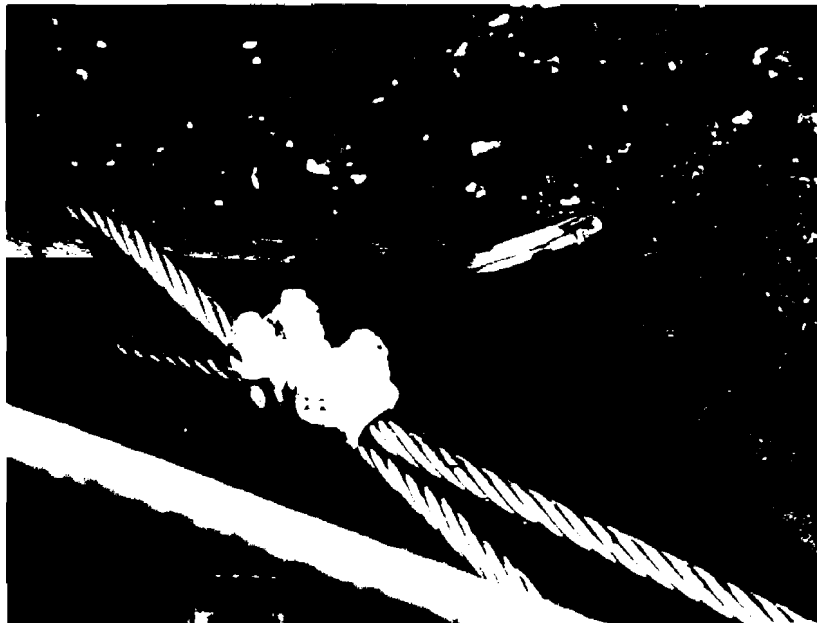
Photo C4-3: Close-up of the probable fracture origin
of the north side tub (8-end) of tank-
car ICX 2827.
