REPORT NO. RR930-PM-79-23
AUGUST 1979

EXAMINATION OF CRACKS IN WABCO AND KNORR DISC BRAKES

PROJECT MEMORANDUM

U.S. DEPARTMENT OF TRANSPORTATION
RESEARCH AND SPECIAL PROGRAMS ADMINISTRATION
TRANSPORTATION SYSTEMS CENTER
Cambridge MA 02142

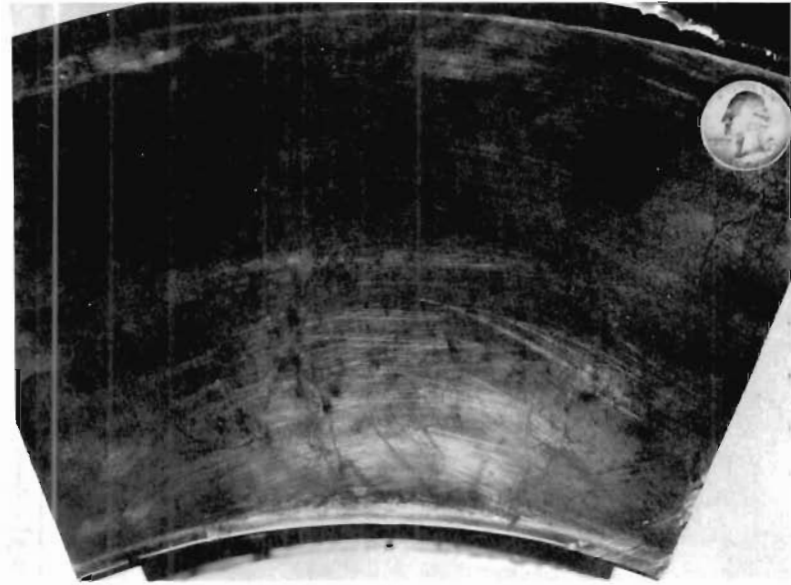
Two types of cracks were observed in both the Wabco and Knorr disc brakes. Cracks of the first type were small, ran in a radial direction, and were located in the middle region of the braking surface (Figures 1-3). These cracks are commonly called heat checks and are not unusual in braking surfaces. The density of cracks varied between the two designs (0.5 crack/cm² for Wabco; 0.1 crack/cm² for Knorr). The Knorr disc had few observable heat checks. Those observed were approximately 4 cm in length and 1 to 2 cm in cross-sectional depth. The Wabco disc had numerous heat checks, with some as long as 10 cm. Their cross-sectional depth was also 1 to 2 cm (Figures 1, 4, and 5).

FIGURE 1. WABCO DISC BRAKE WITH HEAT CHECKS IN MIDDLE OF DISC. THE CRACKS RUN RADIALY ACROSS THE BRAKING SURFACE

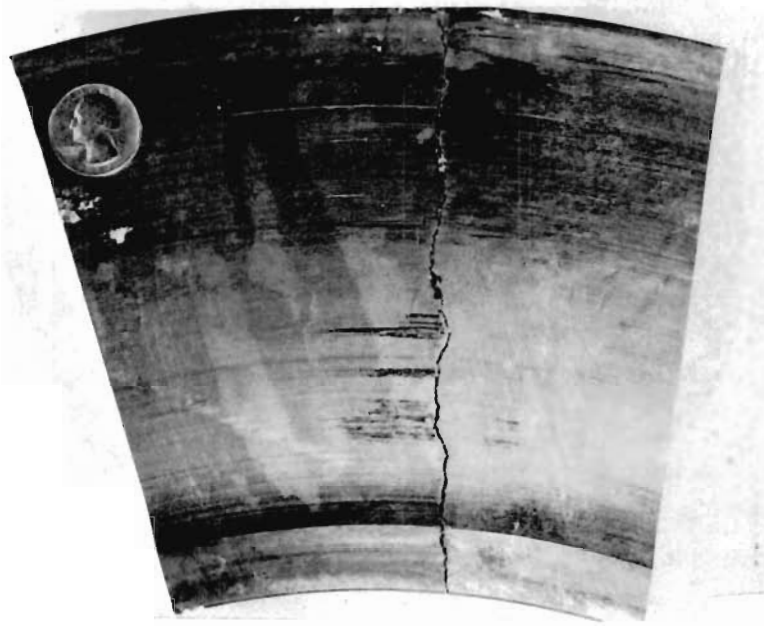
FIGURE 2. KNORR DISC BRAKE WITH HEAT CHECKS (minor cracks) AND MAJOR CRACKS. THE CRACK RUNS FROM THE INNER RADIAL EDGE (lower part of photograph) TO THE OUTER RADIAL EDGE (upper part of photograph).

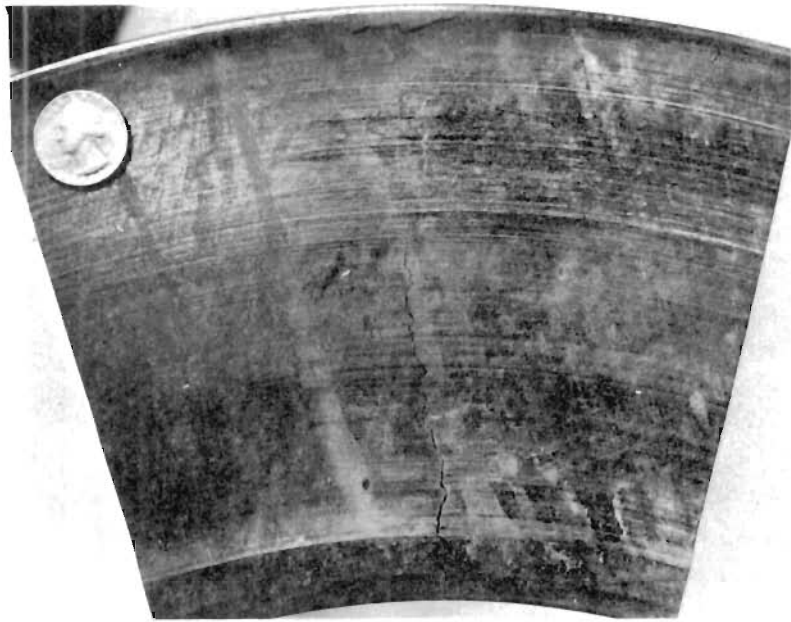
The second type was a major crack passing through the disc thickness. This type of crack was also found in both designs, but with a difference in location. In the Knorr discs, the major cracks had an open end at the inner radial edge of the disc. The cracks ran across the disc in a nearly radial direction with a crack tip generally located a distance from the outer radial edge, but with some cracks completely crossing the disc (Figures 2, 3, 6 and 7). When the major cracks were opened, the crack surfaces were found to be worn and corroded. No information as to the origin of fatigue could be determined. The fact that all of the major cracks in the Knorr disc had at least one open end at the inner edge suggests the origin was at the inner radial edge (Figure 6). All of the major cracks in the Knorr disc occurred between the disc boss and an adjacent cooling fin (See Figure 8).

FIGURE 3. KNORR DISC BRAKE WITH MAJOR CRACK WITH OPEN END AT THE INNER RADIAL EDGE.

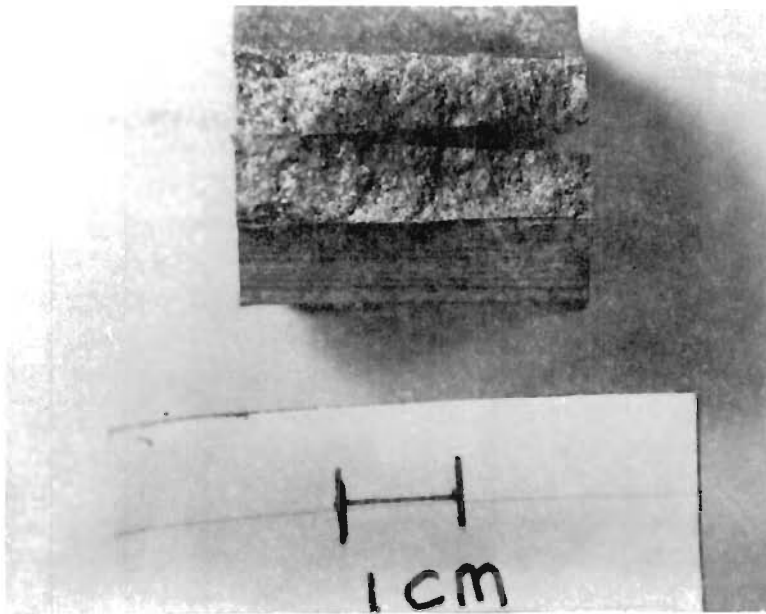
FIGURE 4. WABCO DISC BRAKE HEAT CHECK CRACK. THE CRACK WAS OPENED TO REVEAL THE CRACK SURFACE. THE DARK REGION IS THE CRACK, THE BRIGHTER REGION IS THE REGION FRACTURED TO OPEN THE CRACK. THE DARK MATERIAL IS CORROSION PRODUCTS.

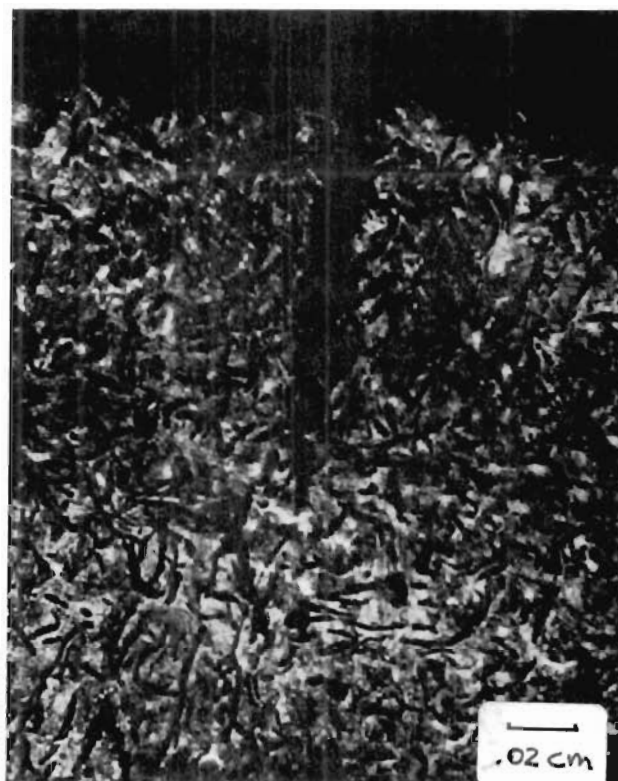
FIGURE 5. CROSS SECTION OF HEAT CHECK IN KNORR DISC BRAKE. THE MAGNIFICATION IS 50X. THE BLACK SEGMENTS IN THE METAL ARE THE GRAPHITE FLAKES.

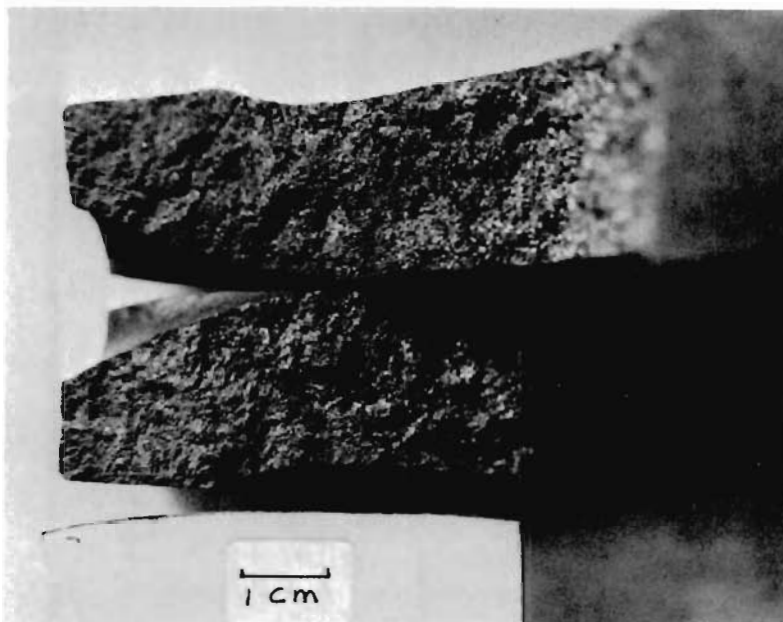
FIGURE 6. CRACK SURFACE OF KNORR NEAR INNER RADIAL EDGE. THE BRAKING SURFACE IS THE TOP EDGE OF THE UPPER PART AND THE BOTTOM EDGE OF THE LOWER PART. THE REGION TO THE LEFT LACKING LUSTER IS THE ORIGINAL CRACK SIZE; THE REST OF THE CRACK SURFACE IS FROM THE OPENING OF THE CRACK. THE DEPRESSION THAT FORMS ON THE BRAKING SURFACE IS A RESULT OF WEAR.

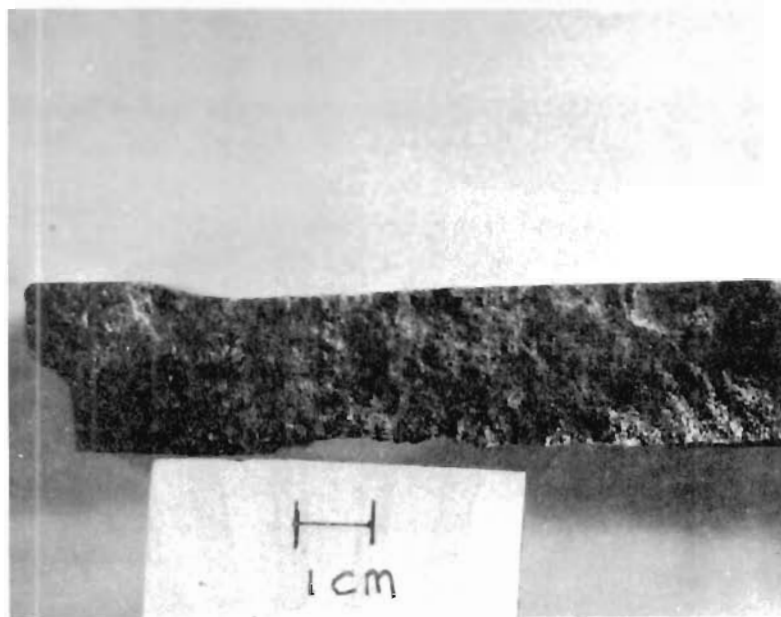
The length of time each disc was in service is unknown. However, the depth of the depressions on the brake disc surfaces indicate that the Knorr disc has lost approximately twice the amount of material as the Wabco disc. The depression is a result of wear caused during braking action (Figures 7 and 8).

FIGURE 7. CRACK SURFACE OF KNORR MAJOR CRACK. THE DARK REGION IS THE CORRODED AND WORN AREA. THE UPPER EDGE IS THE BRAKING SURFACE. NOTE THE WEAR DEPRESSION.

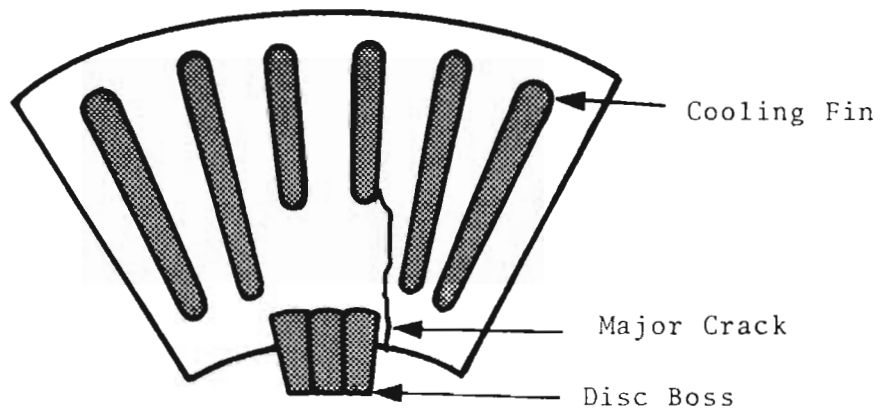
FIGURE 8. KNORR DISC CROSS-SECTION SHOWING LOCATION OF MAJOR CRACK NEAR HUB-DISC CONNECTION.

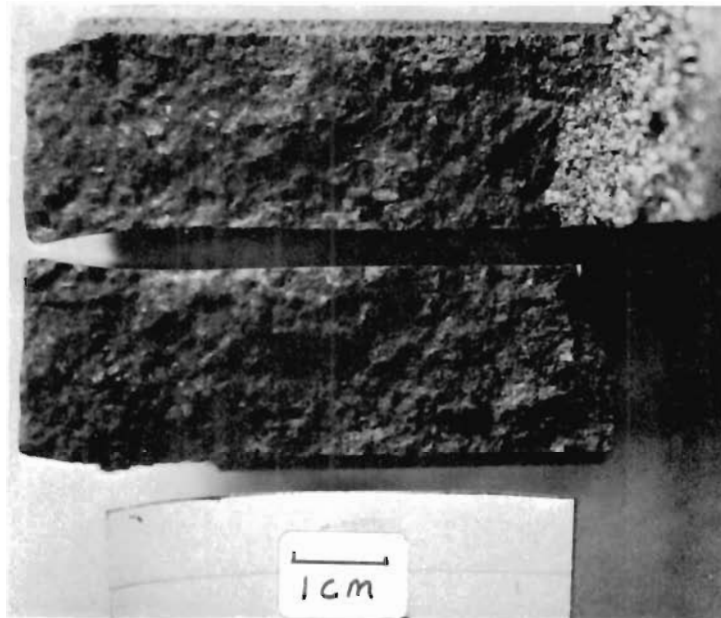
The Wabco disc had only one major crack. It was located with an open end at the outer radial edge of the disc. The crack was nearly radial, with the crack tip stopping in the middle of the braking surface (Figure 9). Because of the condition of the crack surface, no additional information was obtained. The major crack branched into the heat checks that crossed its path.

FIGURE 9. WABCO MAJOR CRACK NEAR THE OUTER RADIAL EDGE. THE DARK MATERIAL IS THE CORRODED AND WORN REGION. THE BRAKING SURFACES ARE THE MIDDLE EDGES. THE DEPRESSION IN THE BRAKING SURFACE IS A RESULT OF WEAR.

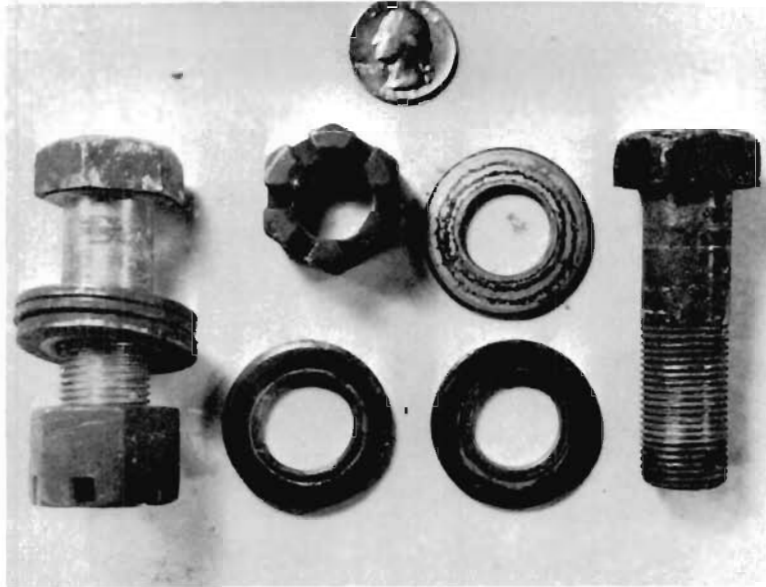
The connecting bolts showed no signs of wear (Figure 10). Scratches on the surface had removed the protective coating which appeared to have been a copper alloy. No debris was detected on the bolt surfaces. The bolts showed no signs of cracking or failure. No apparent damage was observed to have occurred to the nuts or washers.

FIGURE 10. WABCO BOLTS AS RECEIVED. NOTE SURFACE CONDITION BEING FAIRLY SMOOTH WITH NO APPARENT WEAR.

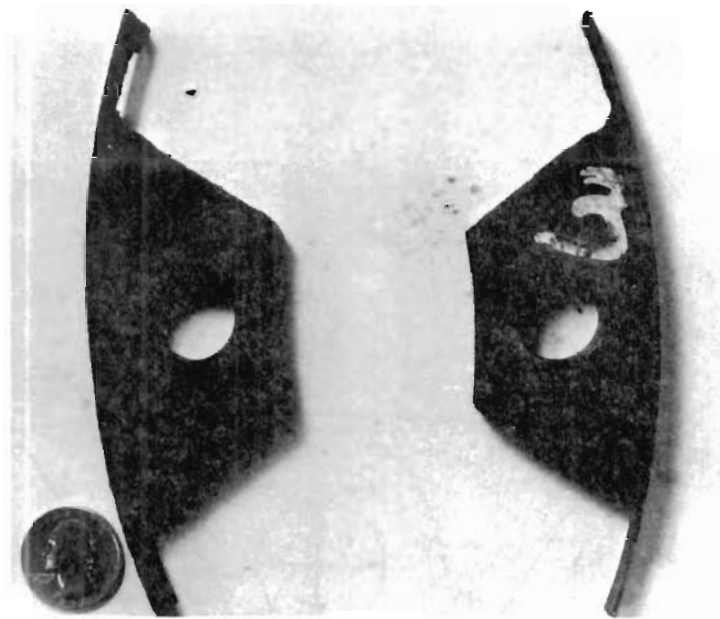
Measurements were taken of the tang holes in two directions, the rolling and radial directions (Figures 11 and 12), and at the outside and inside surfaces. The acceptable diameter, as stated by Wabco, is between 0.745 and 0.805 inch. All measurements were within these limits (Table 1). The holes appear to have elongated in the radial direction. No major differences were detected between the outside and inside surface measurements.

FIGURE 11. WABCO BRAKE DISC TANGS AS RECEIVED. SHOWN ARE THE STAMPED (left) AND PAINTED (right) SIDES OF HOLES NUMBER 2 AND 3. THE SIDE WITH THE LARGE PAINTED THREE IS THE OUTSIDE SURFACE WHILE THE OTHER HOLE SHOWS THE SURFACE THAT WAS IN CONTACT WITH THE HUB.

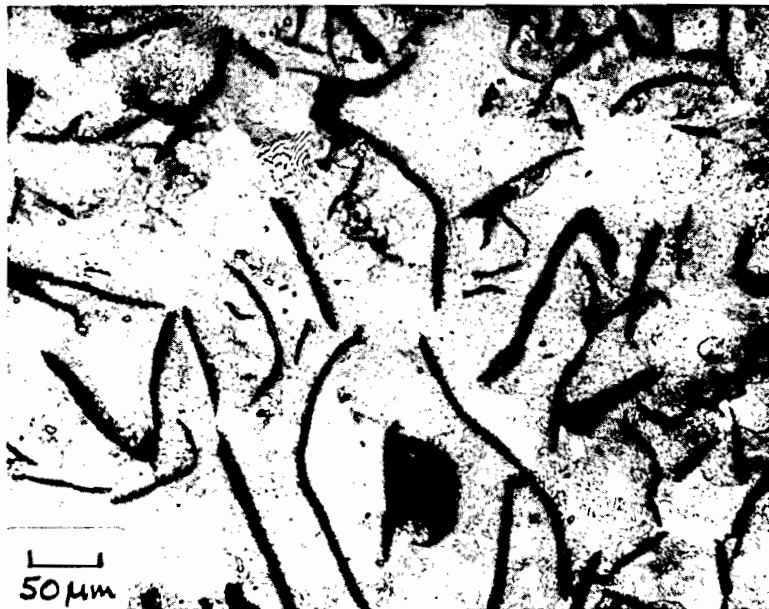
The microstructure of the tangs consisted of pearlite colonies with randomly distributed and oriented graphite flakes (Figure 16). This is typical of a gray cast iron. The microstructure of the tangs was very similar to that of the disc region of the brake (Figures 16 through 18). The graphite flake density for the tangs was $2.8 \times 10^4 / \text{cm}^2$, while in the disc it was 2.3×10^4 flakes/cm². The average colony size in the tangs was 40 μm while in the disc it was 35 μm . These differences could account for the differences in microhardness between the disc and tangs.

FIGURE 16. MICROSTRUCTURE OF WABCO DISC BRAKE TANG. THE SAMPLE WAS TAKEN NEAR THE HOLE SURFACE. MAGNIFICATION 560X.
